SOUTH CAROLINA AERONAUTICS COMMISSION

STATEWIDE AIRFIELD PAVEMENT MANAGEMENT SYSTEM UPDATE

6J4 - Saluda County Airport

2023

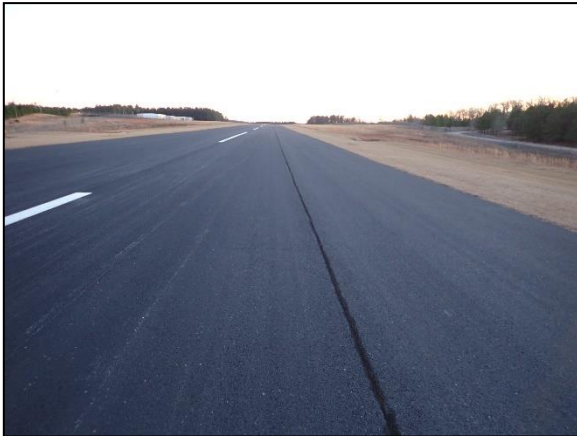
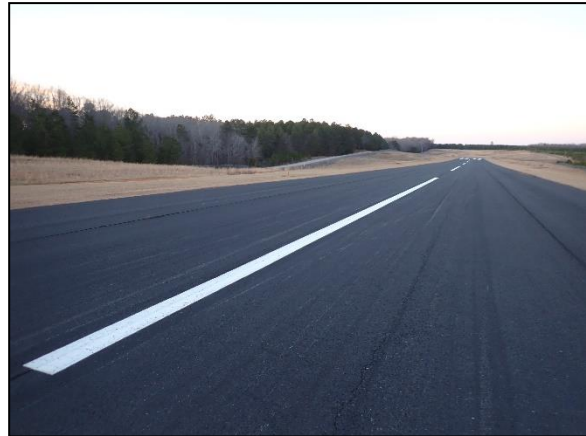
RW 1-10

Branch ID	Branch Use	Number of Sections	Branch Area (SF)	Branch Area-Weighted Avg PCI	Branch Condition Rating
RW 1	RUNWAY	1	191,340	65	Fair

Section ID	Area (SF)	Surface	Est. Last Major Work Year	Est. Last Global Treatment Year	PCI	Condition Rating	PCI % Climate	PCI % Load	PCI % Other
10	191,340	AAC	2005	2015	65	Fair	100	0	0

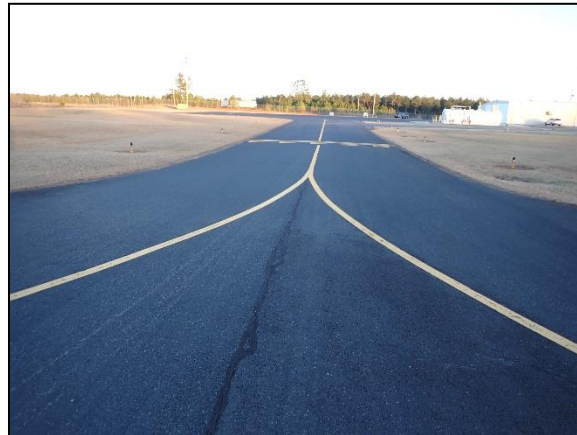
TW A-10

Branch ID	Branch Use	Number of Sections	Branch Area (SF)	Branch Area-Weighted Avg PCI	Branch Condition Rating
TW A	TAXIWAY	1	9,822	73	Satisfactory

Section ID	Area (SF)	Surface	Est. Last Major Work Year	Est. Last Global Treatment Year	PCI	Condition Rating	PCI % Climate	PCI % Load	PCI % Other
10	9,822	AC	1967	2015	73	Satisfactory	100	0	0

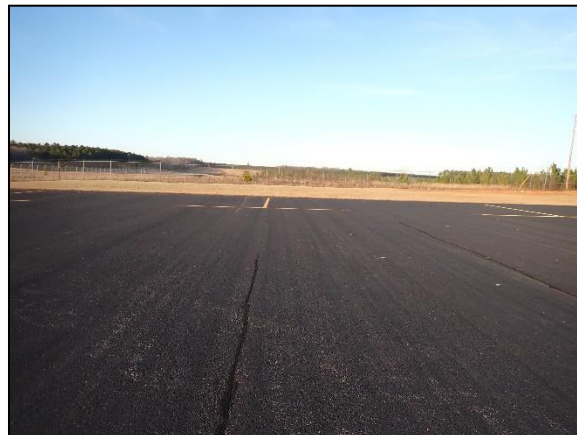
AP 01-10

Branch ID	Branch Use	Number of Sections	Branch Area (SF)	Branch Area-Weighted Avg PCI	Branch Condition Rating
AP 01	APRON	2	32,311	72	Satisfactory

Section ID	Area (SF)	Surface	Est. Last Major Work Year	Est. Last Global Treatment Year	PCI	Condition Rating	PCI % Climate	PCI % Load	PCI % Other
10	27,575	AAC	2005	2015	67	Fair	100	0	0
20	4,736	PCC	2021	-	100	Good	0	0	0

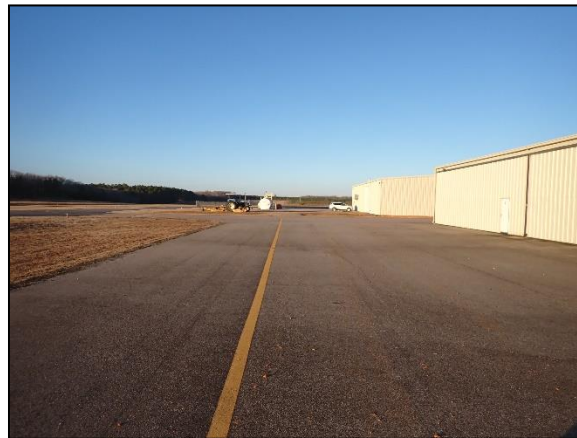
AP 02-10

Branch ID	Branch Use	Number of Sections	Branch Area (SF)	Branch Area-Weighted Avg PCI	Branch Condition Rating
AP 02	APRON	1	30,795	82	Satisfactory

Section ID	Area (SF)	Surface	Est. Last Major Work Year	Est. Last Global Treatment Year	PCI	Condition Rating	PCI % Climate	PCI % Load	PCI % Other
10	30,795	AC	2012	-	82	Satisfactory	100	0	0
