SOUTH CAROLINA AERONAUTICS COMMISSION

# STATEWIDE AIRFIELD PAVEMENT MANAGEMENT SYSTEM UPDATE

DLC - Dillon County Airport

2023

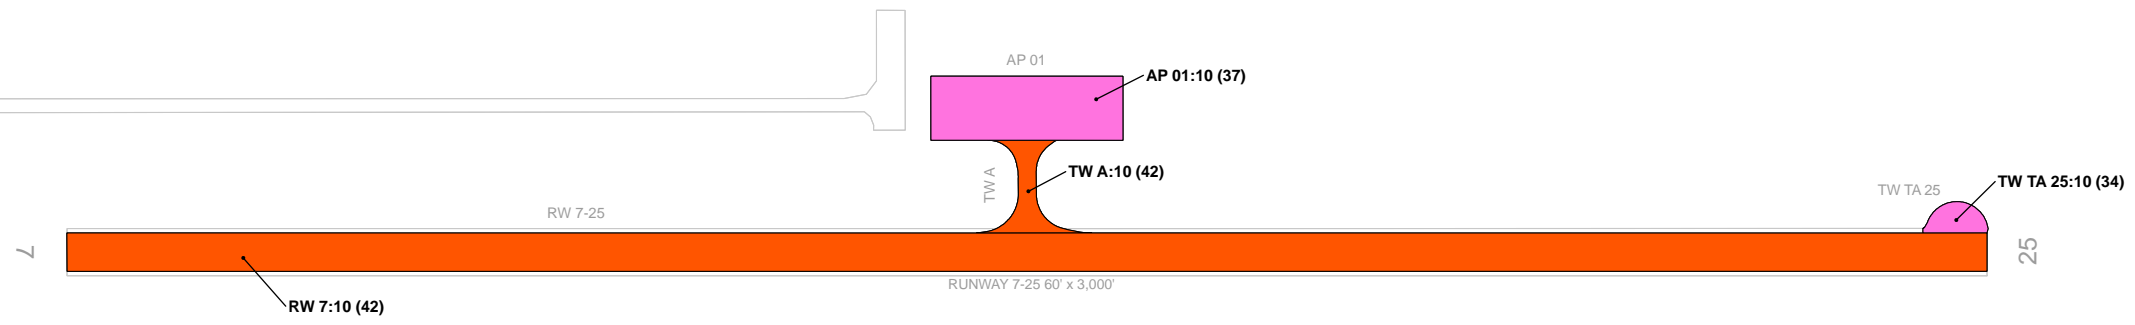
The PCI survey for Dillon County Airport (DLC) was performed in January 2023. **The overall area-weighted average PCI value of the network was 41**, representing a condition rating of **Poor**. None of inspected pavements are in Good, Satisfactory or Fair condition. All the pavements are in Poor or worse condition as summarized in **Figure 4**.

Network ID	Branch ID	Branch Use	Section ID	Area (SF)	Surface	PCI	Condition Rating	PCI% Climate	PCI% Load	PCI% Other
DLC	AP 01	Apron	10	30,000	AC	37	Very Poor	100	0	0
DLC	RW 7	Runway	10	180,000	AC	42	Poor	100	0	0
DLC	TW A	Taxiway	10	6,864	AC	42	Poor	100	0	0
DLC	TW TA25	Taxiway	10	3,807	AC	34	Very Poor	68	32	0

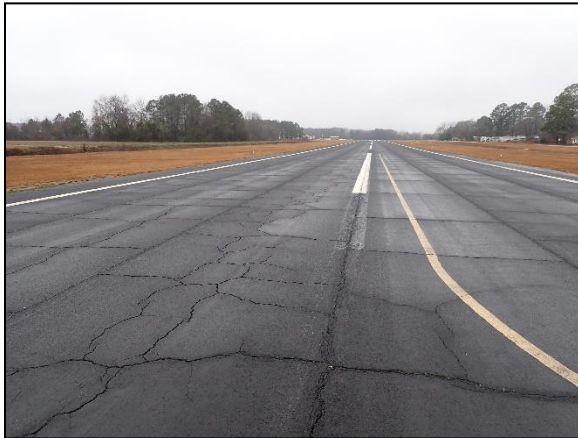
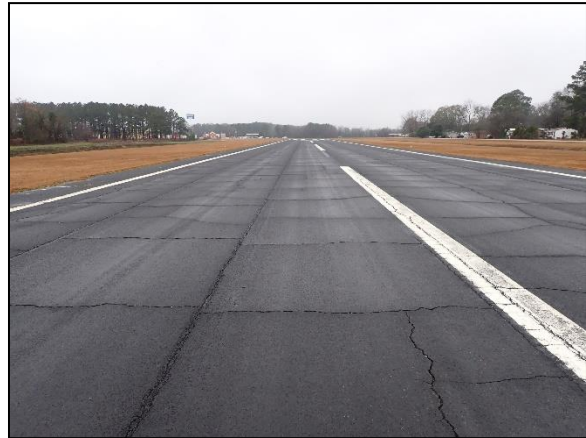
RW 7-10

Section ID	Area (SF)	Surface	Est. Last Major Work Year	Est. Last Global Treatment Year	PCI	Condition Rating	PCI % Climate	PCI % Load	PCI % Other
10	180,000	AC	1967	2015	42	Poor	100	0	0

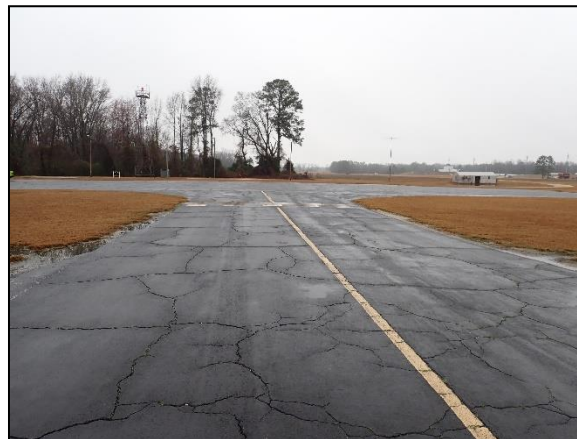
TW A-10

Section ID	Area (SF)	Surface	Est. Last Major Work Year	Est. Last Global Treatment Year	PCI	Condition Rating	PCI % Climate	PCI % Load	PCI % Other
10	6,864	AC	1967	2015	42	Poor	100	0	0

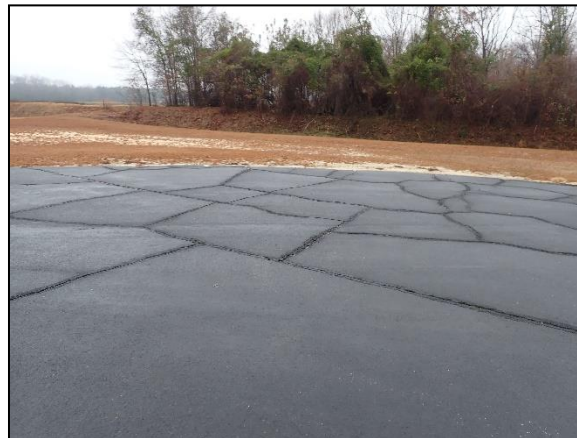
TW TA 25-10

Section ID	Area (SF)	Surface	Est. Last Major Work Year	Est. Last Global Treatment Year	PCI	Condition Rating	PCI % Climate	PCI % Load	PCI % Other
10	3,807	AC	1967	2015	34	Very Poor	68	32	0

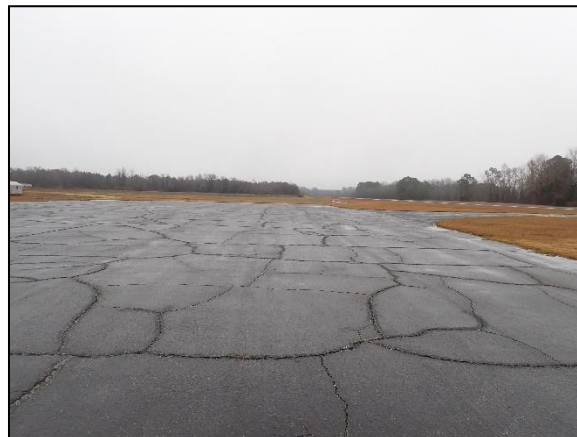
AP 01-10

Section ID	Area (SF)	Surface	Est. Last Major Work Year	Est. Last Global Treatment Year	PCI	Condition Rating	PCI % Climate	PCI % Load	PCI % Other
10	30,000	AC	1967	-	37	Very Poor	100	0	0
