# SOUTH CAROLINA AERONAUTICS COMMISSION

# STATEWIDE AIRFIELD PAVEMENT MANAGEMENT SYSTEM UPDATE

PHH - Robert F. Swinnie Airport

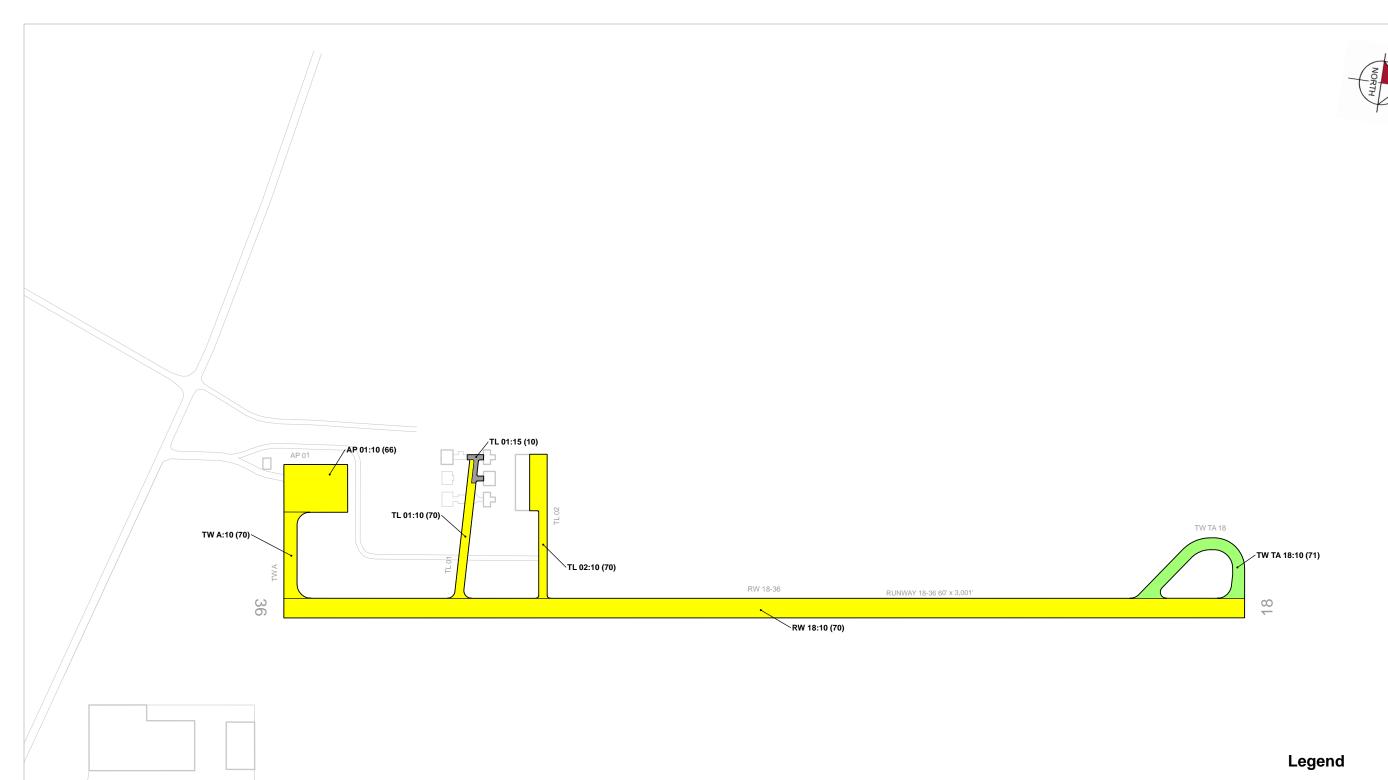
The area-weighted average PCIs by branch use are summarized in the figure below. The current PCIs at a section-level are displayed graphically on the **2023 Airfield Pavement Condition Index Exhibit** and are summarized in **Table 2**.

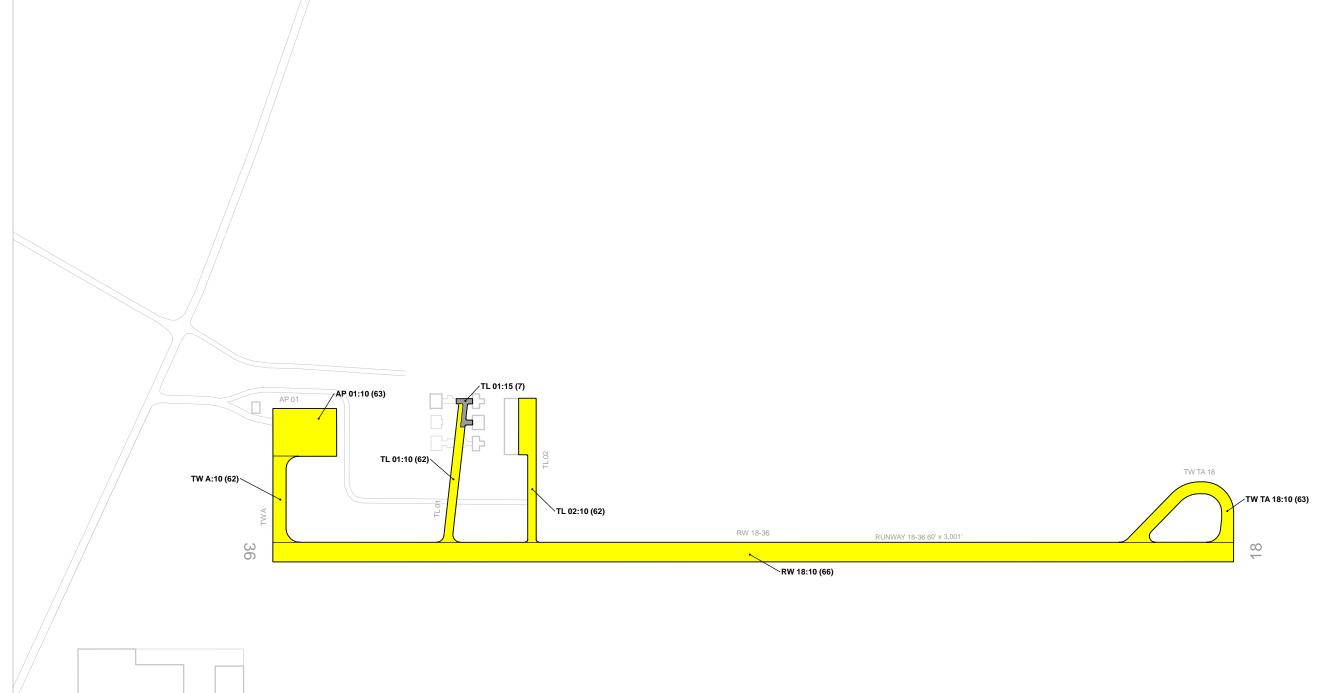
Network	Branch ID	Section ID	Current					
ID	Branchib	Section ib	PCI	2024	2025	2026	2027	2028
PHH	AP 01	10	66	65	65	64	63	63
PHH	RW 18	10	70	69	68	68	67	66
PHH	TL 01	10	70	68	67	65	64	62
PHH	TL 01	15	10	10	9	8	8	7
PHH	TL 02	10	70	68	67	65	64	62
PHH	TW A	10	70	68	67	65	64	62
PHH	TW TA 18	10	71	69	68	66	65	63
