SOUTH CAROLINA AERONAUTICS COMMISSION

STATEWIDE AIRFIELD PAVEMENT MANAGEMENT SYSTEM UPDATE

PYG - Pageland Airport

2023

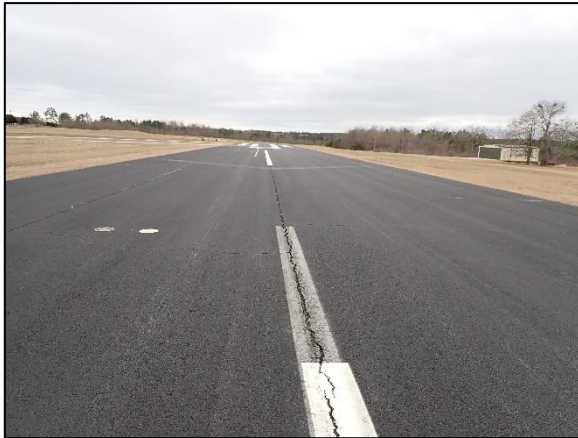
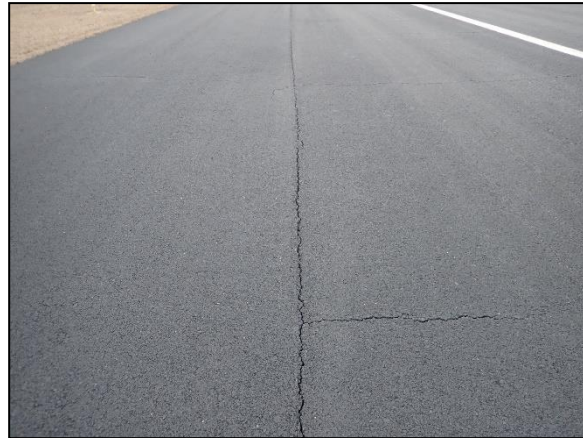
RW 6-10

Section ID	Area (SF)	Surface	Est. Last Major Work Year	Est. Last Global Treatment Year	PCI	Condition Rating	PCI % Climate	PCI % Load	PCI % Other
10	203,760	AC	2003	2017	62	Fair	100	0	0

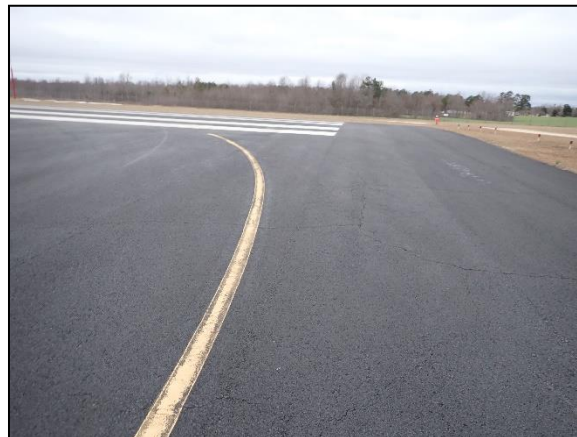
TW A-10

Section ID	Area (SF)	Surface	Est. Last Major Work Year	Est. Last Global Treatment Year	PCI	Condition Rating	PCI % Climate	PCI % Load	PCI % Other
10	6,539	AC	2003	2017	64	Fair	100	0	0

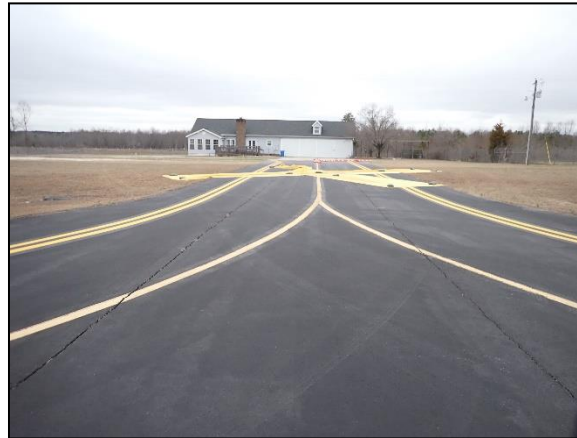
TW B-10

Section ID	Area (SF)	Surface	Est. Last Major Work Year	Est. Last Global Treatment Year	PCI	Condition Rating	PCI % Climate	PCI % Load	PCI % Other
10	9,735	AC	2012	2017	63	Fair	100	0	0

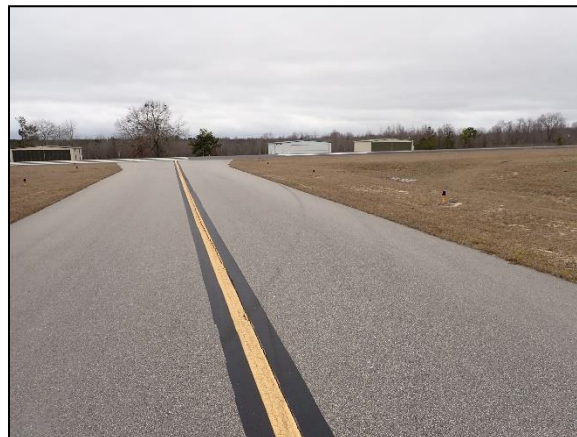
TW TA 6-10

Section ID	Area (SF)	Surface	Est. Last Major Work Year	Est. Last Global Treatment Year	PCI	Condition Rating	PCI % Climate	PCI % Load	PCI % Other
10	14,473	AC	2018	-	88	Good	100	0	0

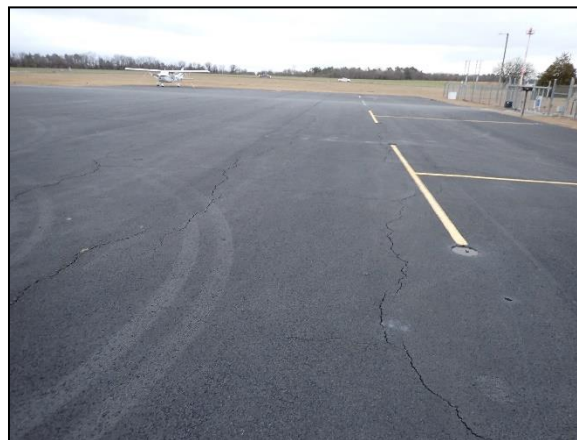
AP 01-10

Section ID	Area (SF)	Surface	Est. Last Major Work Year	Est. Last Global Treatment Year	PCI	Condition Rating	PCI % Climate	PCI % Load	PCI % Other
10	27,450	AC	2003	2017	64	Fair	100	0	0
