2022 Pavement Condition Index Report

Charleston International Airport

For The
Charleston County Aviation Authority

Issued: January 18, 2024

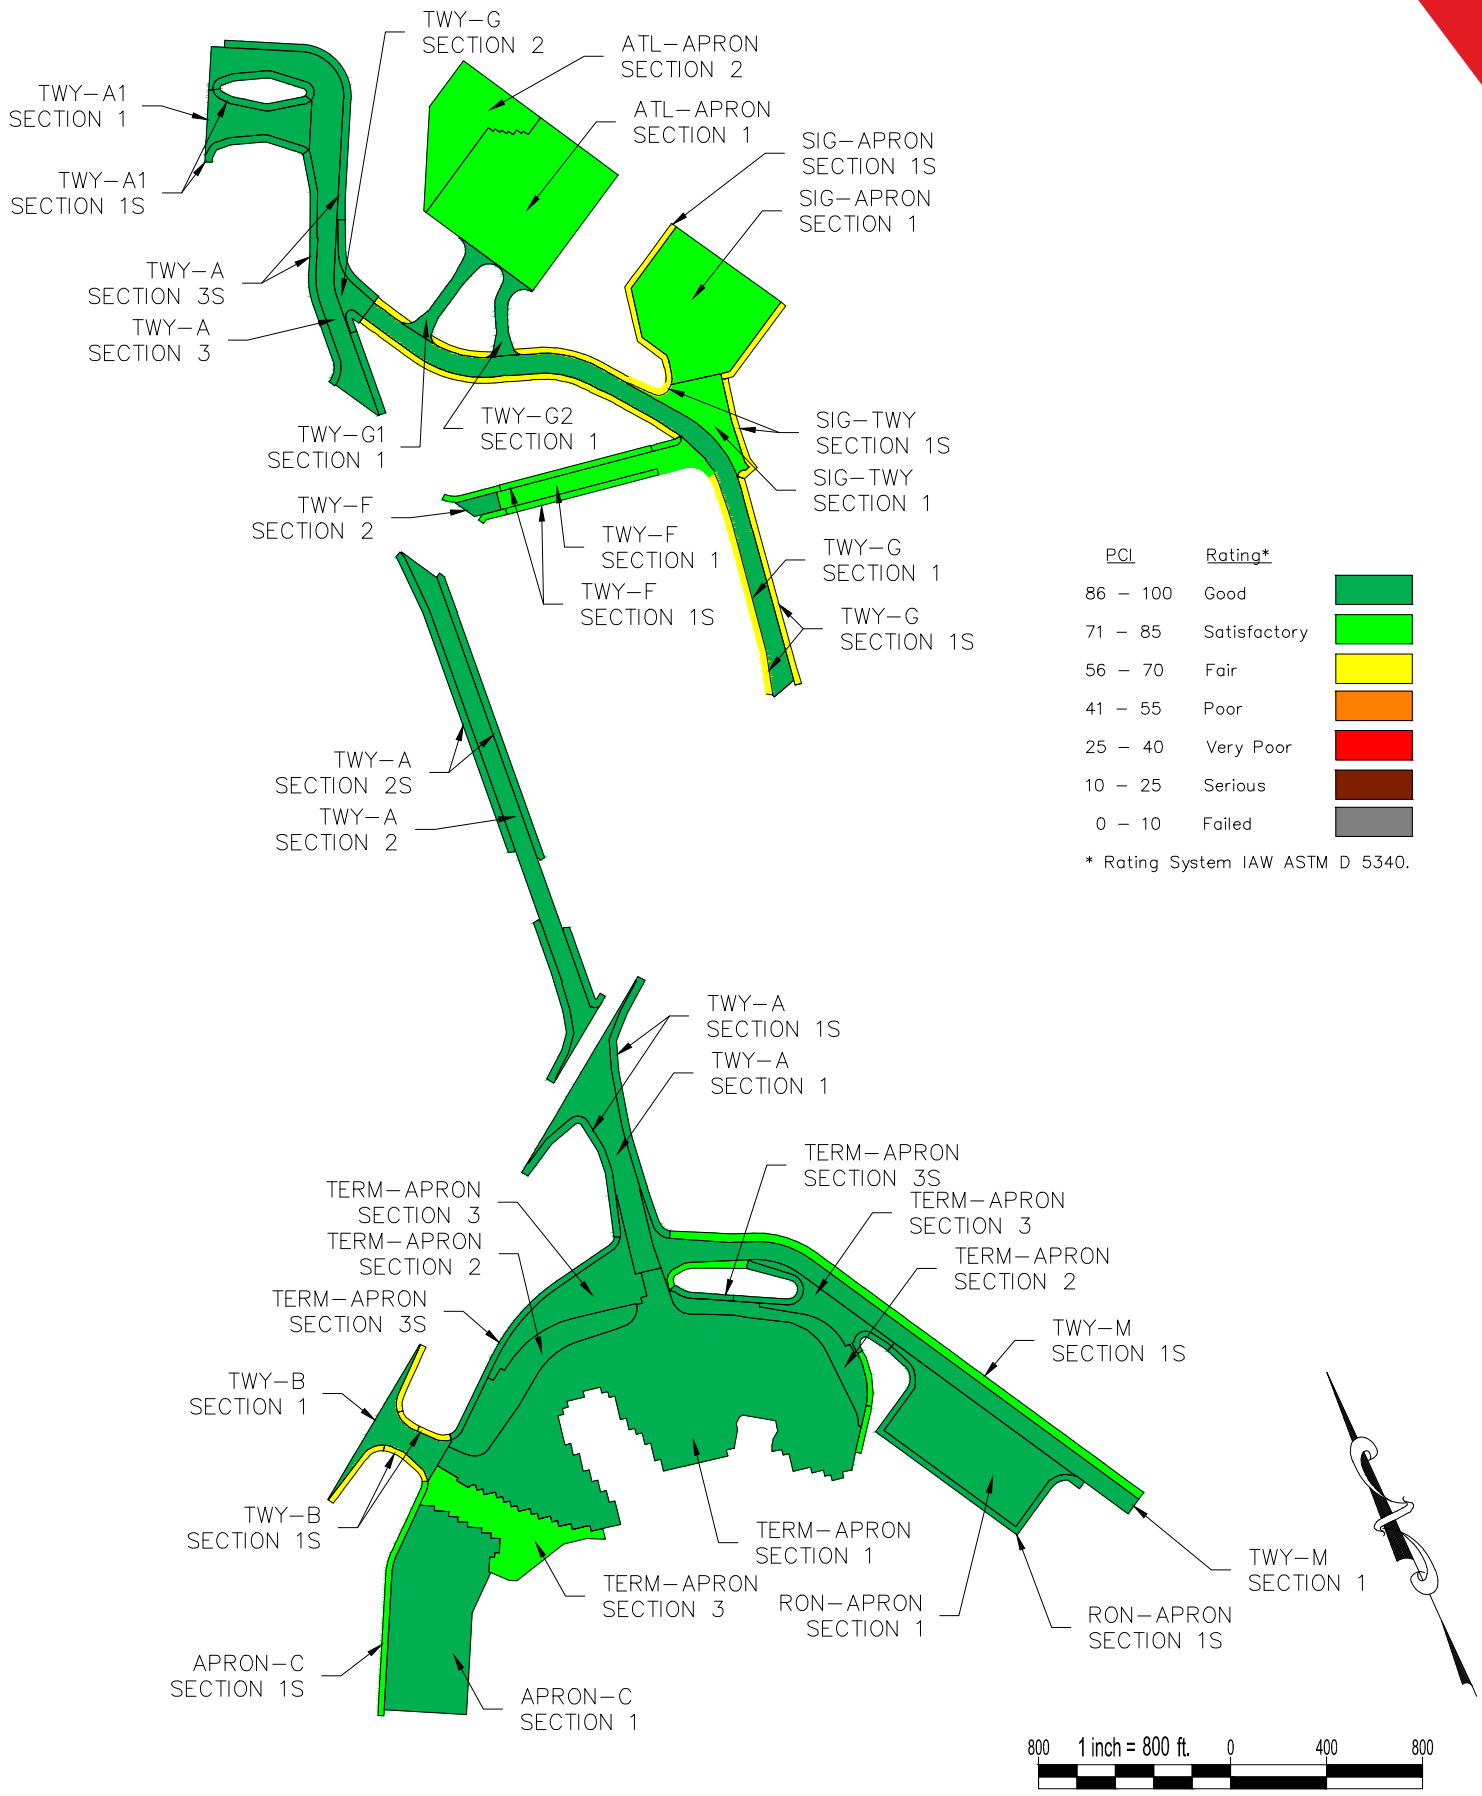
FIG II-1

The Network PCI rating for the 2022 Survey of Charleston International Airport is 90 (Good).

Figure II.1 – CHS Section PCI Ratings shows a pictorial overview of the branches and sections with PCI ratings. Refer to Table II.1 for the individual branch/section PCI ratings, and Table II.2 for a network pavement inventory.

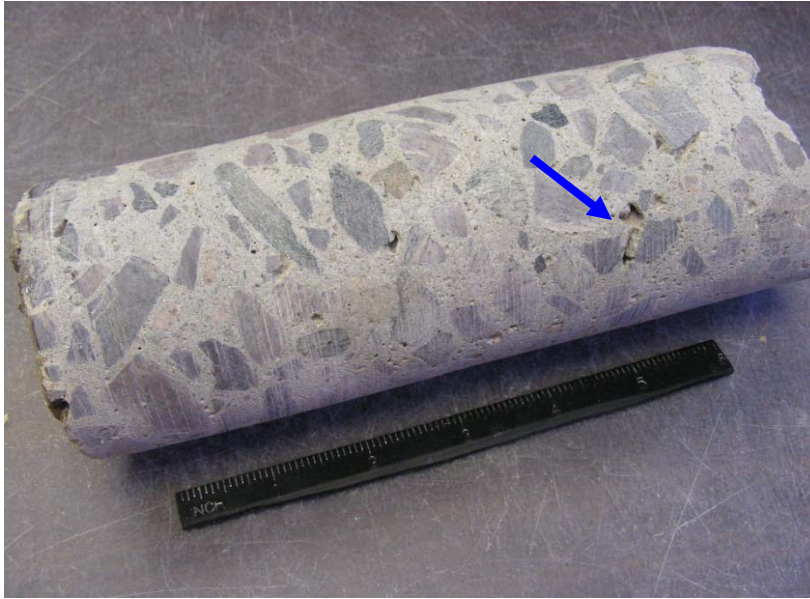
The unlabeled core has a diameter of nearly 1-3/4 inches and is 7 to 8 inches long. The bottom surface of the core had been broken off within the slab and the top surface is deeply worn. No reinforcement was present in the core sample. Figure 1 shows the core in its as-received condition.

Figure 1. Core as received, with its top surface on the left side of the photograph. Overall minimal amounts of small and medium size unconsolidated air voids are visible. One of the larger voids (5/8 inch long and up to 3/16 inch wide) is indicated by the arrow.

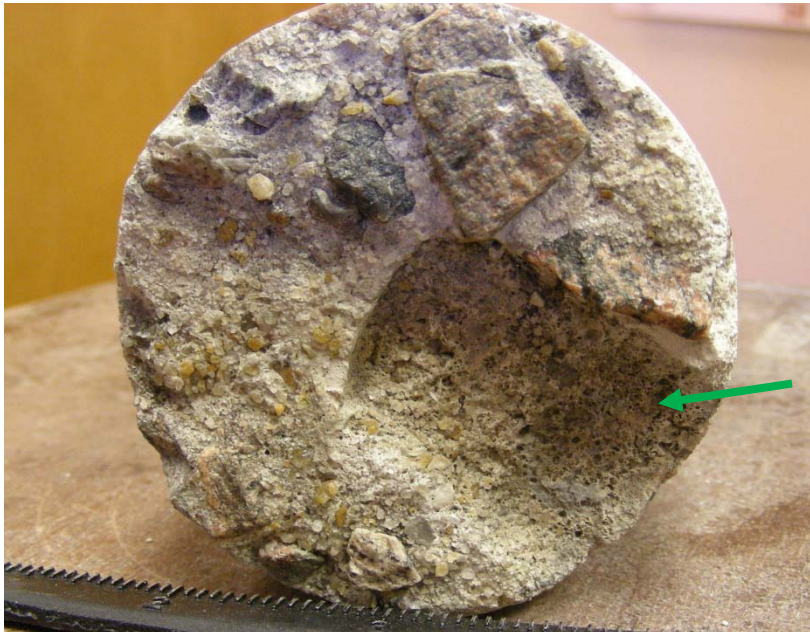
A relatively large coarse aggregate socket is also evident on the top surface, where a coarse aggregate particle had de-bonded from the concrete. Both the coarse and the fine aggregate particles that remain are generally tightly bonded to the body of the concrete and do not exhibit any deterioration. Figures 2 through 4 show various views of the surface zone of the concrete, with Figure 2 showing the top surface, Figure 3 (and cover photograph) showing a side view of a coarse aggregate particle that is elevated significantly above the main body of the concrete, and Figure 4 providing a closer view of the aggregate socket.

Figure 2. Top surface of core, representing significantly deteriorated top surface of apron. A large coarse aggregate particle (socket is 1-1/4 in. long and 1 inch wide) is indicated by the arrow.

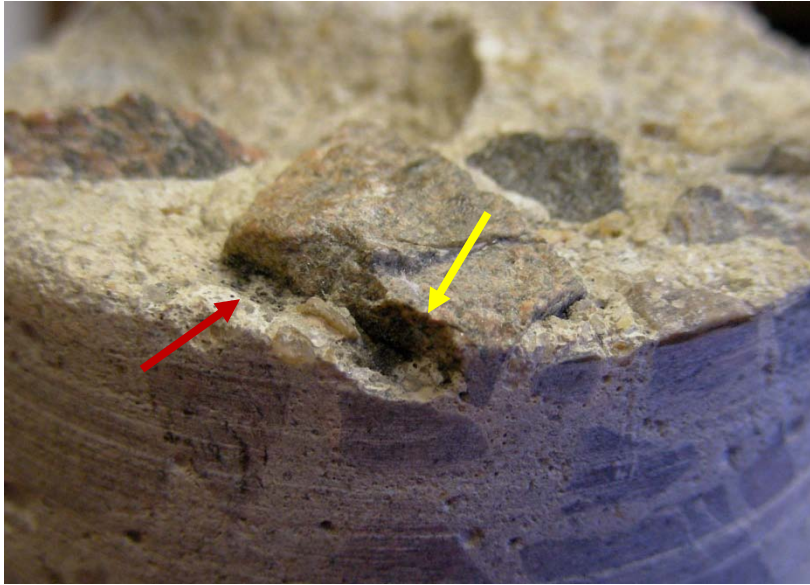
Figure 3. Top surface of core showing a coarse aggregate particle exposed in relief up to approximately 3/16 inch. A small section of the concrete appears to have broken away from the circumference of the core, likely during coring operation (yellow arrow). For scale purposes, the chip appears to be about 3/16 inch deep. Abundant amounts of dirt and debris are present along paste-aggregate interface exposed by the concrete that had broken off (arrow), indicating that a separation between the concrete and paste had been present for an extended period of time and been exposed to moisture. Green, organic growth is evident along this interface and also to the left (red arrow), indicating long-term exposure to moisture.

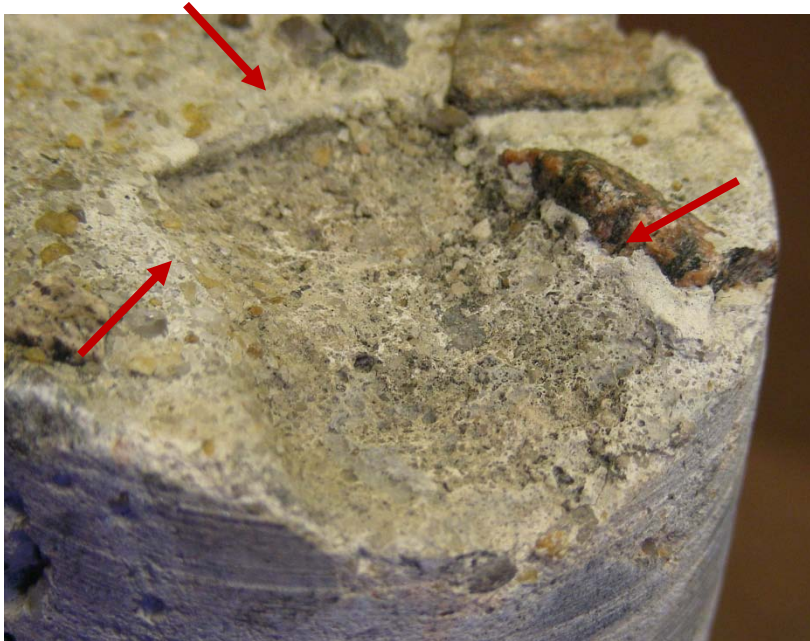
Figure 4. Depression left when relatively large coarse aggregate particle separated from top surface, arrows indicate original outline of particle. For scale, the width of the socket is approximately 1 inch.

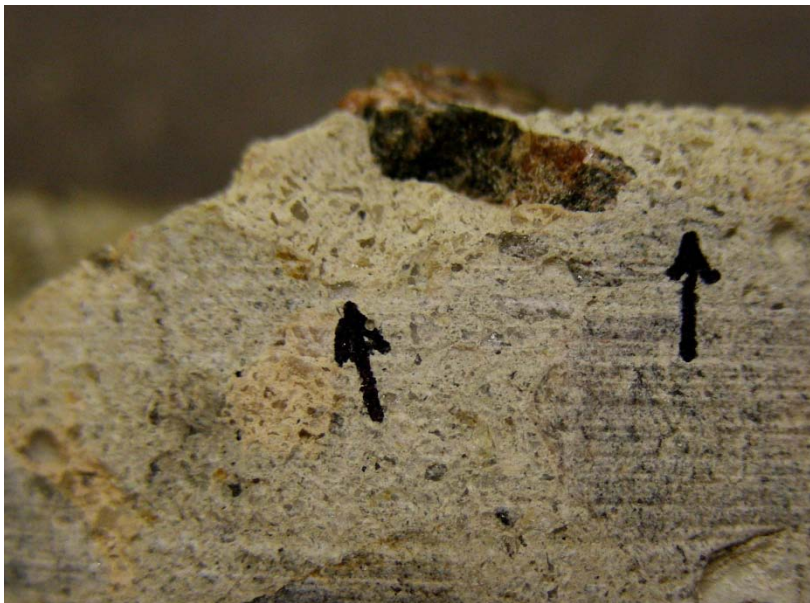
Deteriorated paste extends from a negligible depth to 1/16 inch. The deepest alteration occurs adjacent to coarse aggregate particles. One narrow zone of carbonation extends to a depth of 1/2 inch. In general, the paste-aggregate interface is often more permeable than other portions of concrete. A number of other areas of paste in the surface region are very thin and only somewhat altered, suggesting that the soft paste had already eroded off the surface.

Figure 5. Zone of light-colored, relatively soft, altered cement paste is indicated by arrows. For scale purposes, the aggregate particle in the near-surface zone is approximately 3/8 inch long.

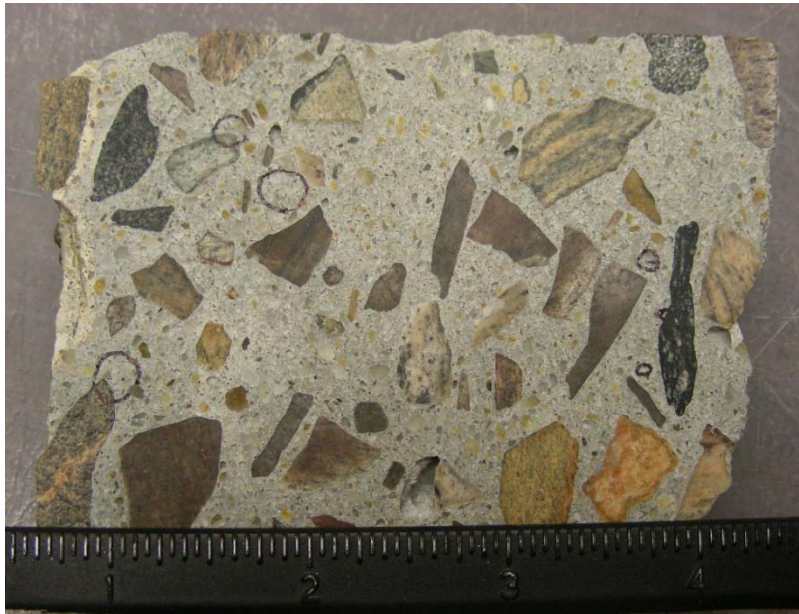
The concrete exhibited especially abundant amounts of secondary deposits, likely ettringite, in virtually all of the air voids. Localized concentrations of deposits that completely filled smaller air voids were also detected. These occurrences of ettringite are unusual for concrete that has simply been exposed to moisture migrating through concrete for an extended period of time.

Figure 6. Lapped cross-section of a portion of core sample, top surface of concrete is on left side of photograph. A few areas were circled with a black felt-tip pen to indicate some of the numerous localized concentrations of secondary deposits.

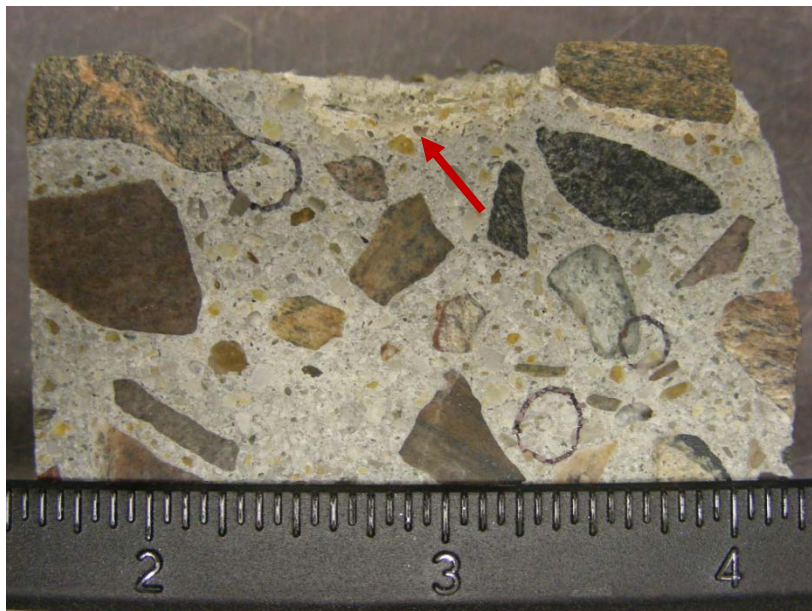
The near-surface paste exhibits minor to moderate amounts of especially narrow, microscopic, discontinuous cracks oriented parallel to the top surface. Optical properties of the paste indicate loss of crystallinity and degradation of some unhydrated portland cement clinker particles. Figure 6 shows a lapped cross-section of the concrete. Figures 7 and 8 given progressively closer views of the near-surface zone the sample.

Figure 7. Closer view of near-surface zone. Coarse aggregate particles standing proud above main body of concrete are evident. The empty socket where a relatively large coarse aggregate particle had been located is indicated an arrow centered between the two sides of the socket. This aggregate socket is also shown in Figure 2.

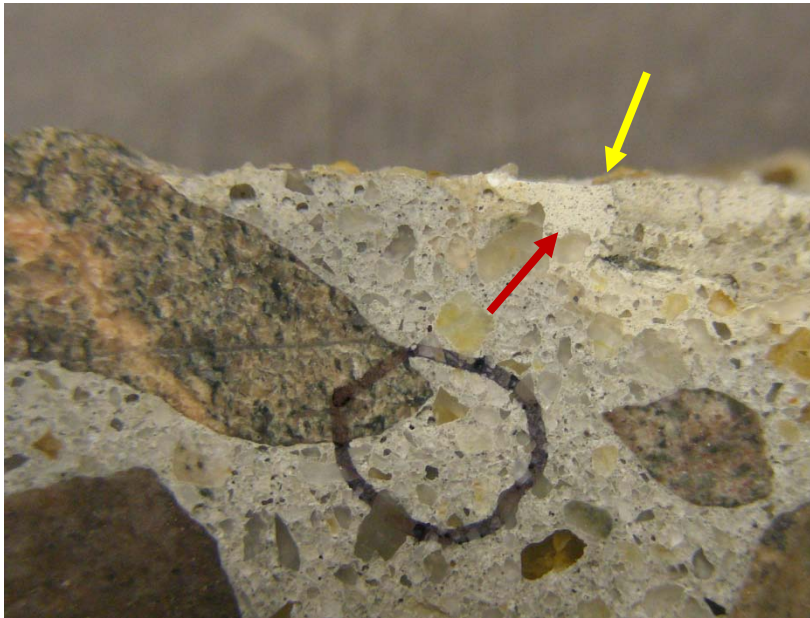
Figure 8. Near-surface zone showing a zone of deteriorated paste (red arrow). The yellow arrow indicates where paste ends and aggregate socket begins.

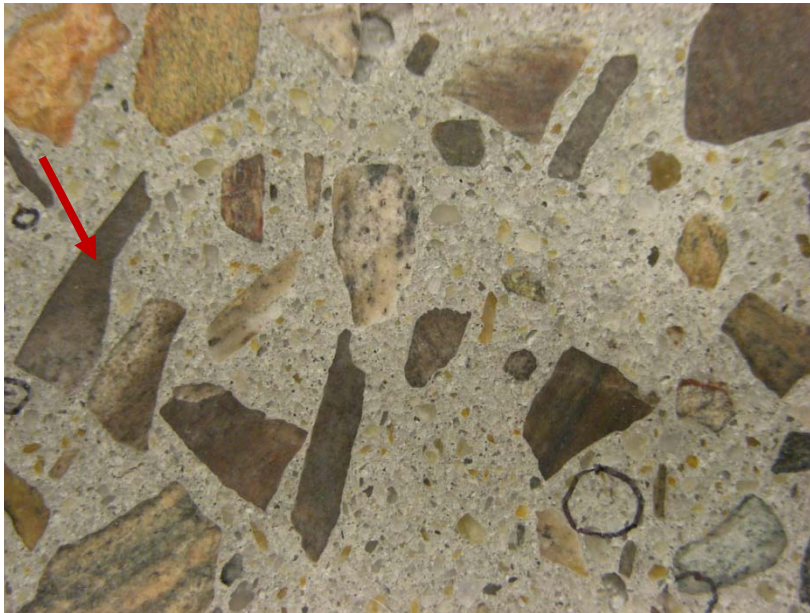
The characteristics of the aggregates, paste, and air-void system of the concrete represented by the core were evaluated as part of the petrographic examination to determine if the general quality of the concrete may have contributed to the surface deterioration problem. Figure 9 shows the lapped cross-section of the concrete illustrating the concrete mixture.

Figure 9. Closer view of concrete mixture. For scale purposes, the aggregate particle indicated by arrow is 3/4 inch long.
