2022 Pavement Condition Index Report

Charleston Executive Airport

For The
Charleston County Aviation Authority

Issued: December 15, 2023

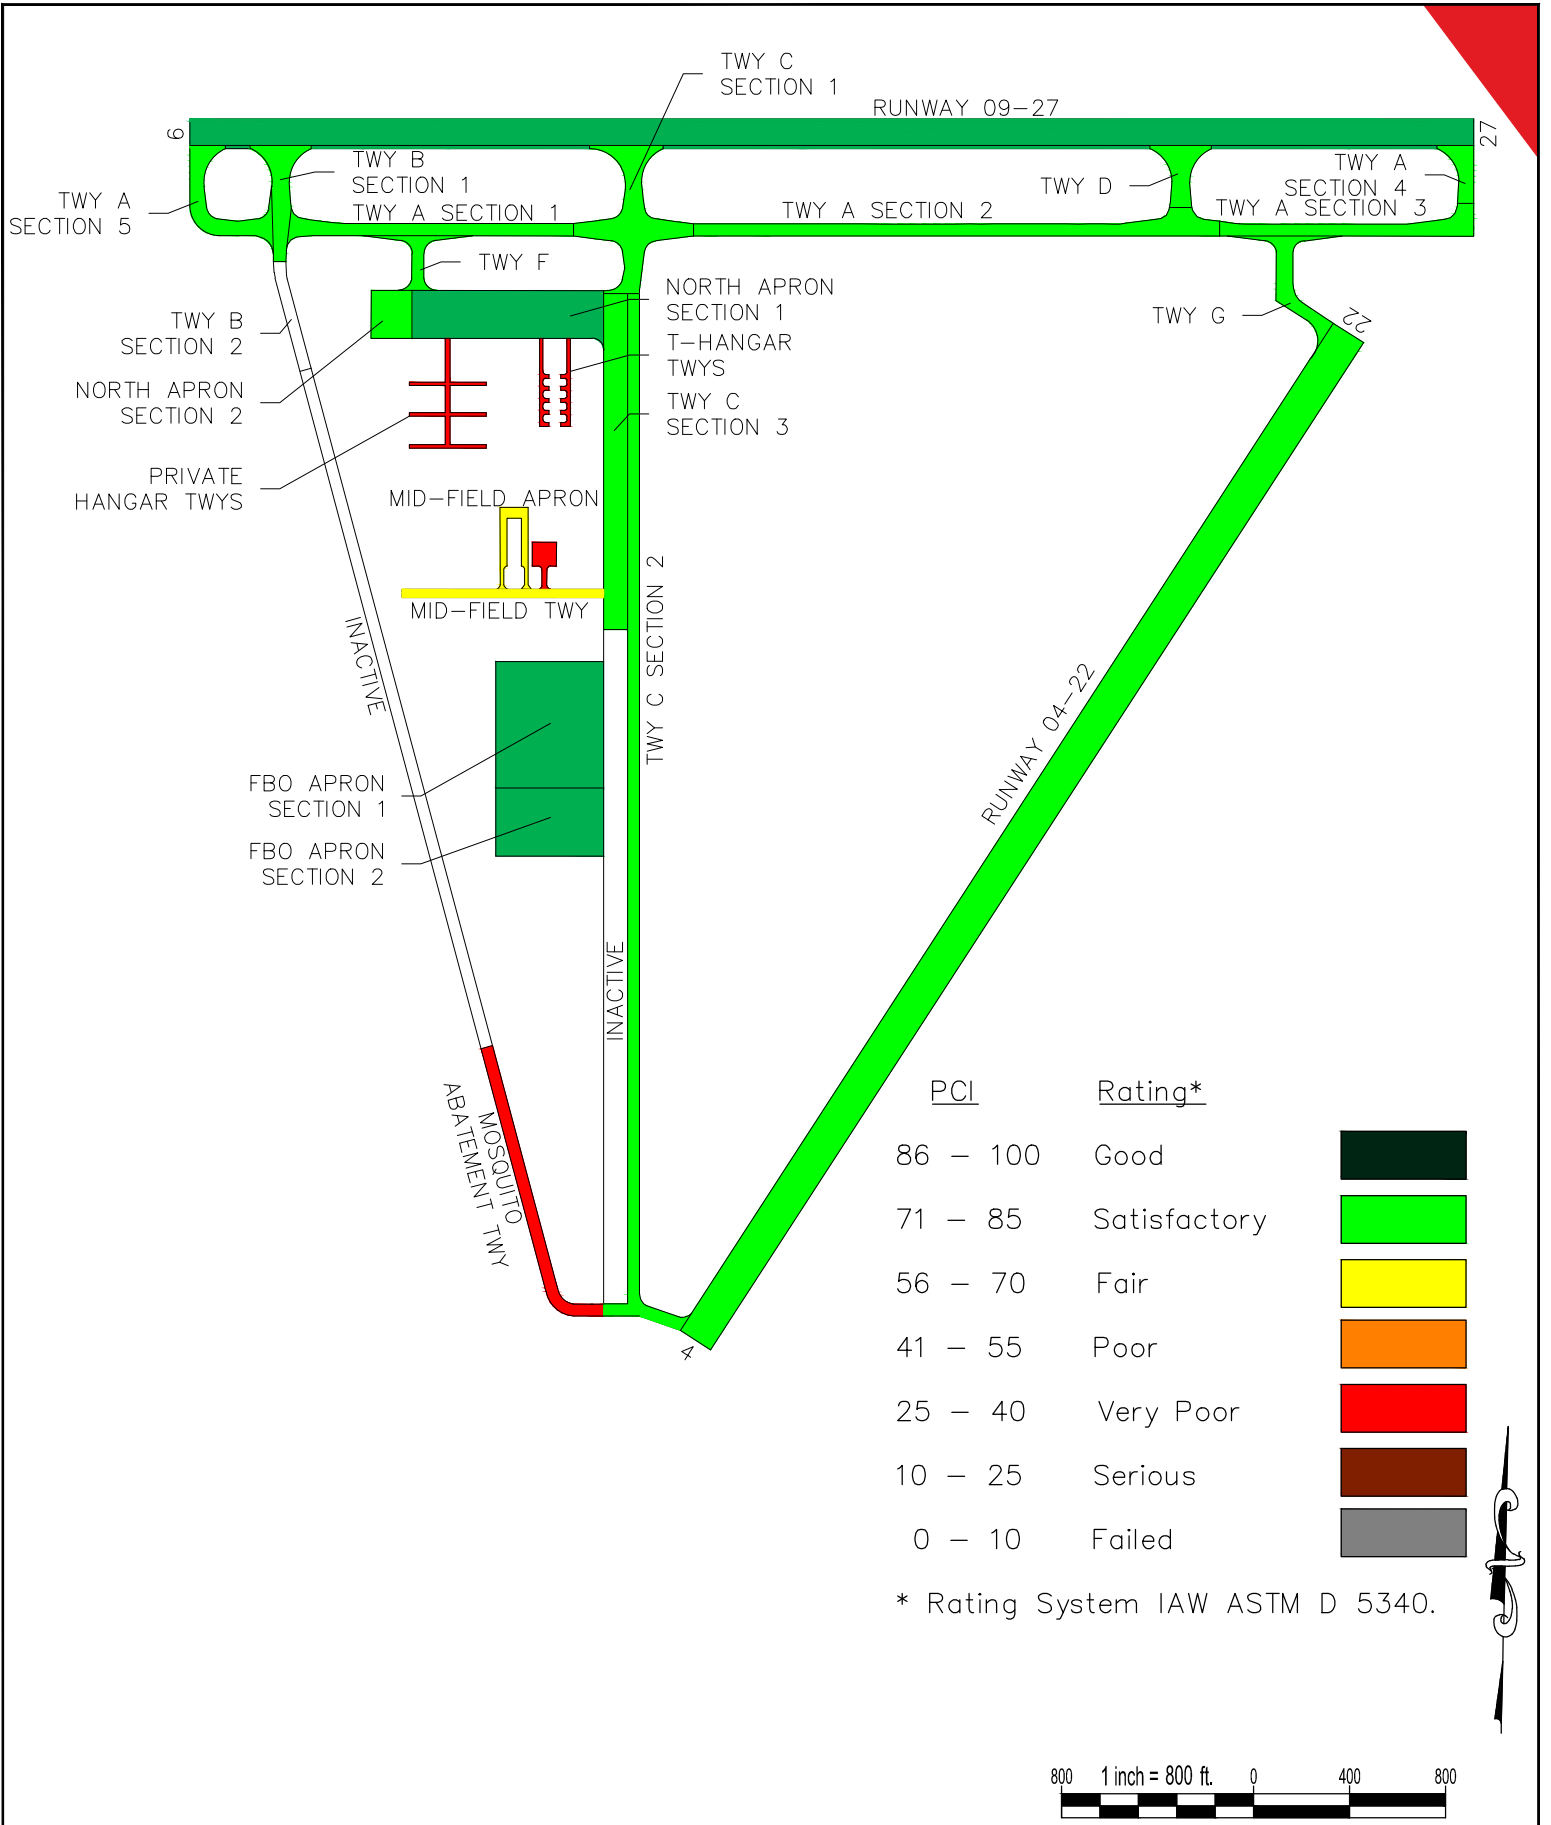
FIG II-1

SECTION PCI RATINGS

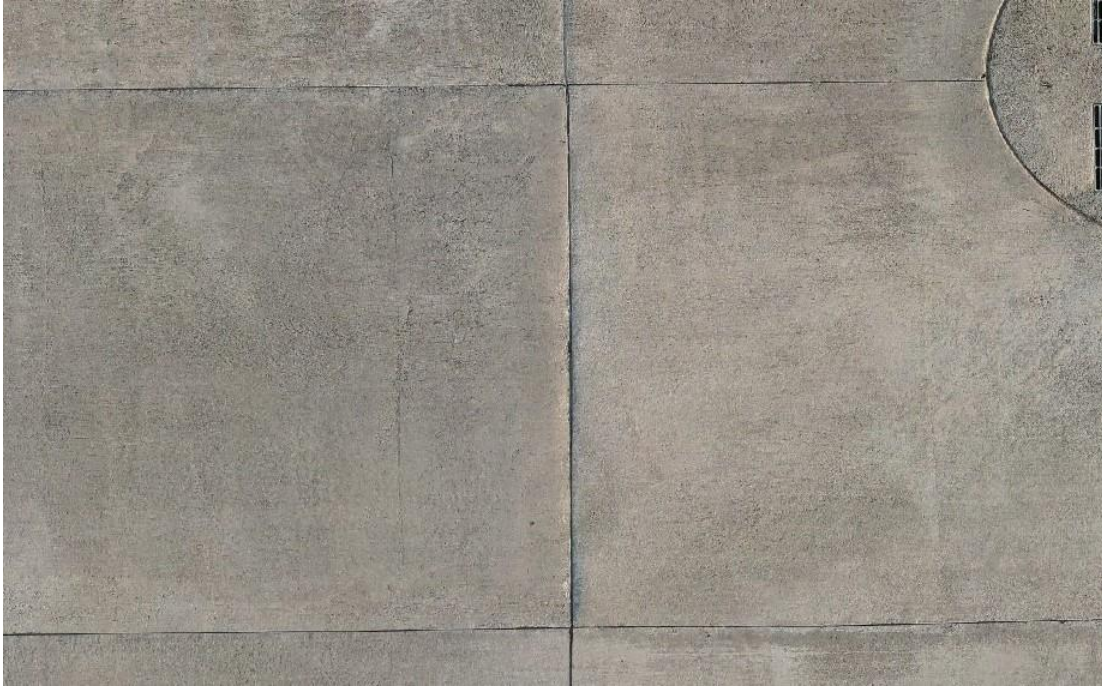
Photograph 1: Typical Linear Crack (low-severity)

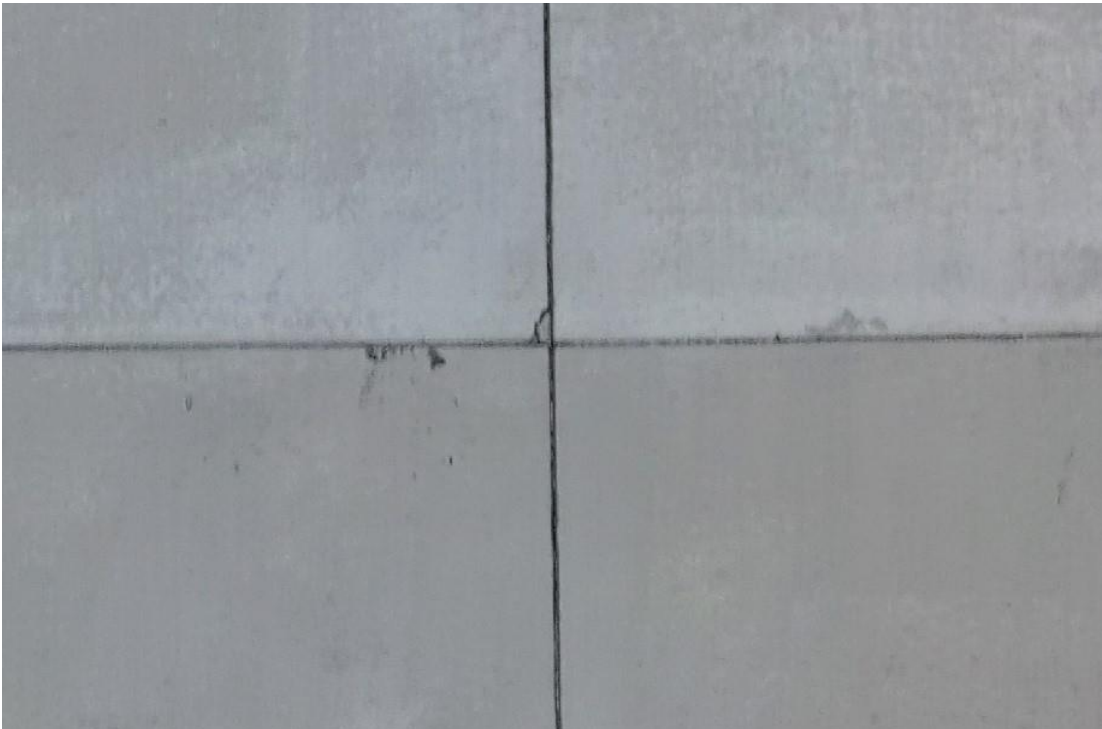
Photograph 2: Typical Joint Spall (low-severity) and Corner Spall (low-severity)

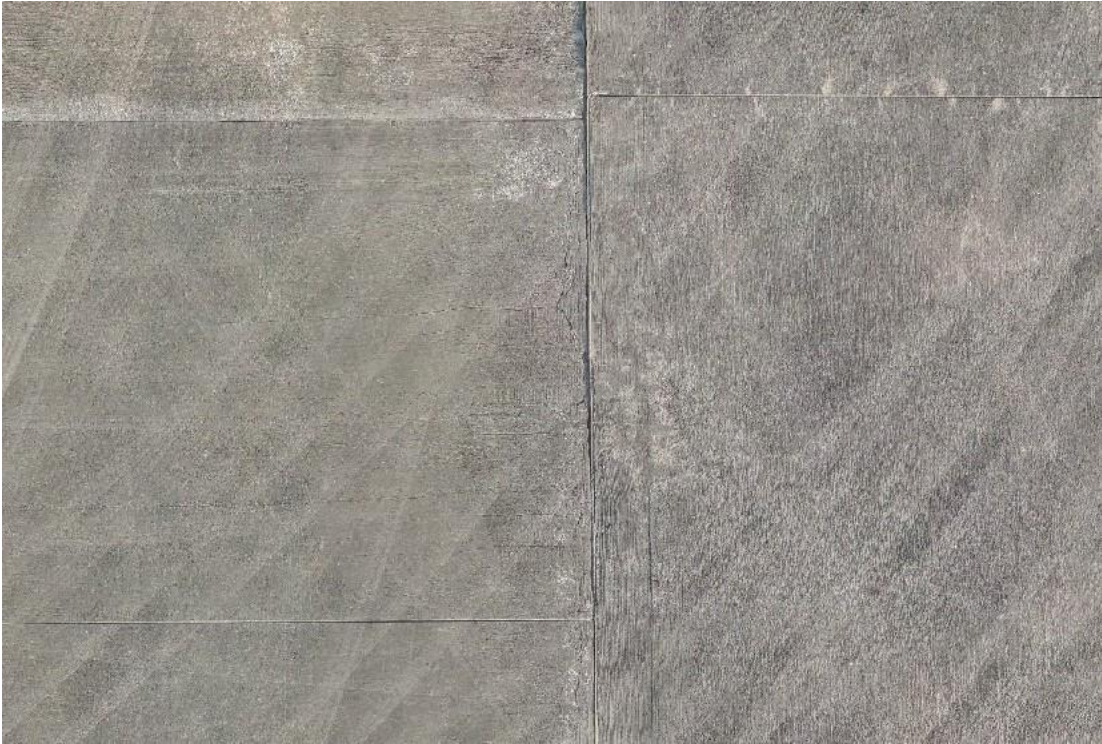
Photograph 3: Typical Linear Crack (low-severity)

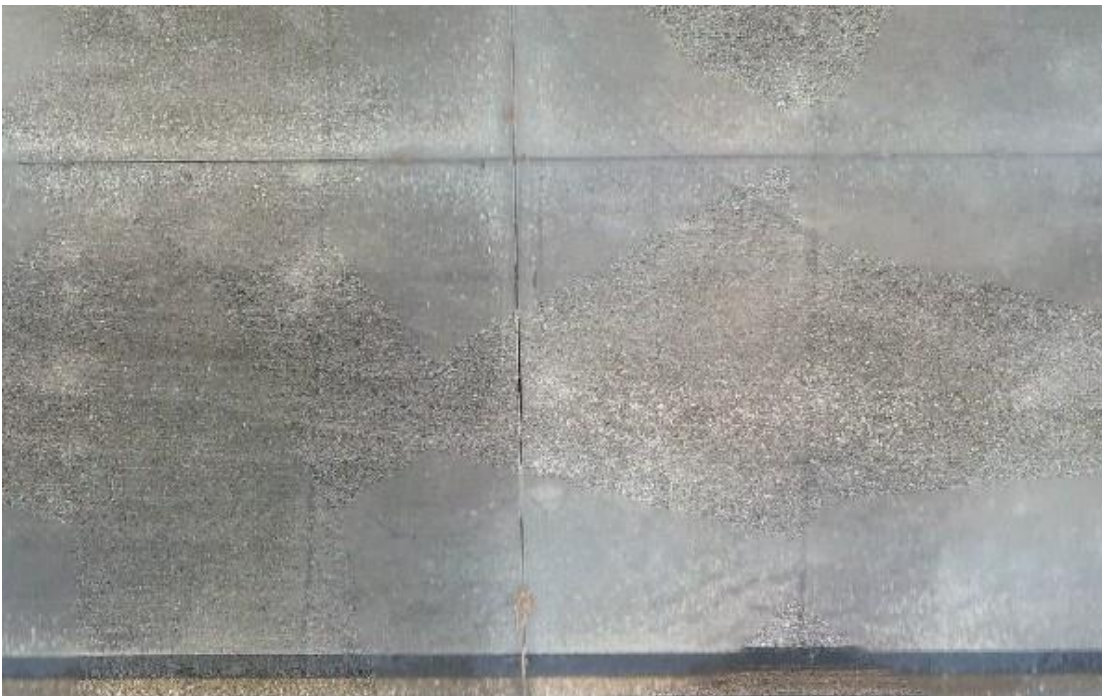
Photograph 4: Typical Joint Sealant Damage (low-severity)

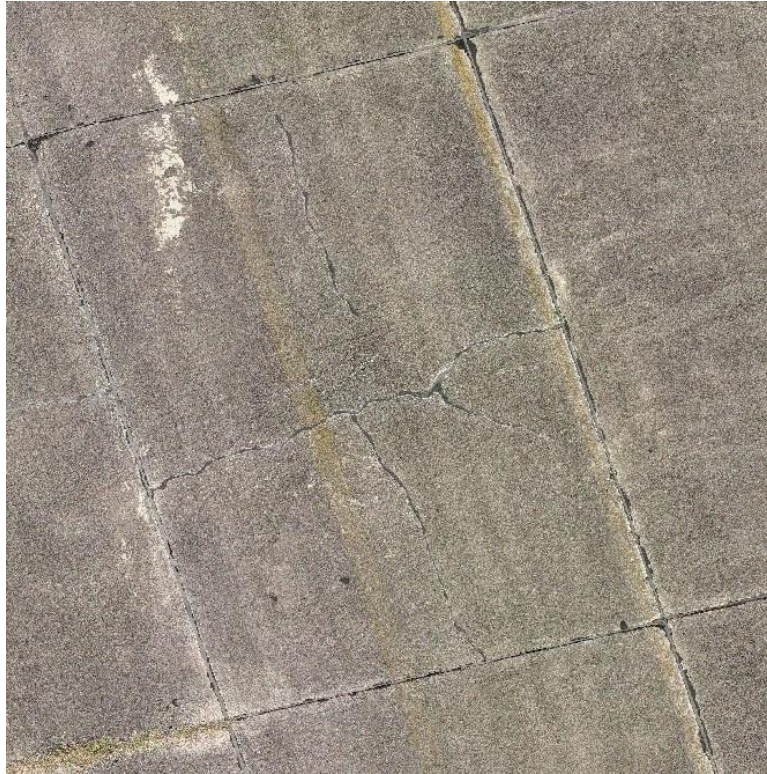
Photograph 5: Shattered Slab (high-severity)

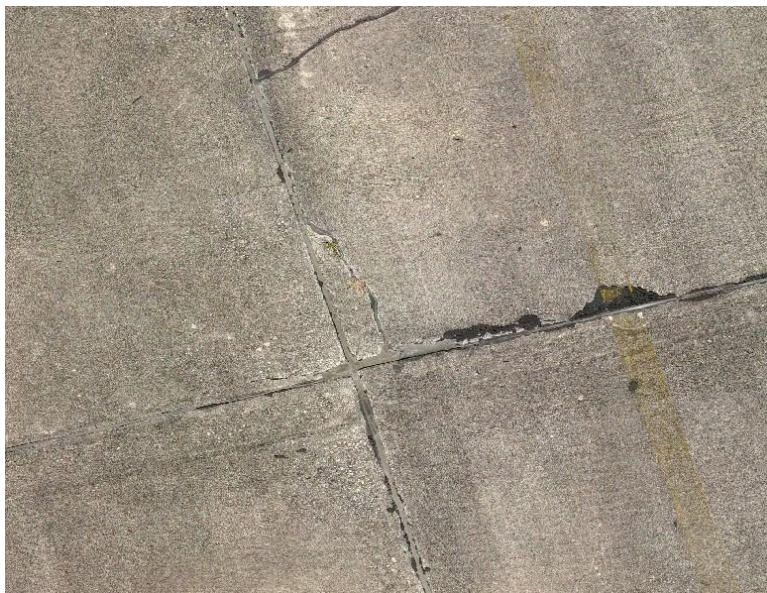
Photograph 6: Typical Corner Break (medium-severity)

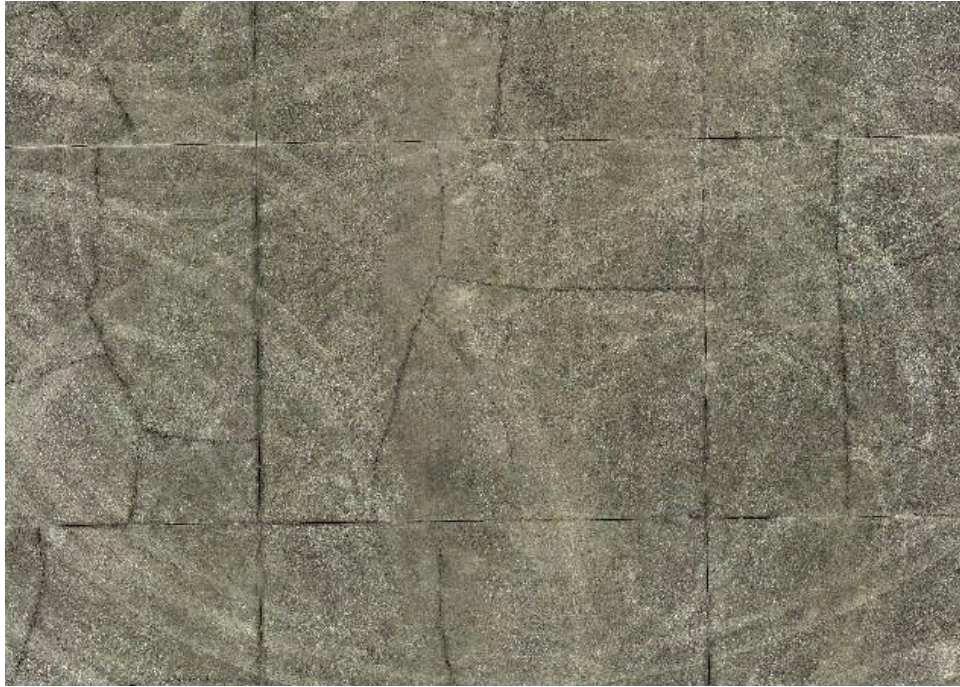
Photograph 7: Typical Shattered Slab (medium-severity)

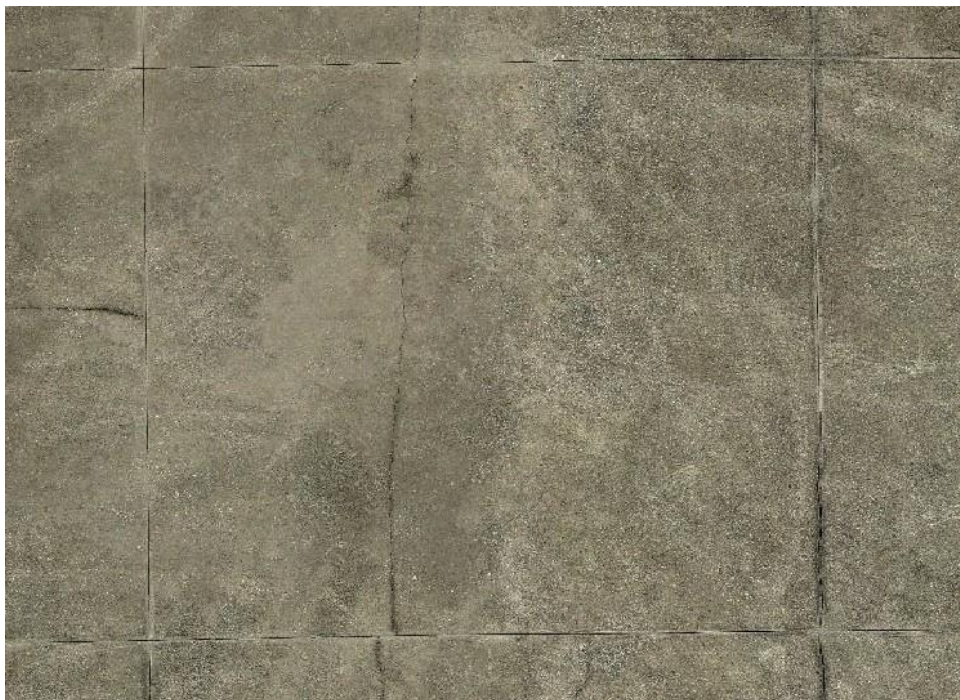
Photograph 8: Typical Linear Crack (medium-severity)

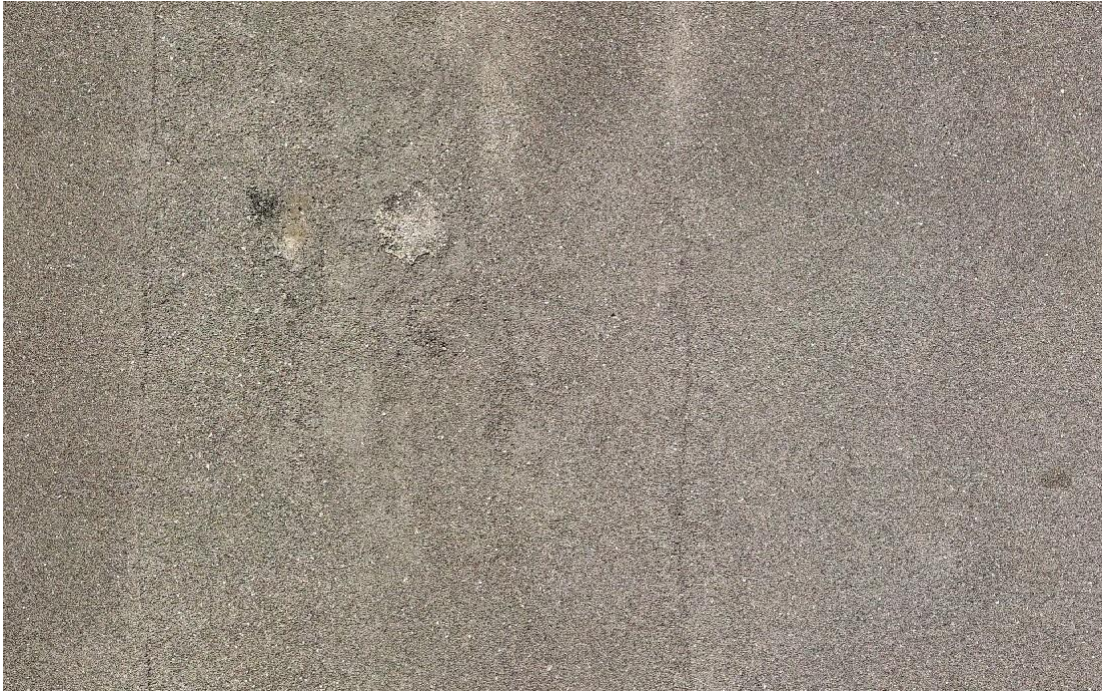
Photograph 9: Alligator Cracking (Low-Severity)

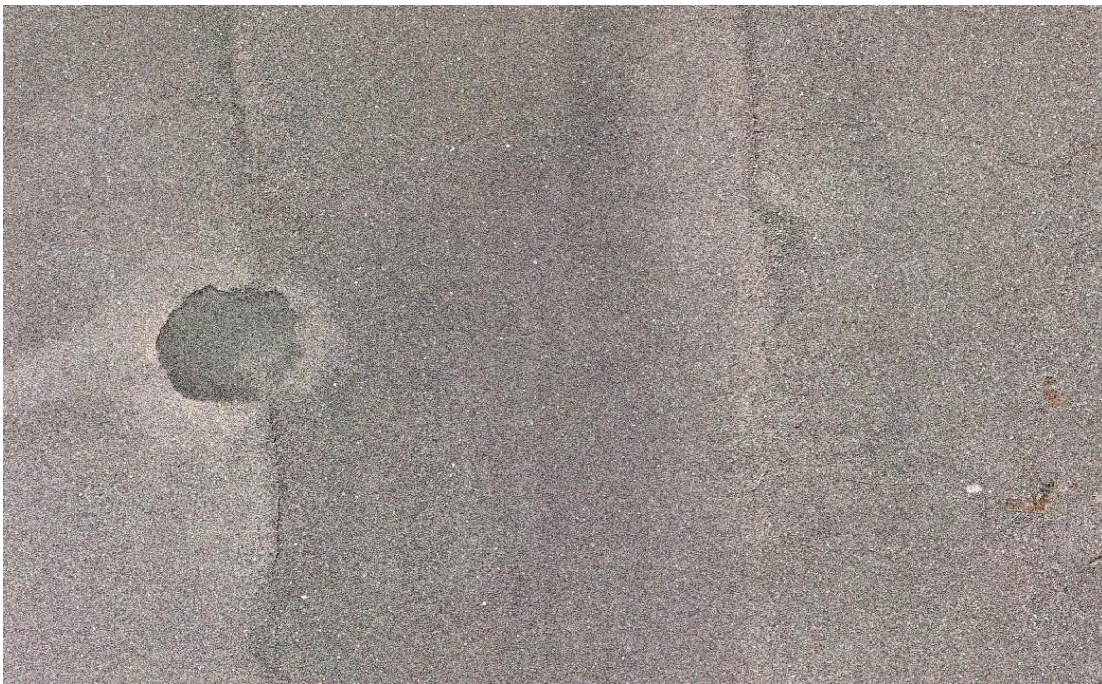
Photograph 10: Patching (Low-Severity) and Longitudinal and Transverse Cracking (Low and Medium-Severity)

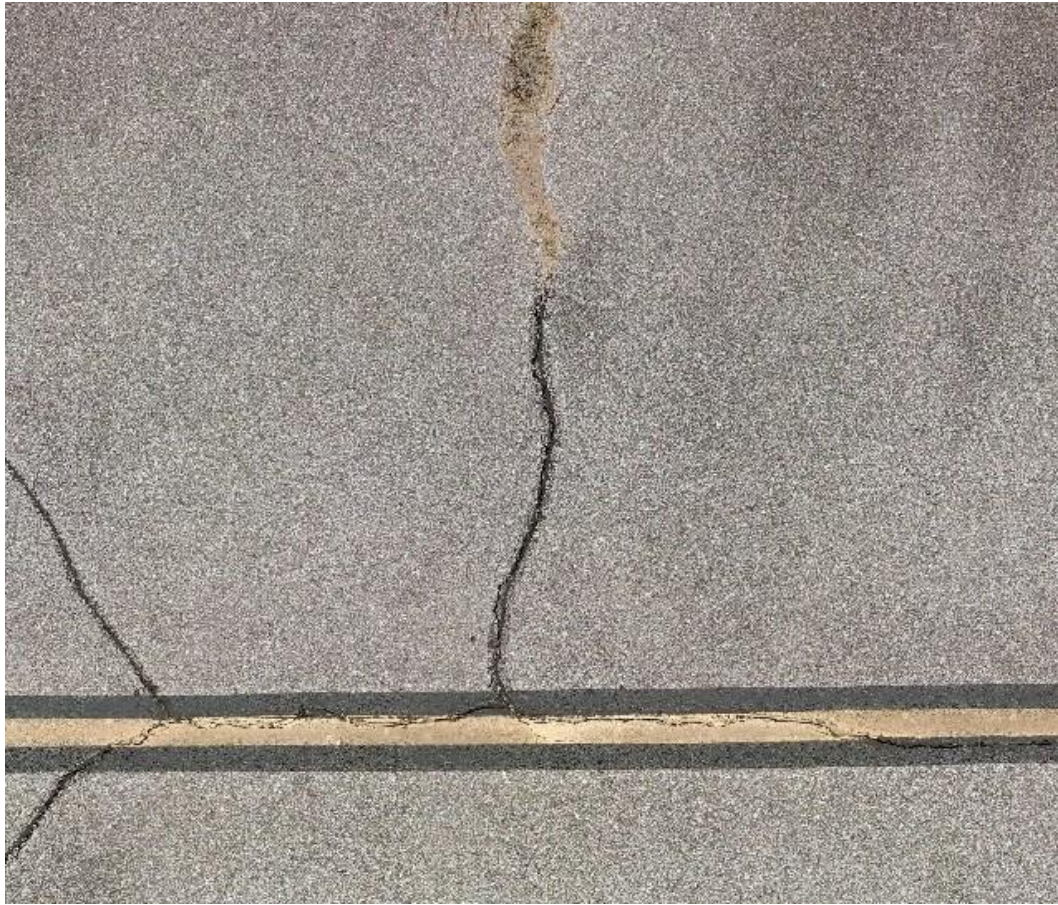
Photograph 11: Typical Longitudinal and Transverse Cracking (Medium-Severity)

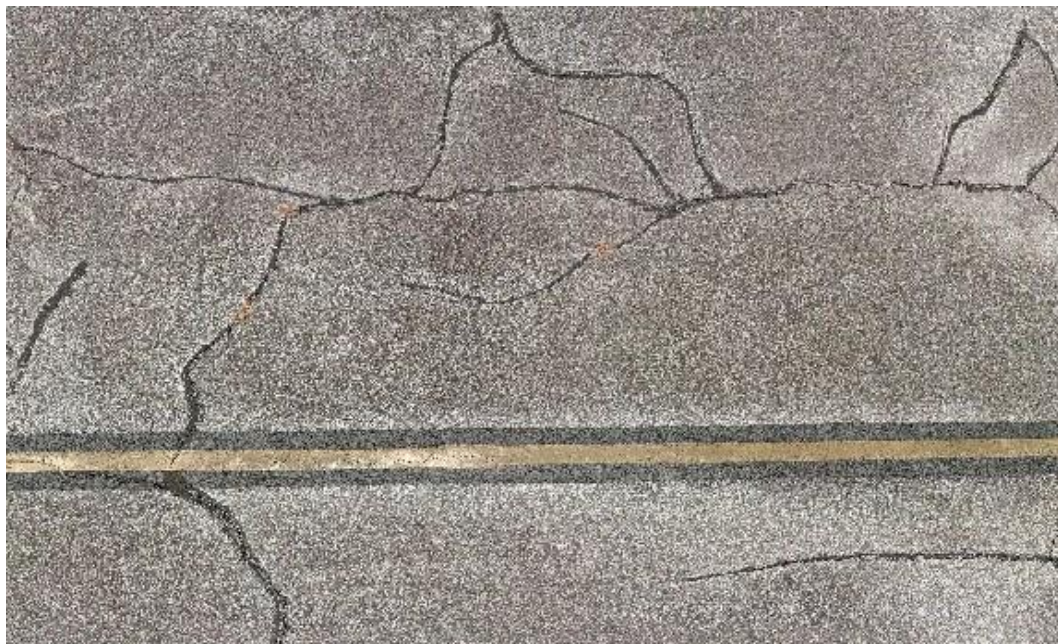
Photograph 12: Alligator Cracking (Low-Severity) and Weather (Low-Severity)

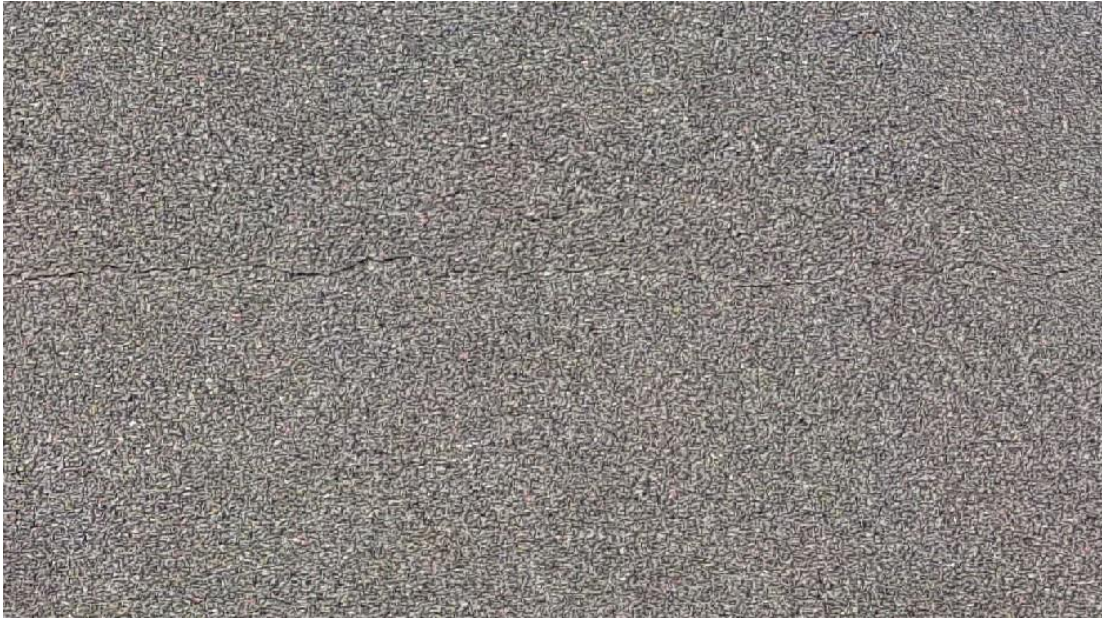
Photograph 13: Typical Longitudinal Cracking (Low-Severity) and Weathering (Low-Severity)

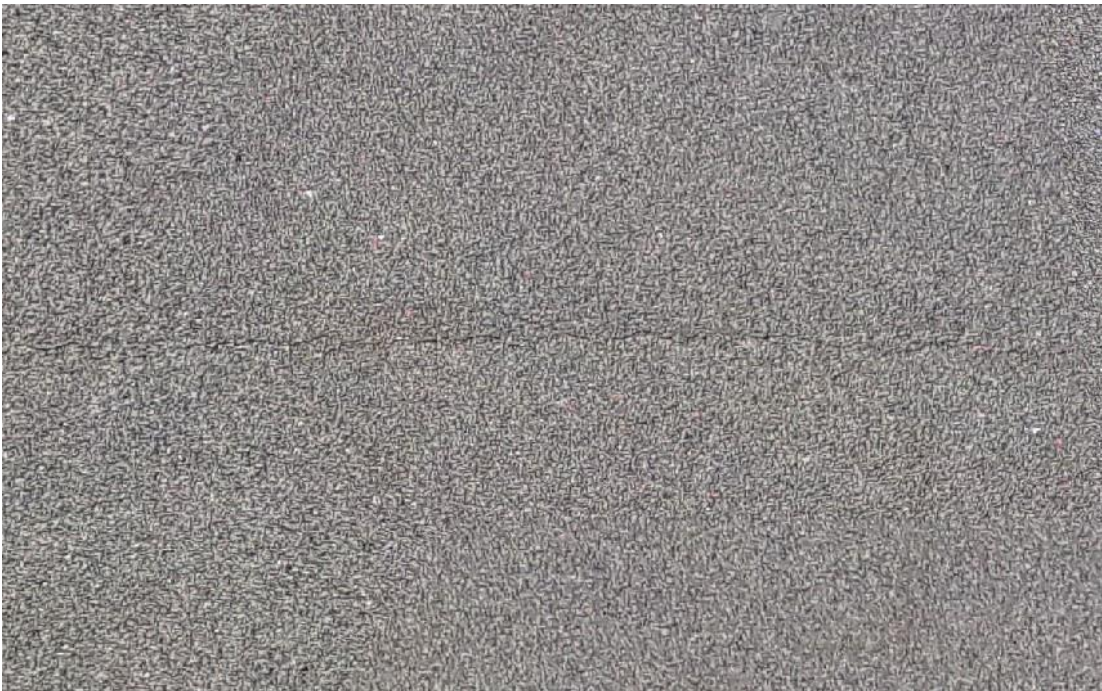
Photograph 14: Typical Longitudinal Cracking (Low-Severity) and Weathering (Low-Severity)

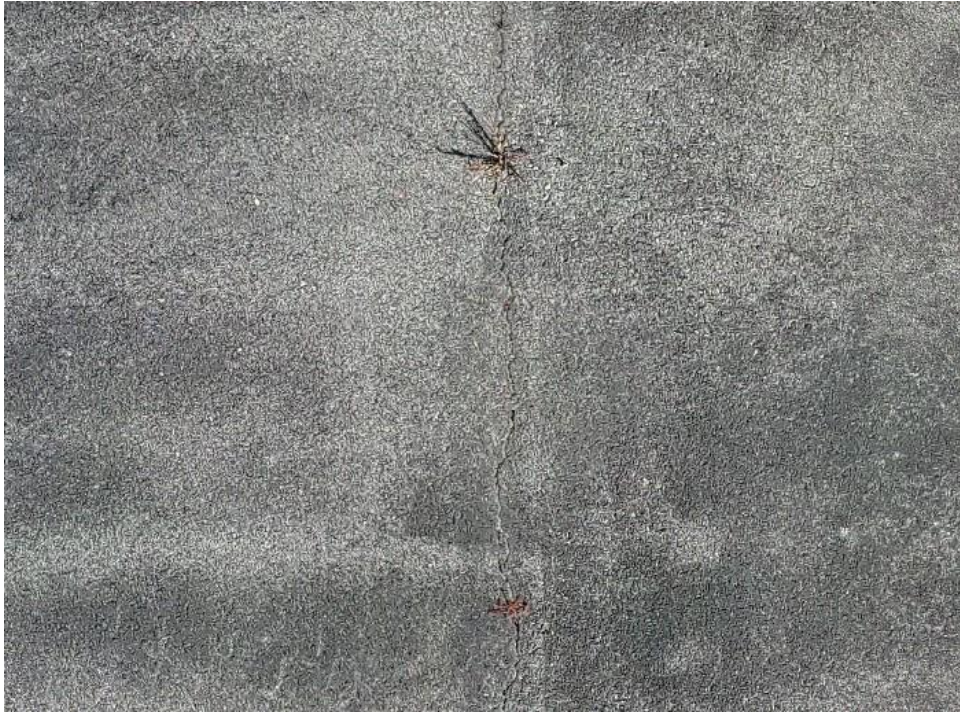
Photograph 15: Typical Longitudinal Cracking (Medium-Severity) and Weathering (Low-Severity)

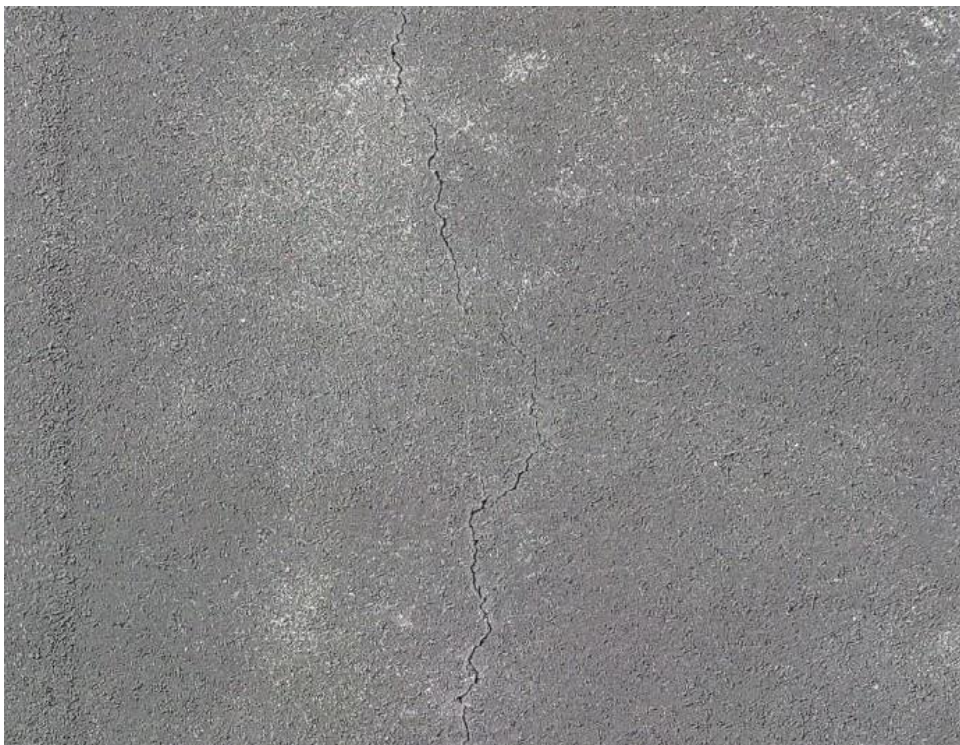
Photograph 16: Typical Longitudinal Cracking (Low-Severity) and Weathering (Low-Severity)

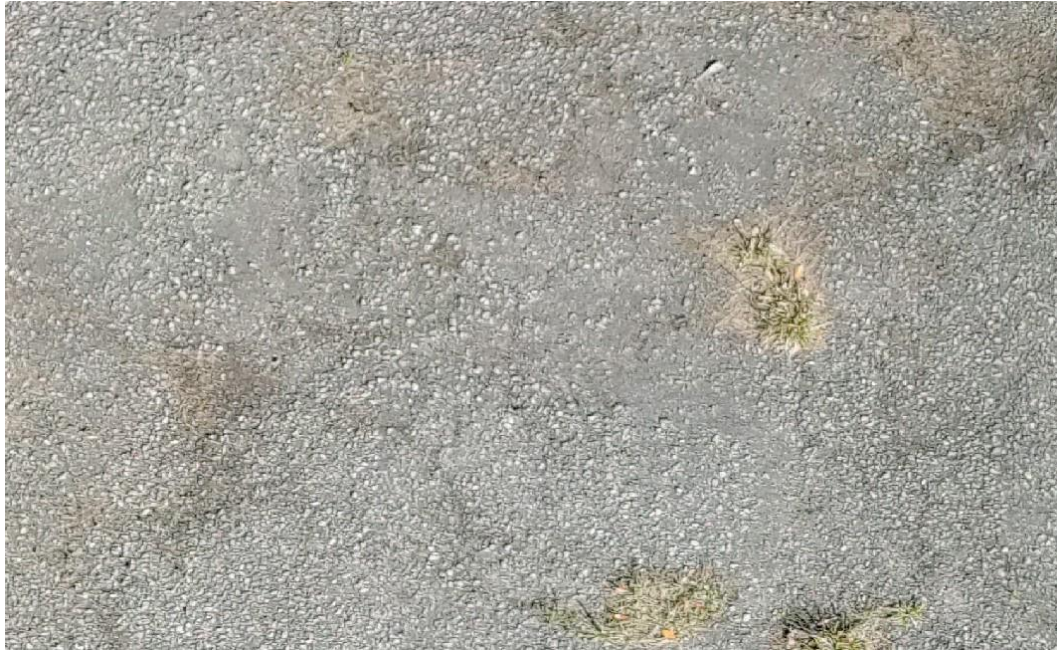
Photograph 17: Alligator Cracking (Medium-Severity)

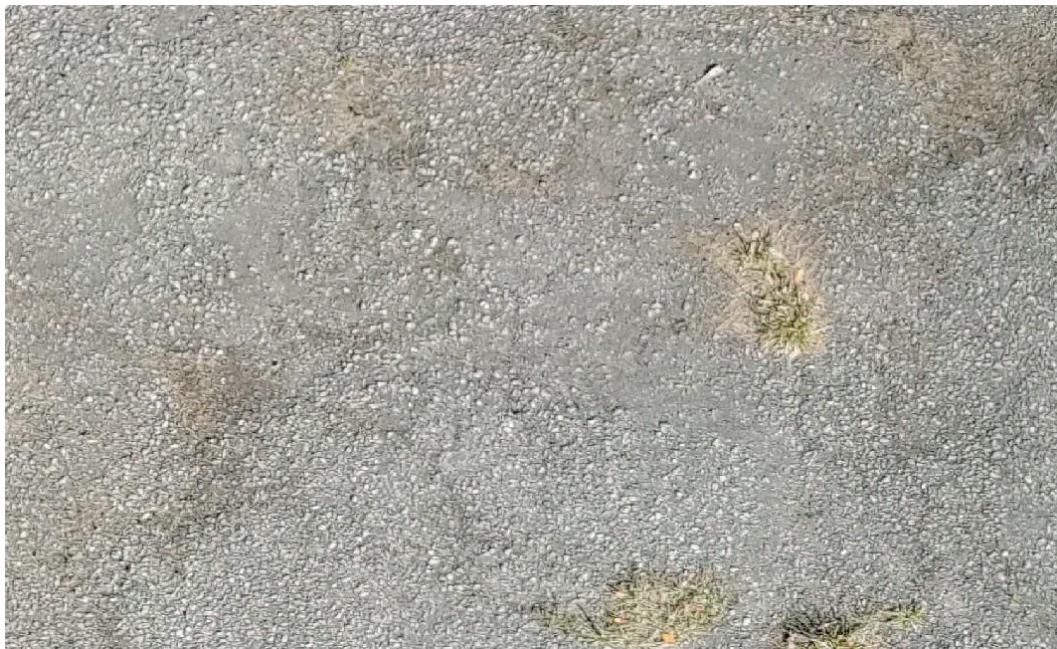
Photograph 18: Raveling (High-Severity)

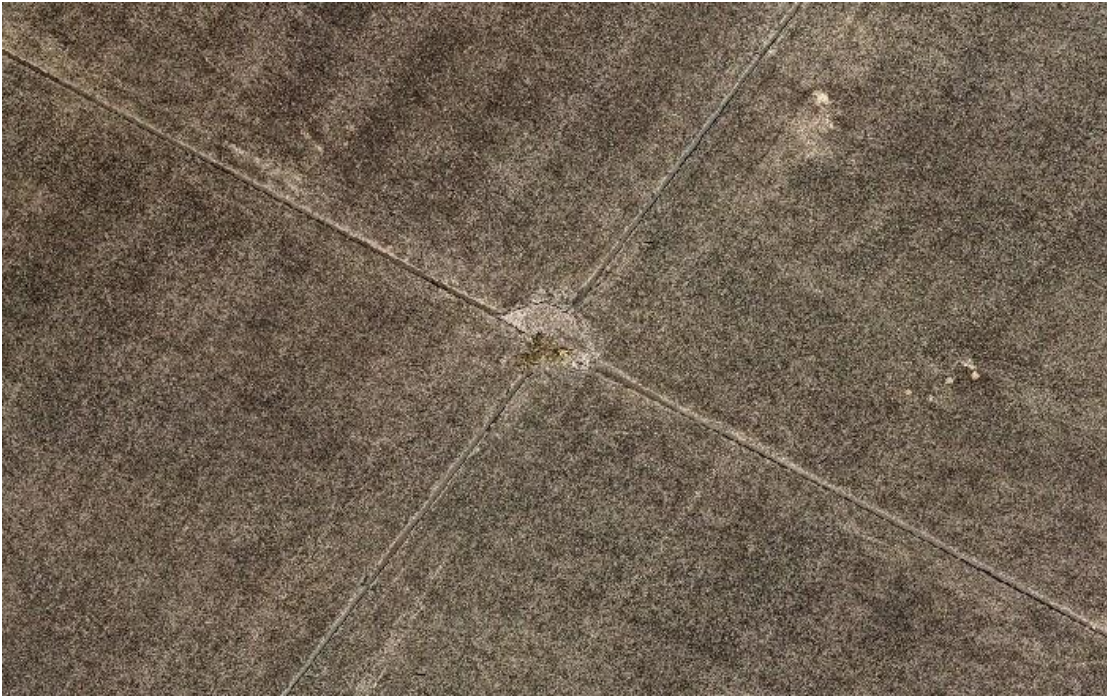
Photograph 19: Typical Small Patch at Spall Repair (medium-severity)

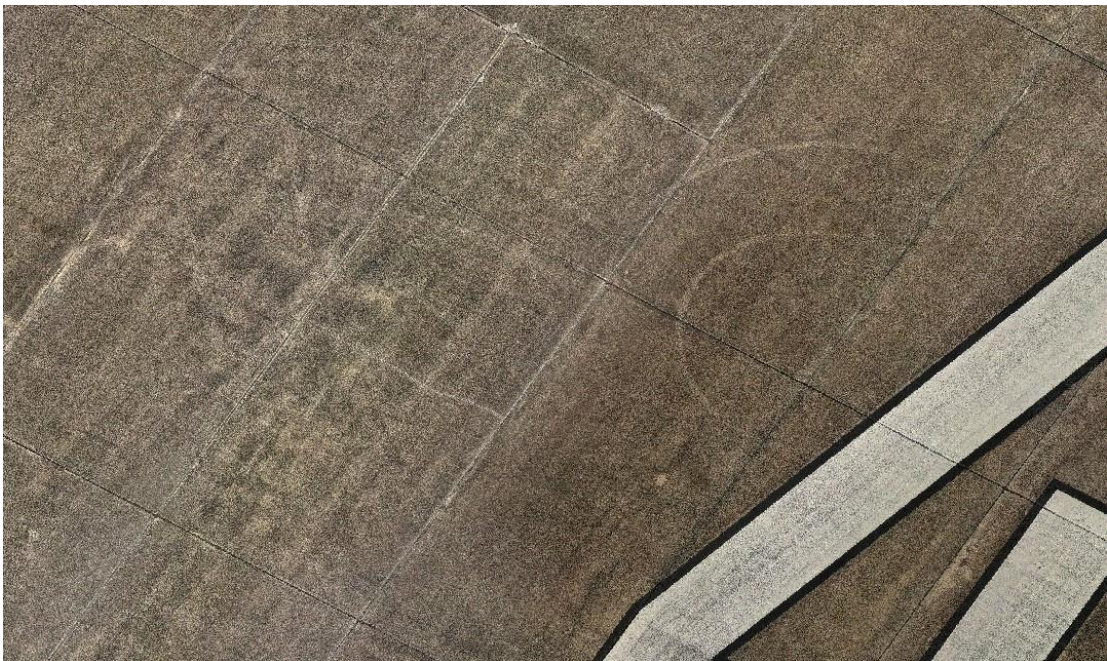
Photograph 20: Typical Linear Crack (low-severity)

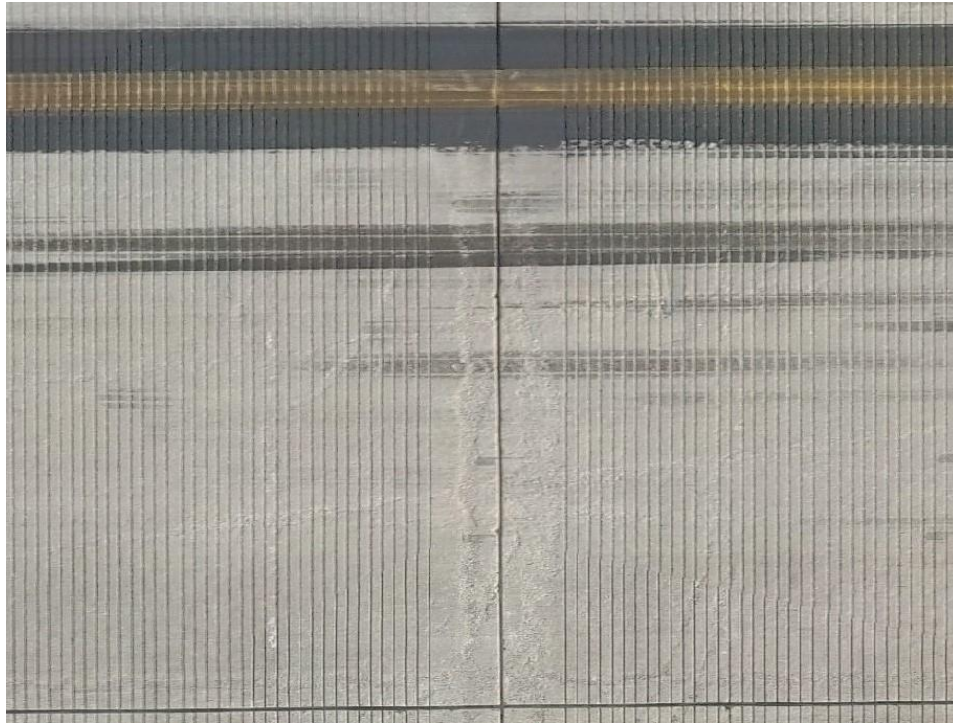
Photograph 21: Typical Scaling (low-severity)

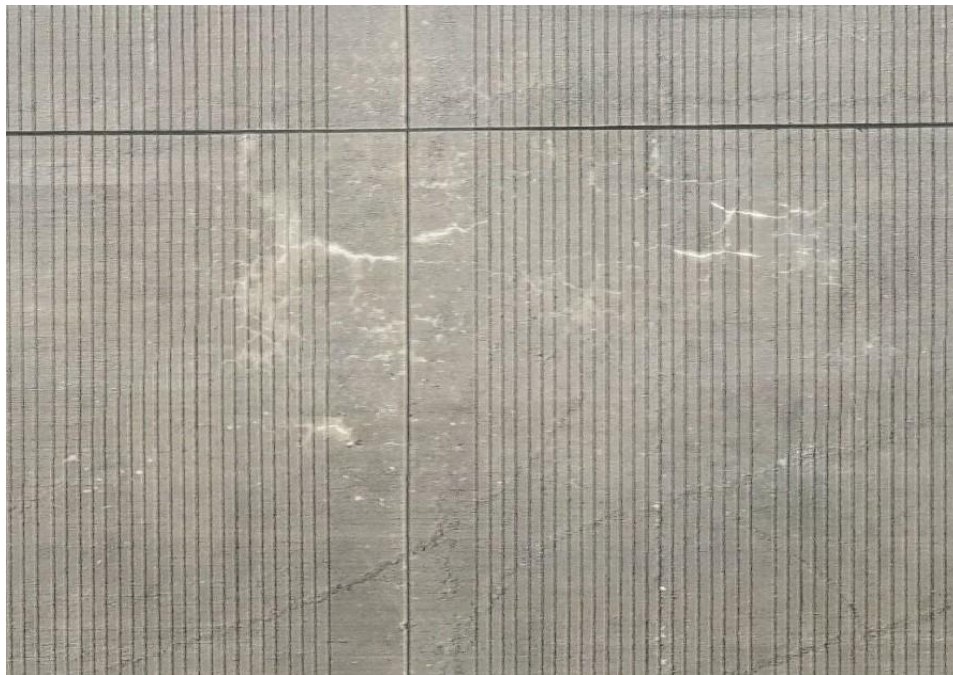
Photograph 22: Typical Shrinkage Cracking (low-severity)

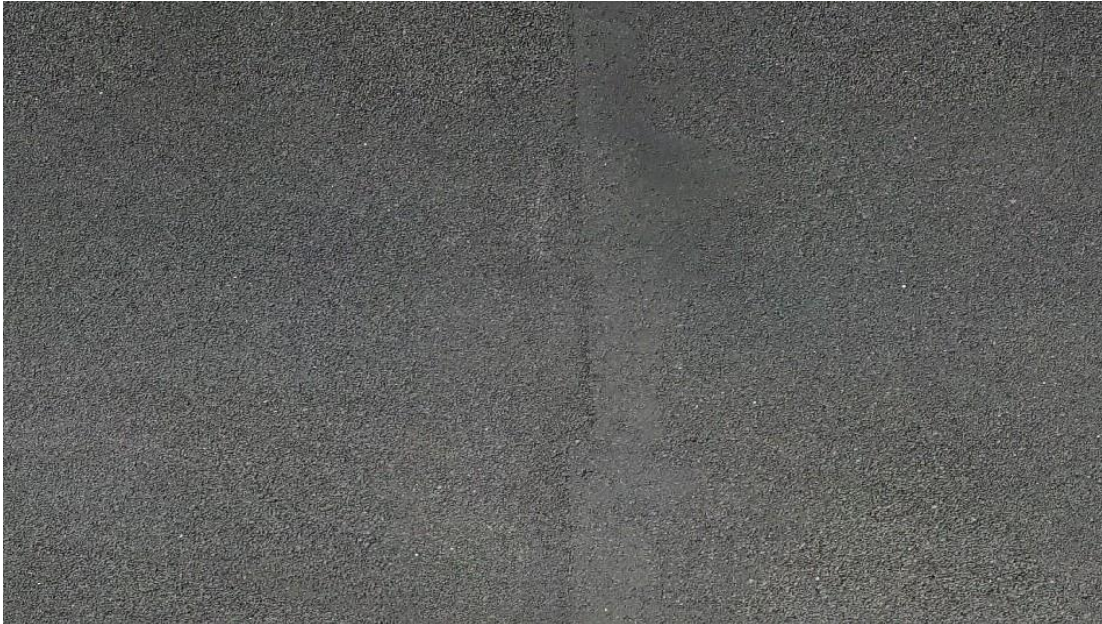
Photograph 23: Typical Transverse Cracking (medium-severity)

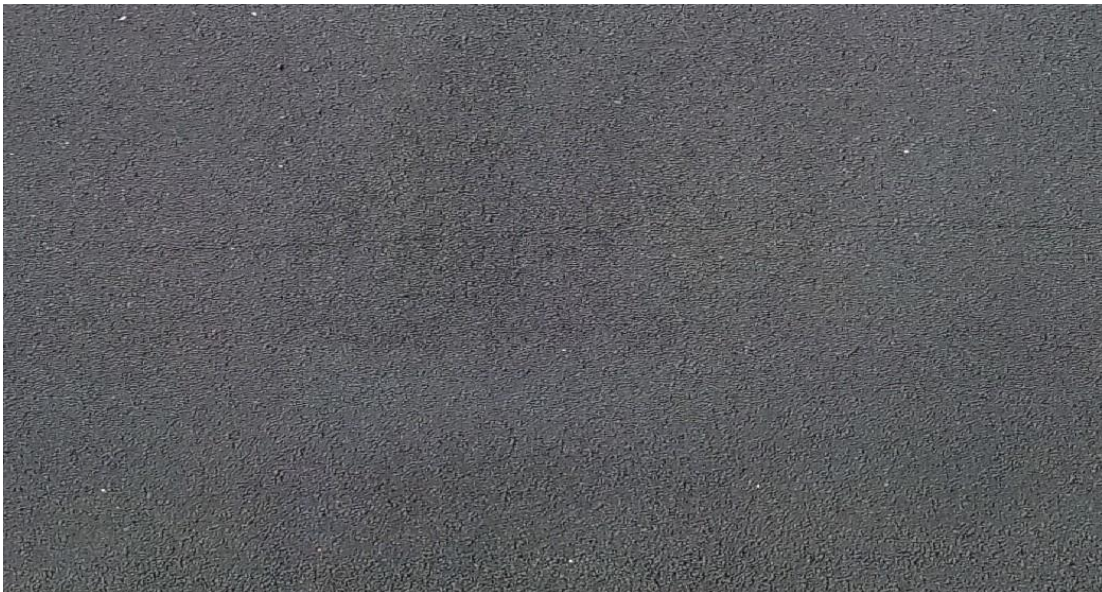
Photograph 24: Typical Longitudinal Cracking (medium-severity)

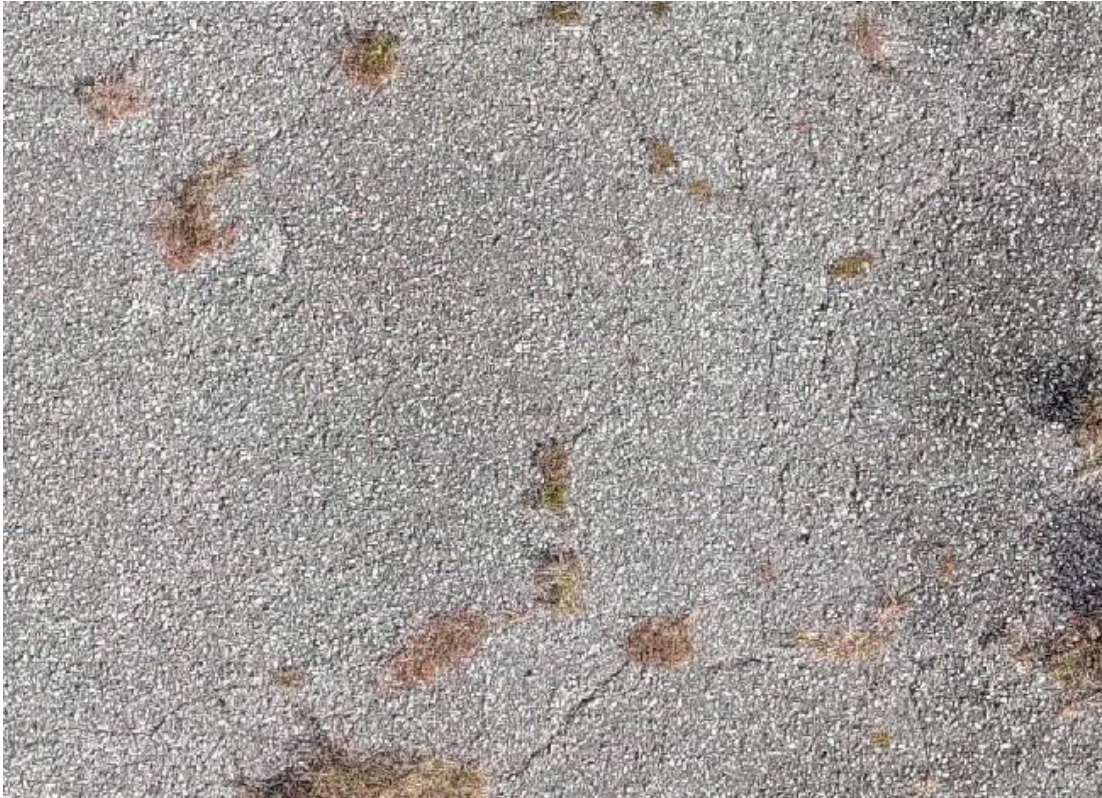
Photograph 25: Raveling (high-severity)

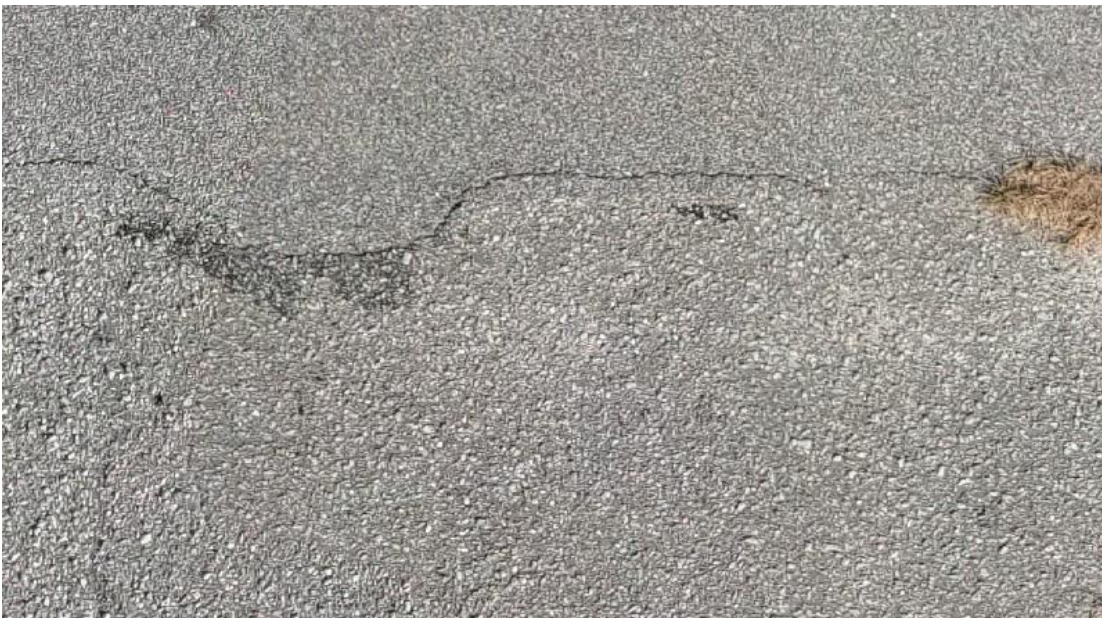
Photograph 26: Typical Transverse Cracking (low-severity)

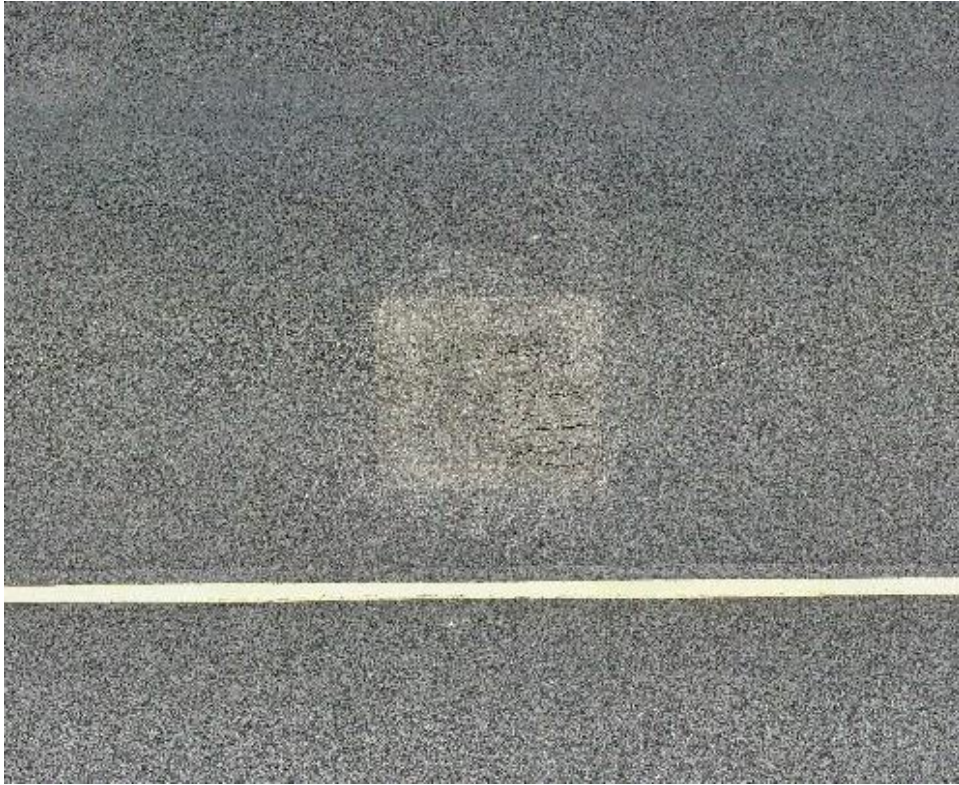
Photograph 27: Patching (medium-severity)

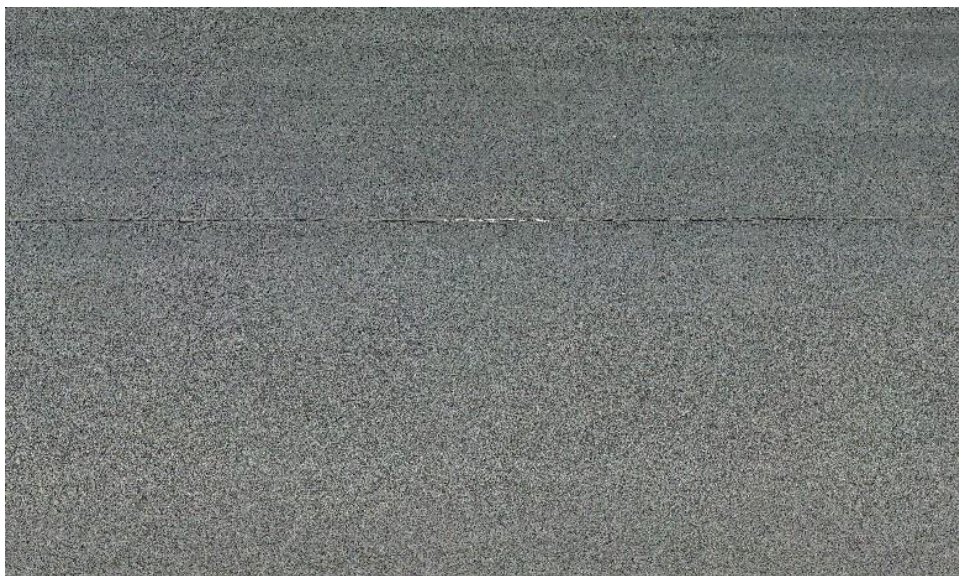
Photograph 28: Typical Longitudinal Cracking (medium-severity)
