2022 Pavement Condition Index Report

Charleston Executive Airport

For The
Charleston County Aviation Authority

Issued: December 15, 2023

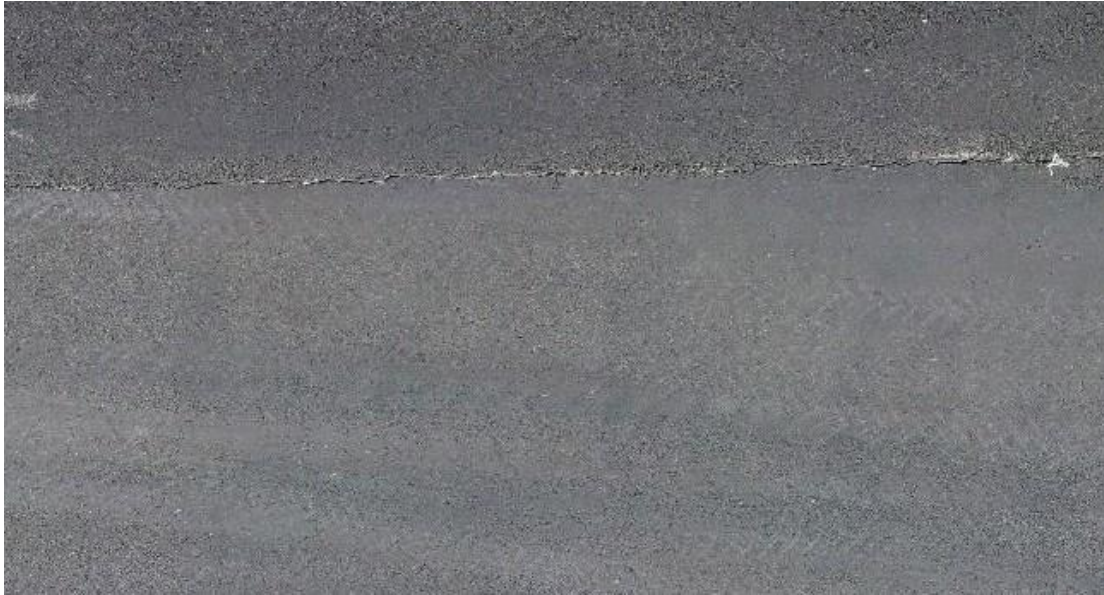
Photograph 29: Typical Longitudinal Cracking (medium-severity)

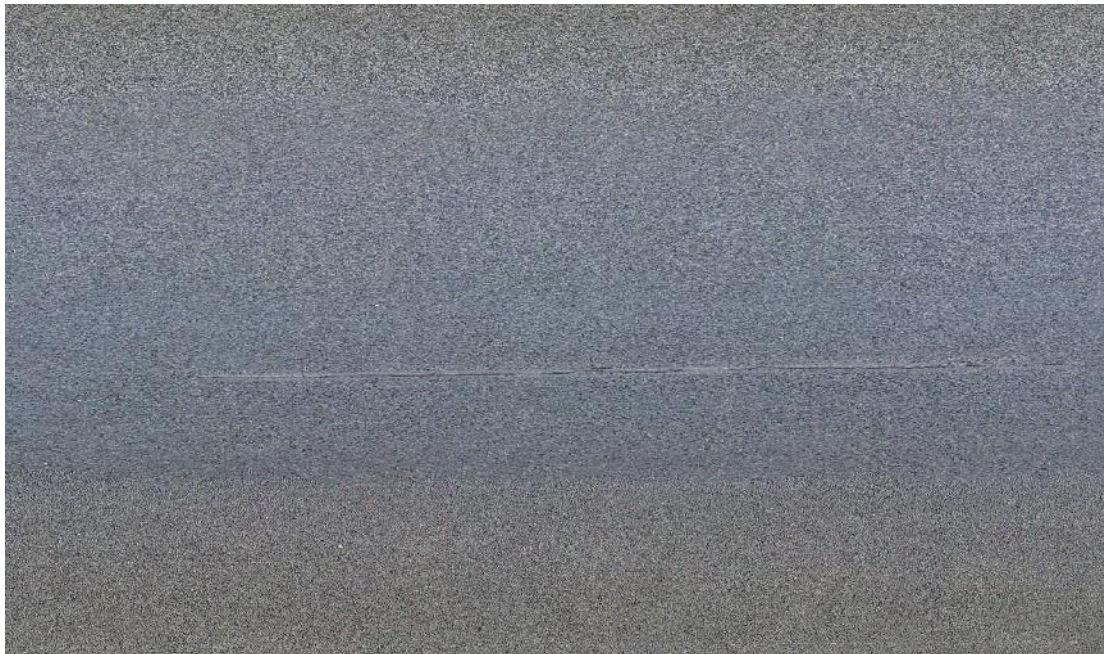
Photograph 30: Typical Longitudinal Cracking (low-severity)

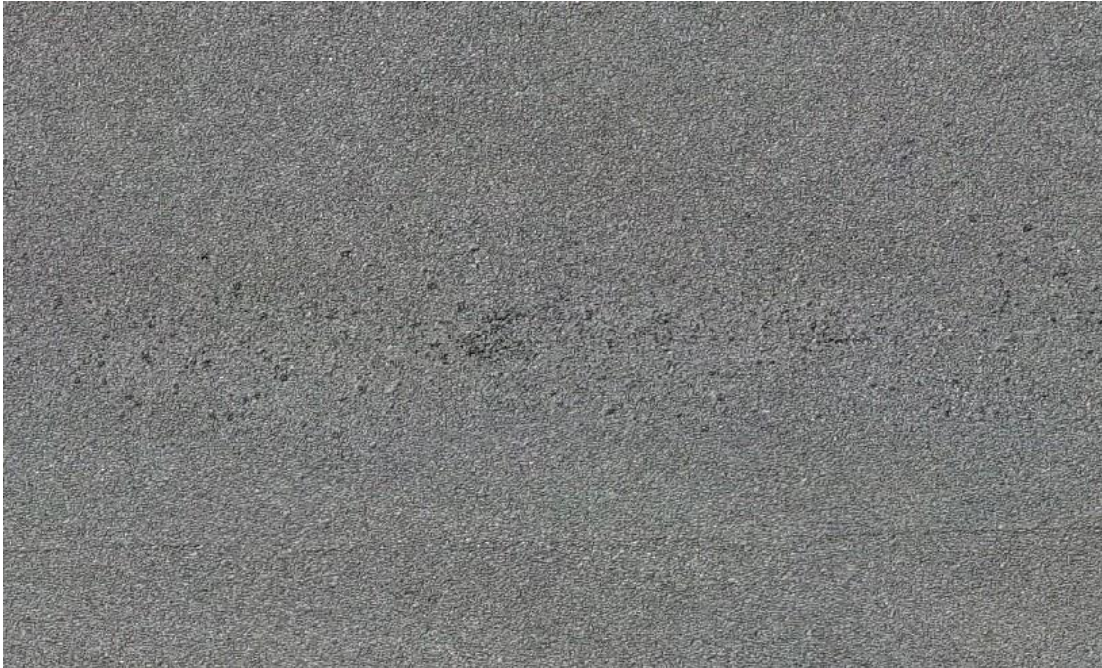
Photograph 31: Raveling (medium-severity)

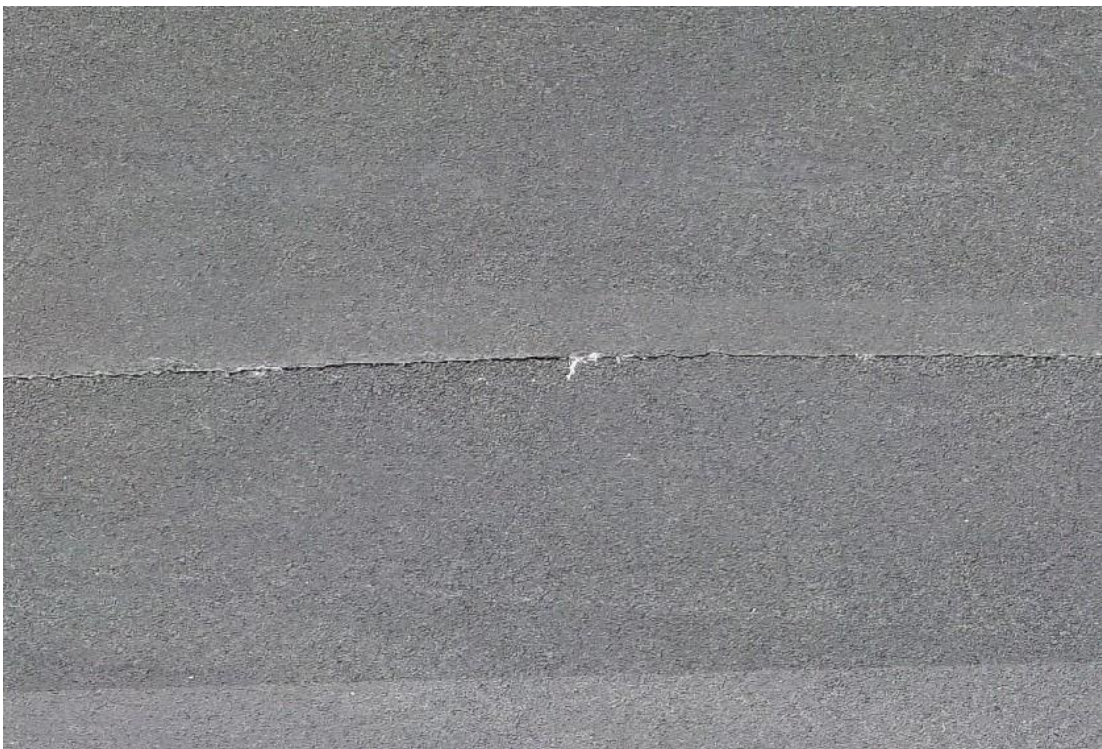
Photograph 32: Typical Longitudinal Cracking (medium-severity)

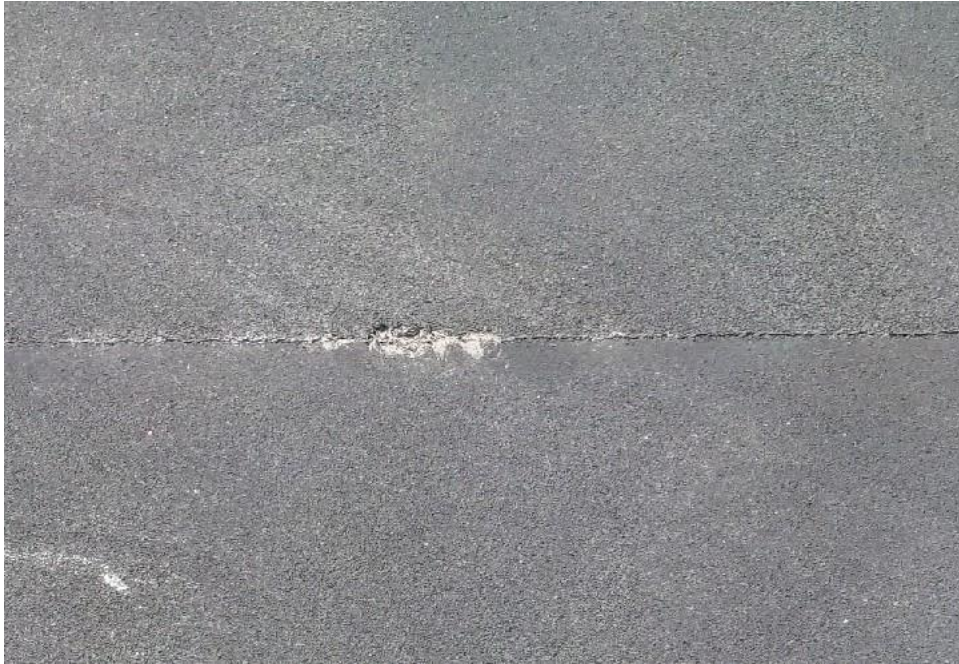
Photograph 33: Typical Transverse Cracking (medium-severity)

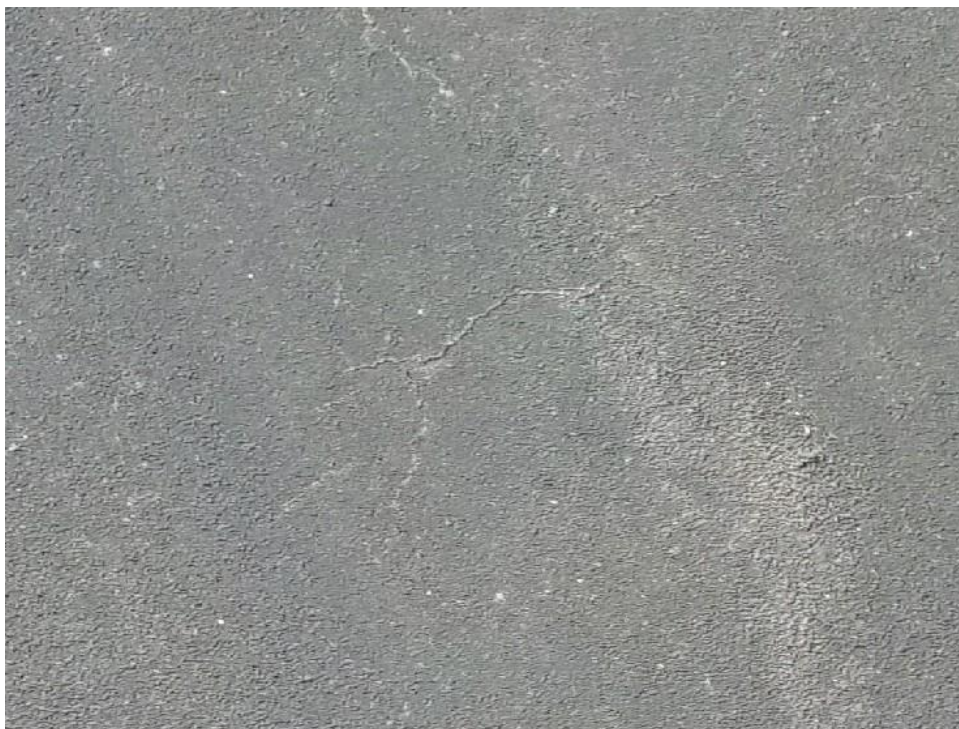
Photograph 34: Typical Transverse Cracking (low-severity)

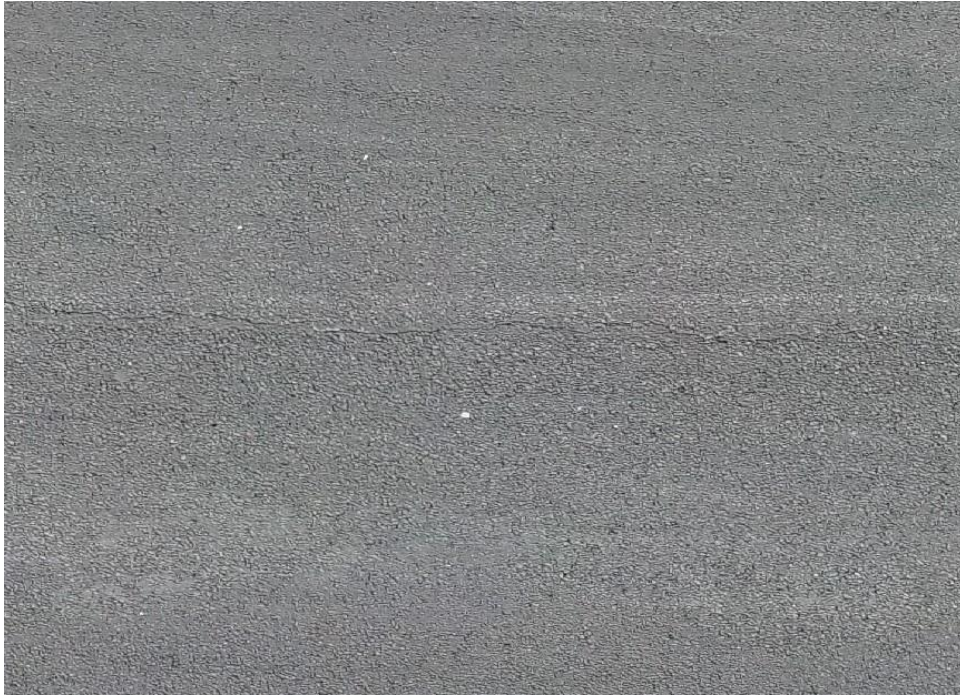
Photograph 35: Typical Longitudinal Cracking (low-severity)

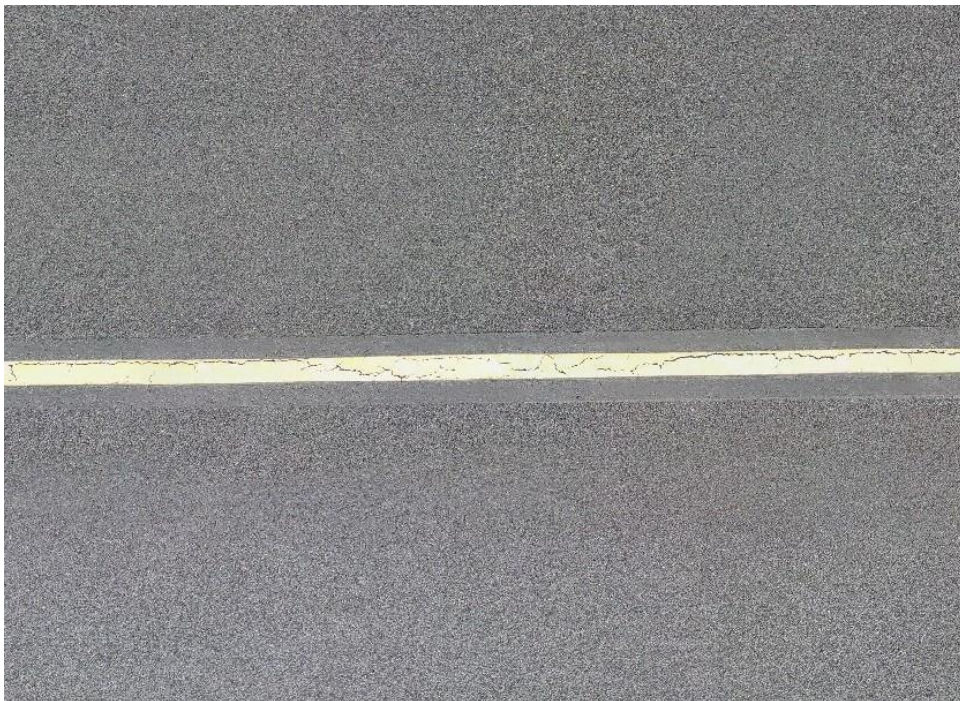
Photograph 36: Typical Longitudinal Cracking (low-severity)

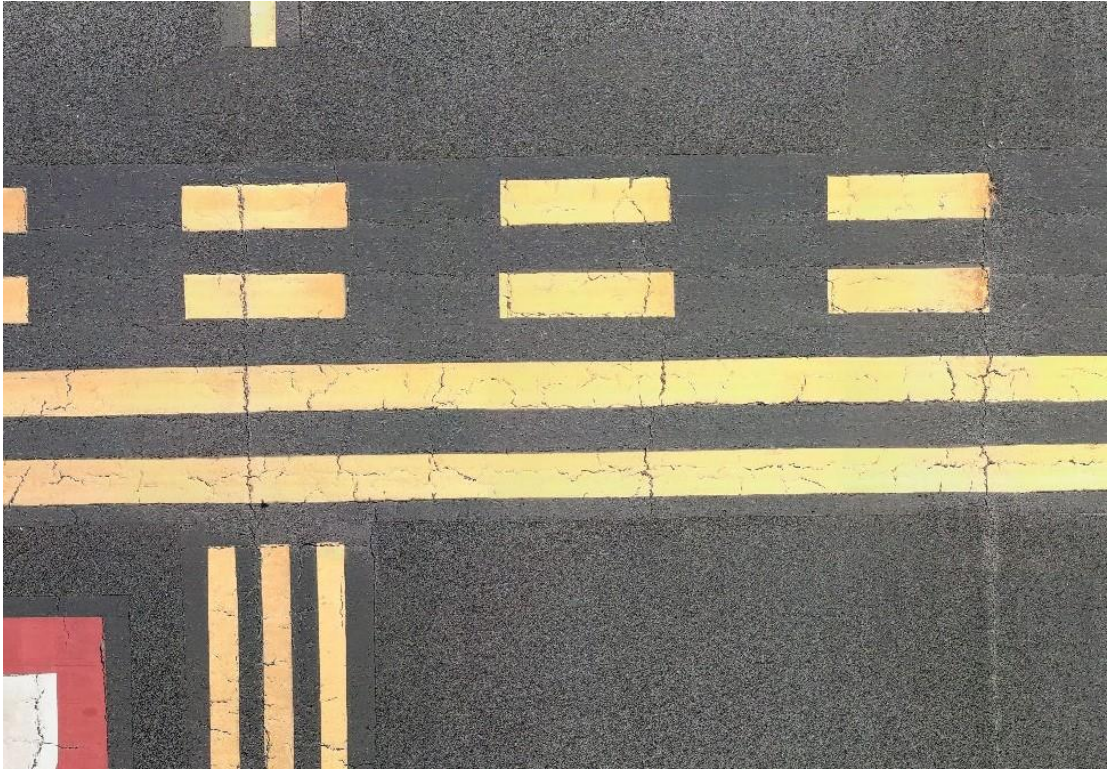
Photograph 37: Typical Longitudinal Cracking (medium-severity)

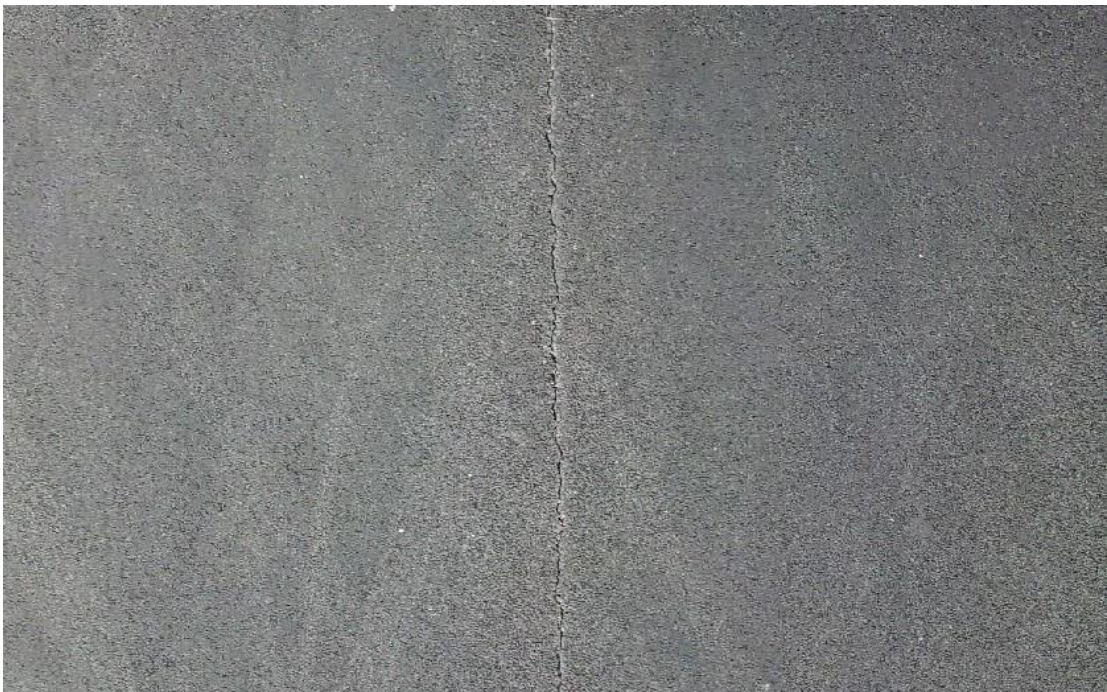
Photograph 38: Typical Longitudinal Cracking (low-severity)

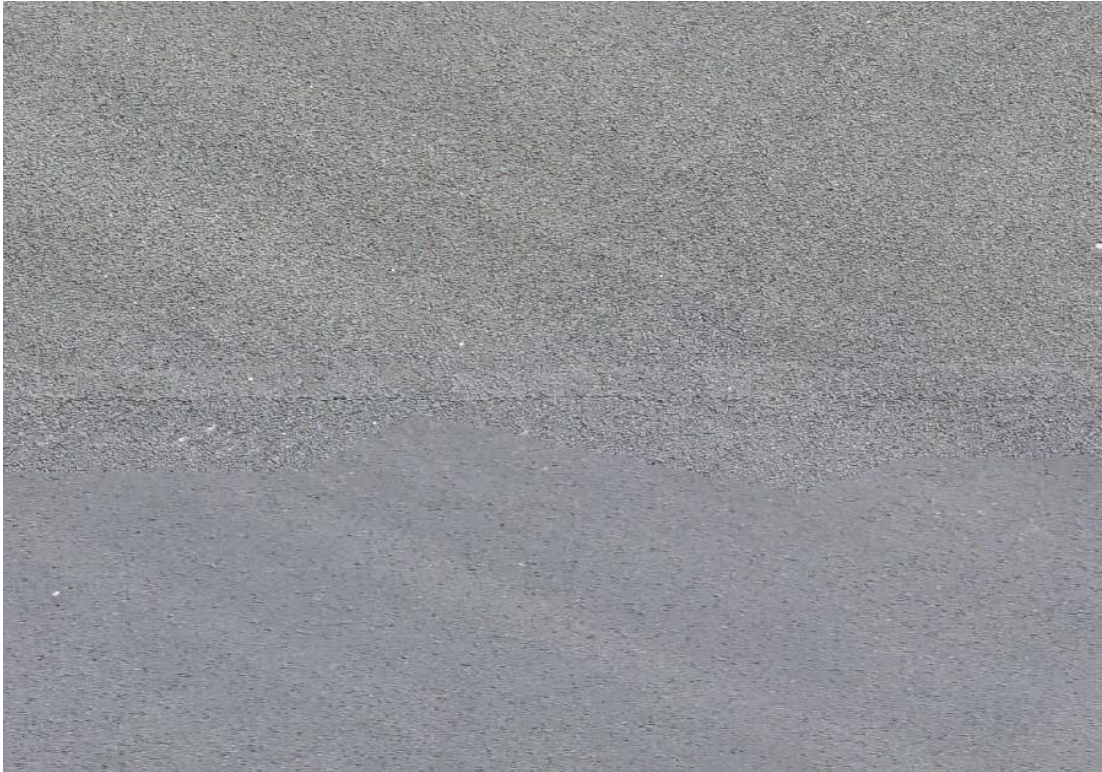
Photograph 39: Typical Longitudinal Cracking (low-severity)

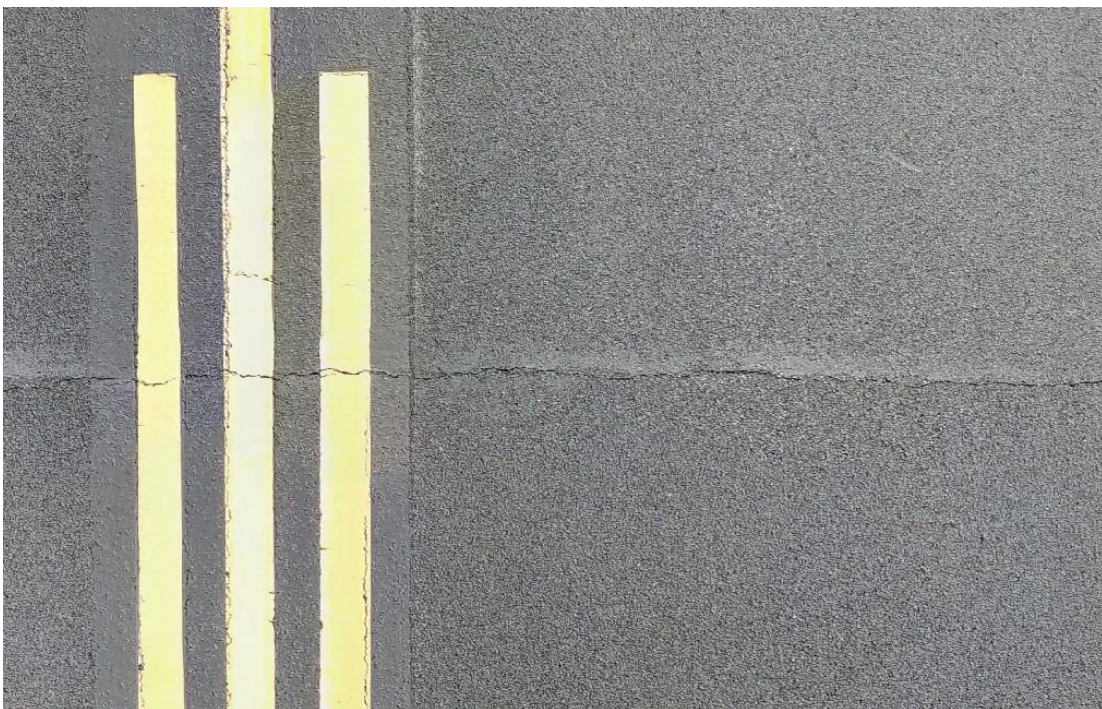
Photograph 40: Typical Longitudinal Cracking (low-severity)

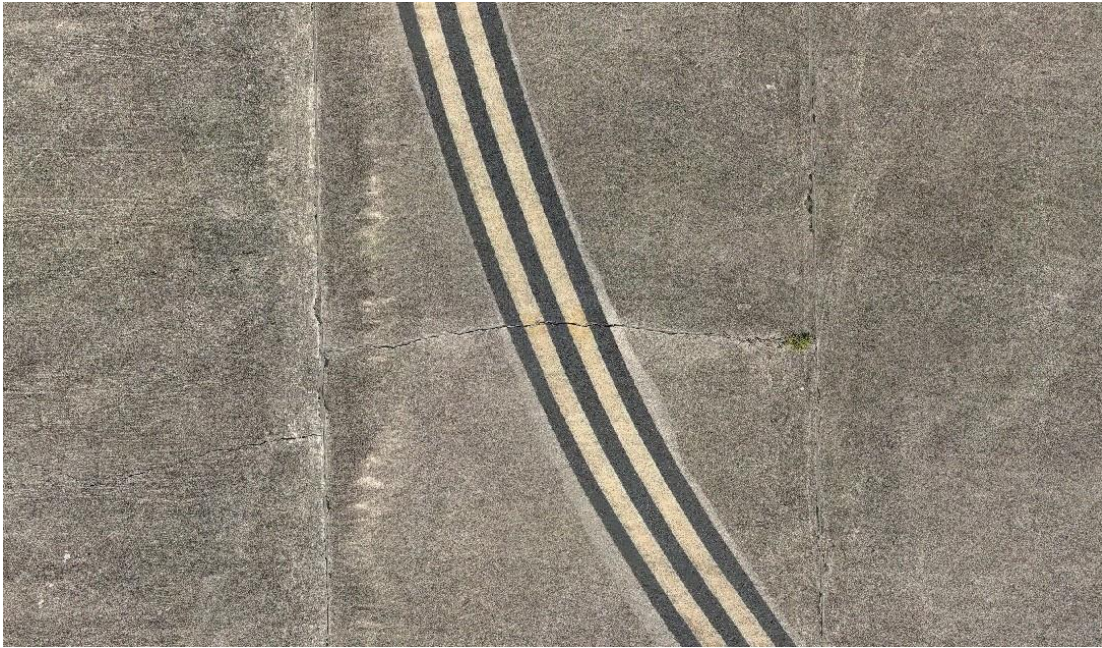
Photograph 41: Typical Linear Crack (medium-severity)

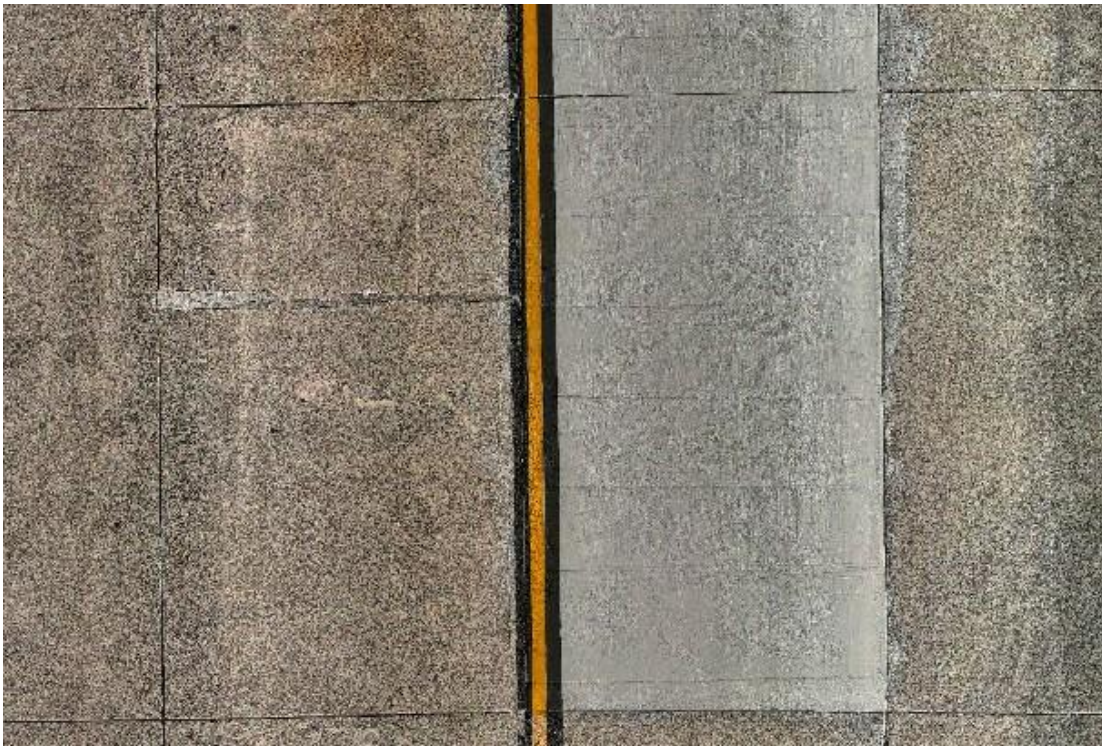
Photograph 42: Typical Small Patch (low-severity) Adjacent to a Replaced Slab

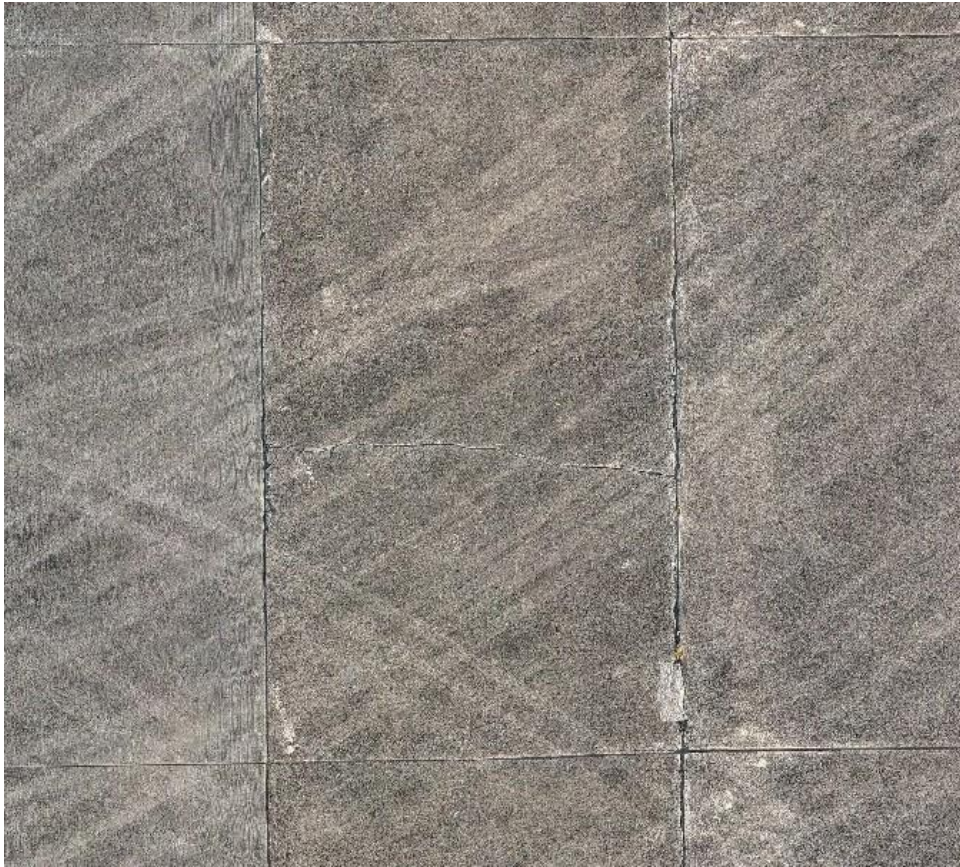
Photograph 43: Typical Linear Crack (medium-severity)

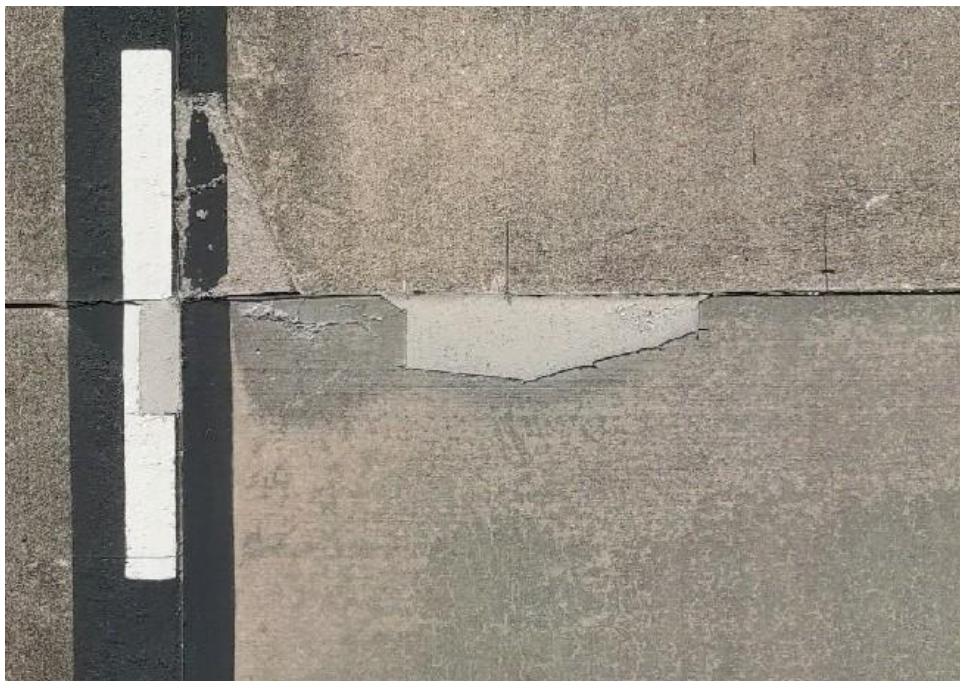
Photograph 44: Typical Joint Spall (medium-severity) Adjacent to a Repaired Joint Spall

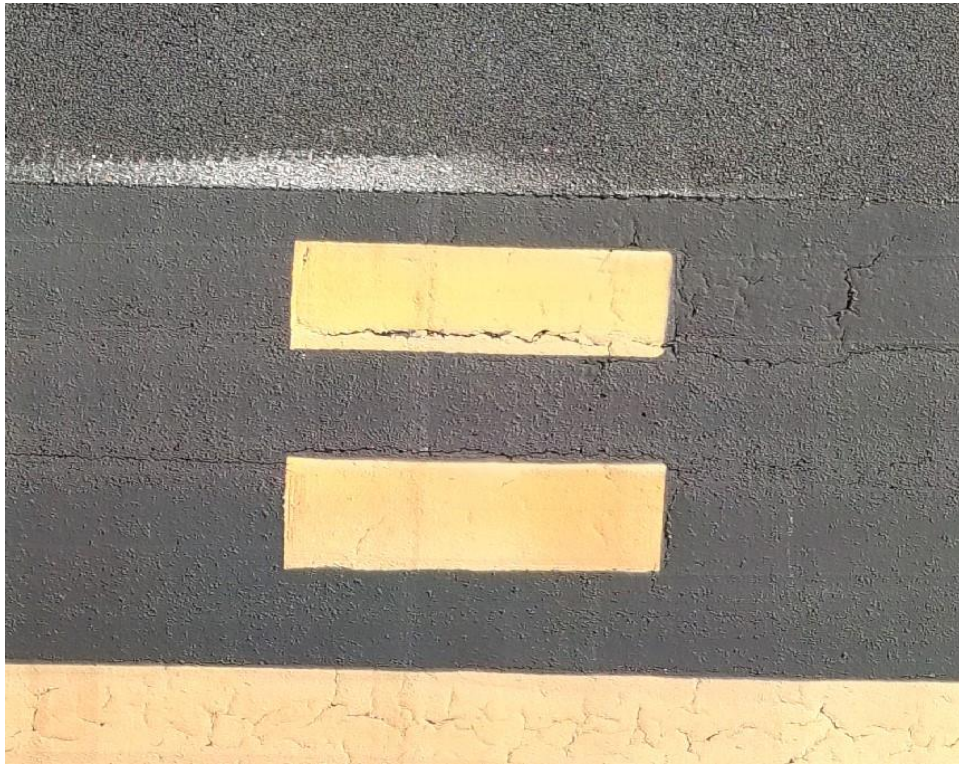
Photograph 45: Typical Longitudinal Cracking (medium-severity)

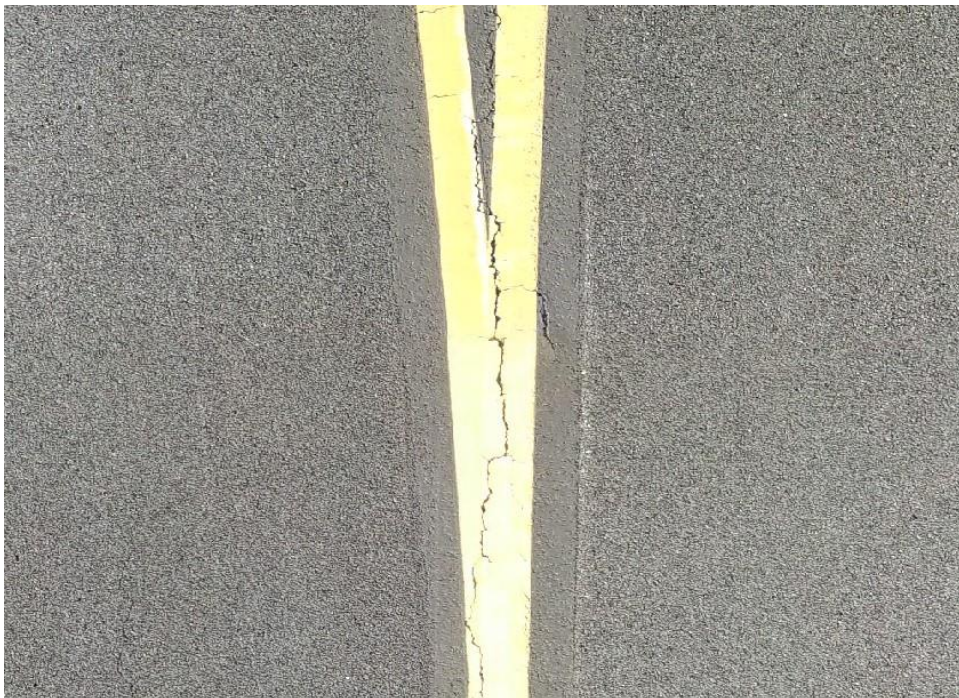
Photograph 46: Typical Longitudinal Cracking (low and medium-severity)

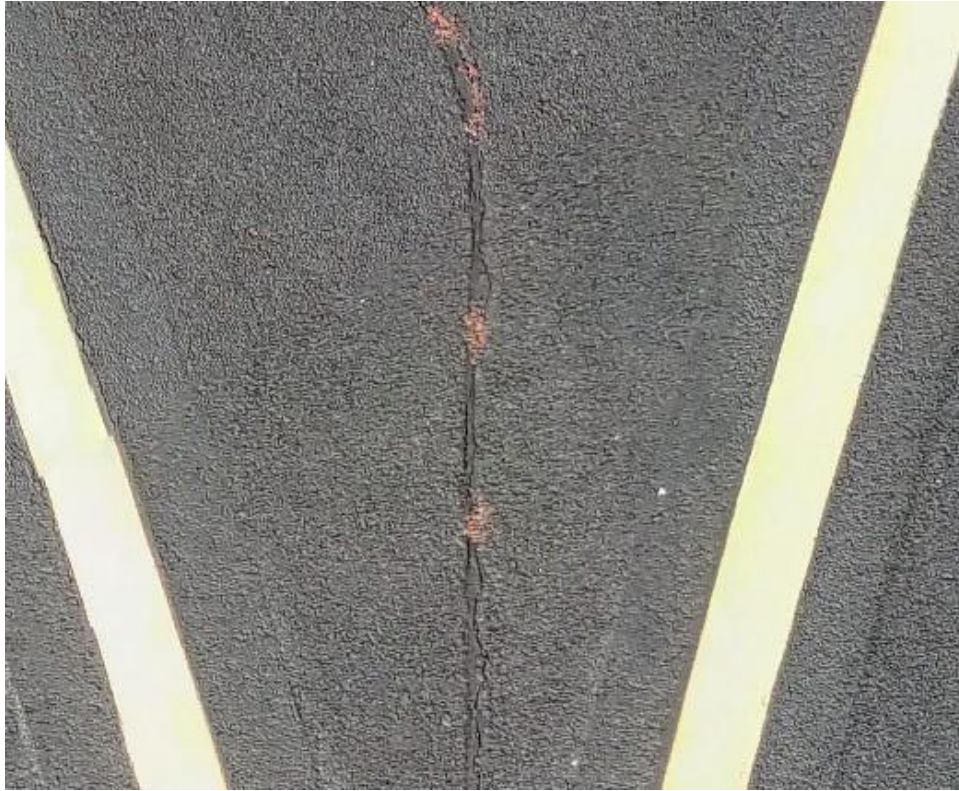
Photograph 47: Typical Longitudinal Cracking (medium-severity)

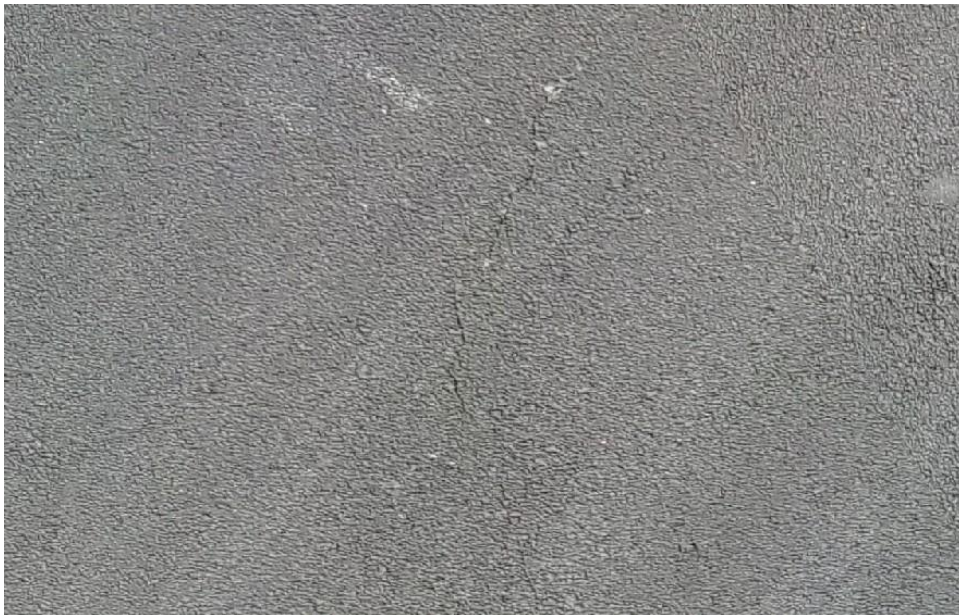
Photograph 48: Typical Joint Spall (medium-severity) Adjacent to a Repaired Joint Spall

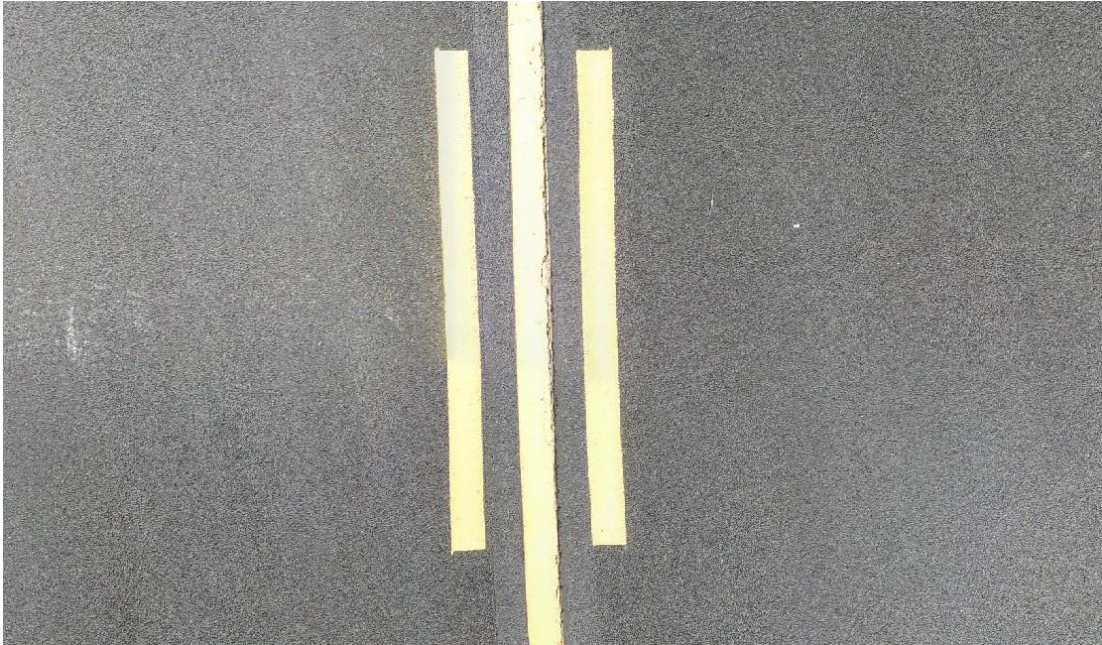
Photograph 49: Typical Longitudinal Cracking (medium-severity)

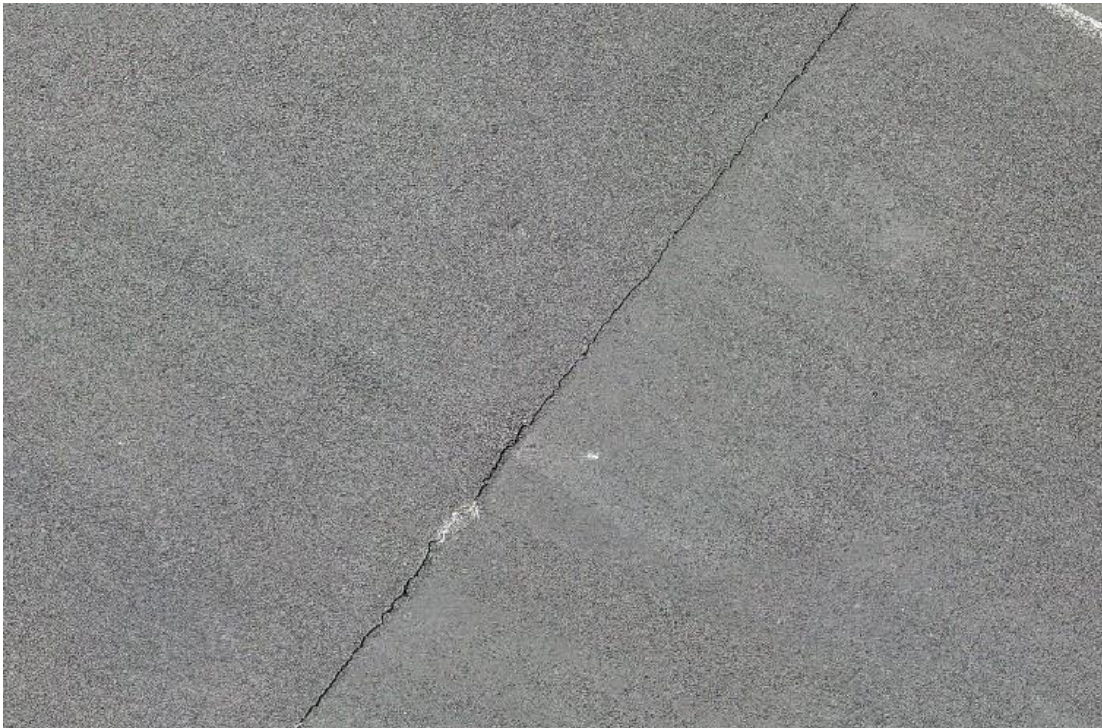
Photograph 50: Typical Transverse Cracking (medium-severity)
