20210525.CA

COLUMBIA METROPOLITAN AIRPORT

PAVEMENT MANAGEMENT PLAN
FINAL REPORT

December 2022

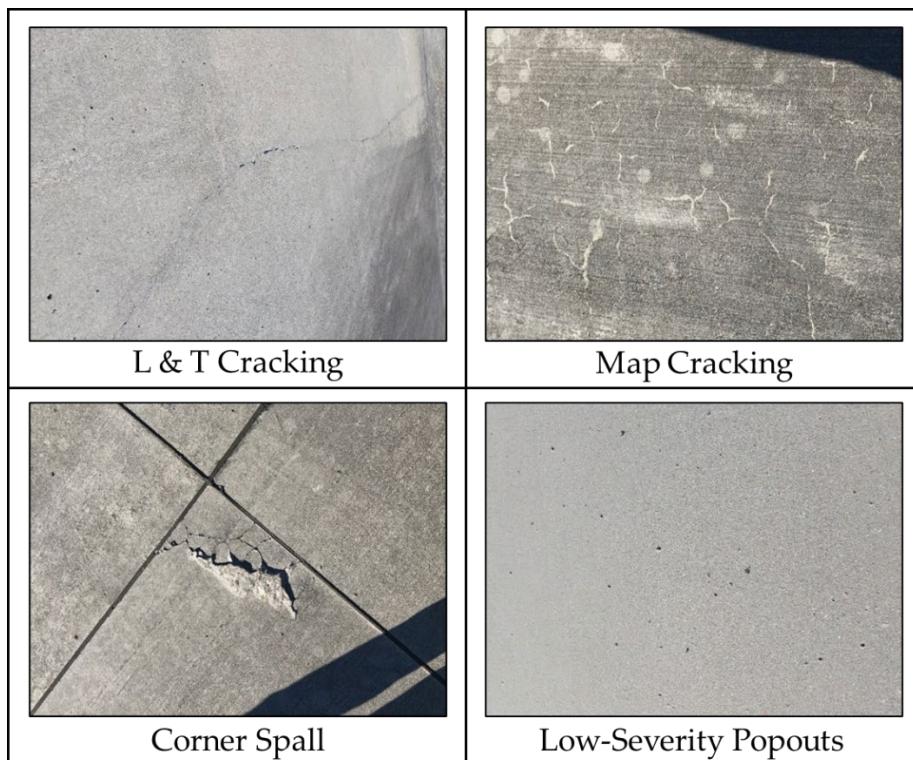
Figure I.4: Examples of Distresses at East Cargo Ramp, CAE

The East Cargo Ramp has two PCC-surface pavement sections. APRECARGO-10 received a PCI score of 83—a “Satisfactory” classification, while APRECARGO-20 received a PCI score of 92—a “Good” classification. The primary distresses contributing to APRECARGO-10’s lower PCI score compared to its counterpart were popouts, joint spalls, and joint corner spalls. In addition to these, instances of longitudinal/transverse cracks were observed. APRECARGO-20 had very few distresses observed—merely a few instances of spalling, patches, joint seal damage, and the presence of map cracking. A summary of the section condition is provided in **Table I.4**, and examples of observed distresses are depicted in **Figure I.4**.

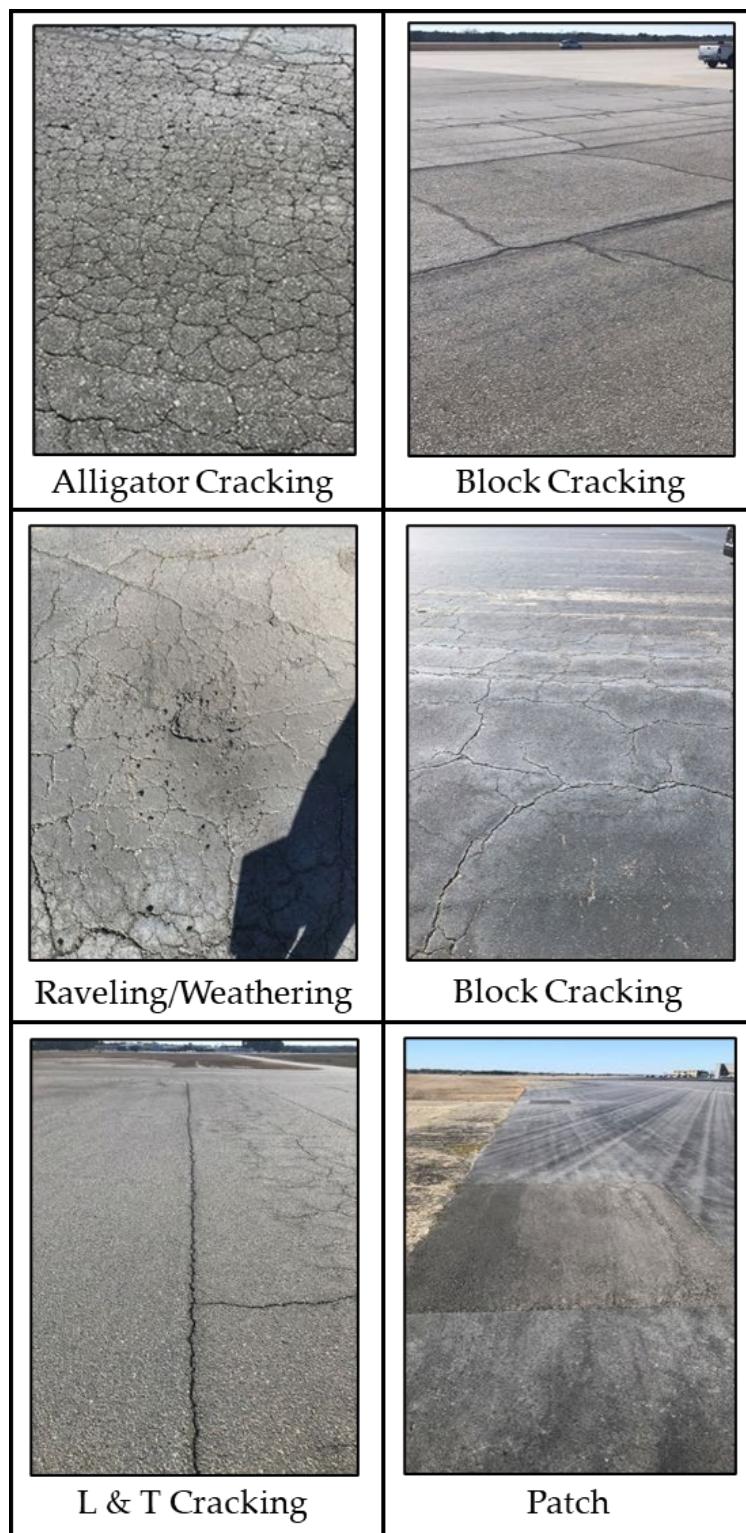
Figure I.5: Examples of Distresses at FBO Ramp, CAE.

The FBO Ramp has 20 sections, with 4 sections being PCC-surfaced, 12 being AC-surfaced, and 4 being AAC-surfaced. Table I.5 summarizes the PCI score for all sections in this branch. Most of the PCC sections are in "Good" condition, except for APRFBO-120, having a weighted score of 89. The AC/AAC-surfaced sections, however, received a classification of "Very poor" based on a weighted PCI score of 39. These sections contained the entire range of asphalt distresses observed at CAE. The primary contributors to PCI deductions were block cracking, alligator cracking, and longitudinal/transverse cracking. A summary of the section conditions is provided in [Table I.5](#) and [Figure I.5](#) shows examples of distresses observed at the FBO Ramp.

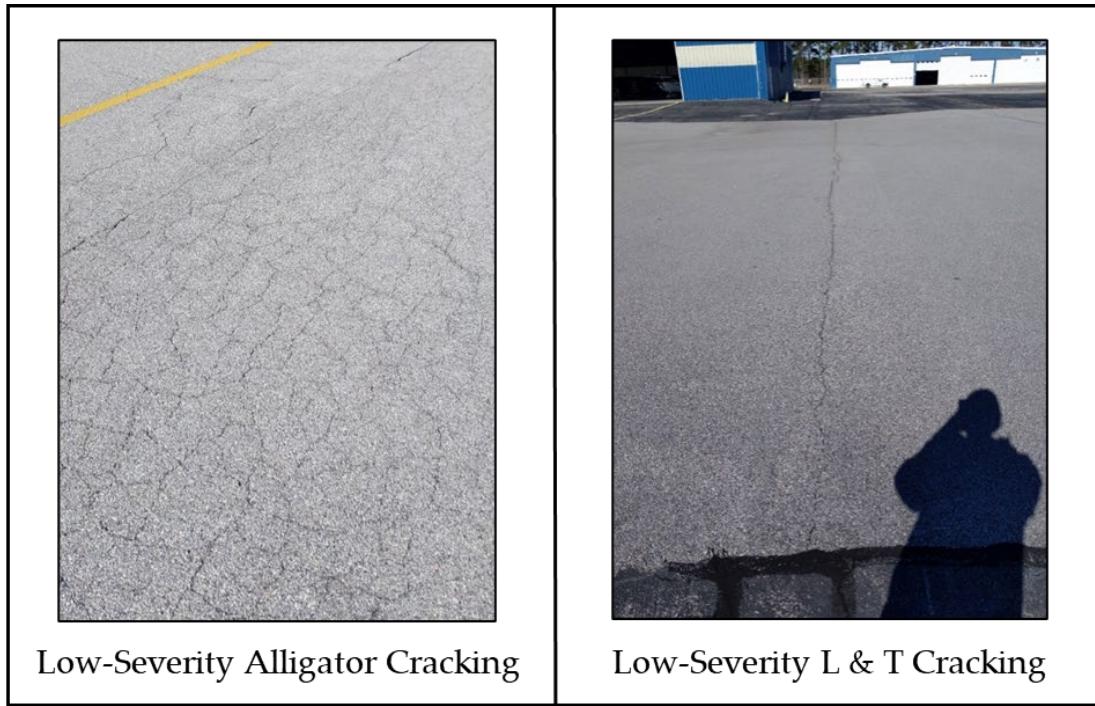
Figure I.6: Examples of Distresses in Section APRFBO-17

One area of particular concern was that of section APRFBO-17, an AAC-surfaced section which received a PCI score of 28—a score drastically lower than the projected “Satisfactory” score of 77 as reported in the APMS 2016. Based on work history records and aerial photography, this area was patched in 2013, and significant decay was not visible during the 2016 APMS inspections. Since the 2016 APMS, however, a significant portion of the section sample presented with low severity alligator cracking and longitudinal/transverse cracking—the source of the lower PCI score. It is recommended that this section be closely monitored due to its rapid rate of deterioration. Photographs specific to this section are shown in **Figure I.6**.

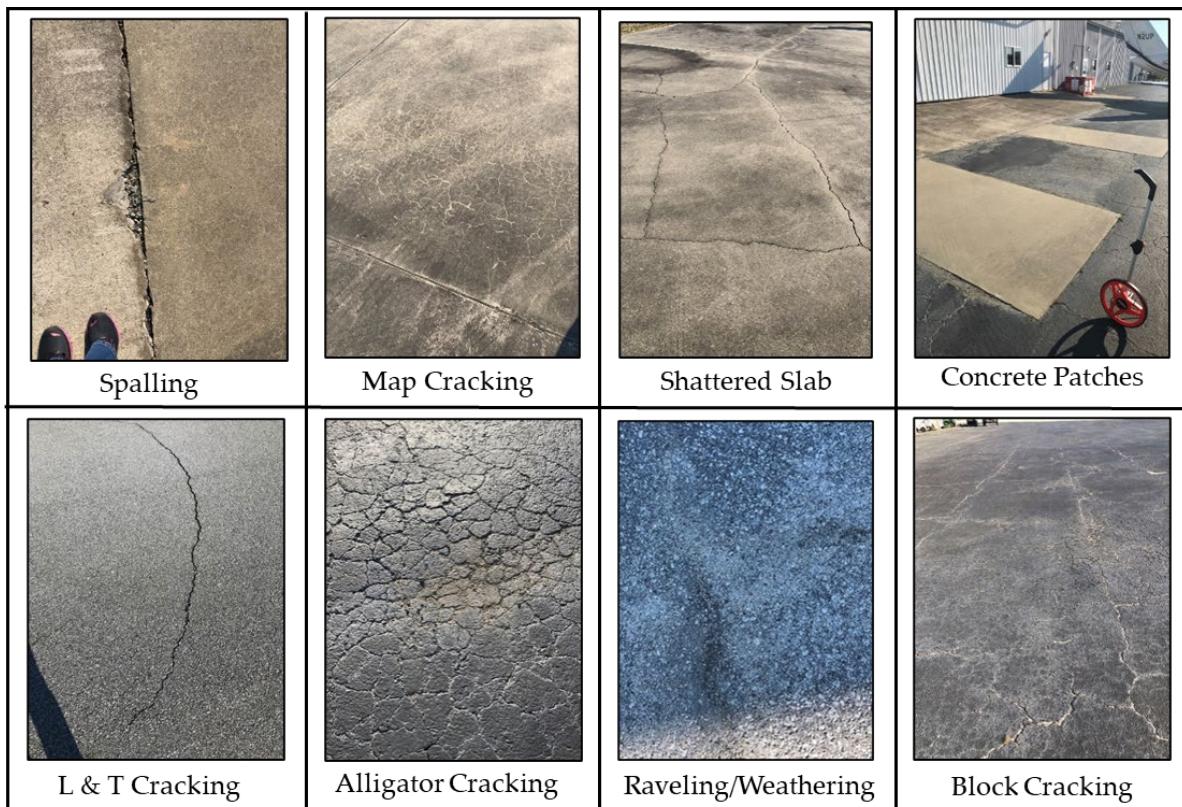
Figure I.7: Examples of Distresses on FBP Ramp, CAE

The East FBO Ramp has 11 sections, with 4 being PCC-surfaced and 7 being AC-surfaced. **Table I.6** summarizes the PCI findings for this area. The PCC pavements of the branch received a weighted score of 31, indicating the pavement’s “Very Poor” condition. These areas had significant identified distresses, including shattered slabs, durability cracking, and spalling. The AC-surfaced areas received a slightly better score of 51, indicating the pavement’s Poor condition. Primary distresses in this area included alligator cracking, block cracking, and long./trans. cracking. **Figure I.7** shows examples of these distress types observed at CAE.

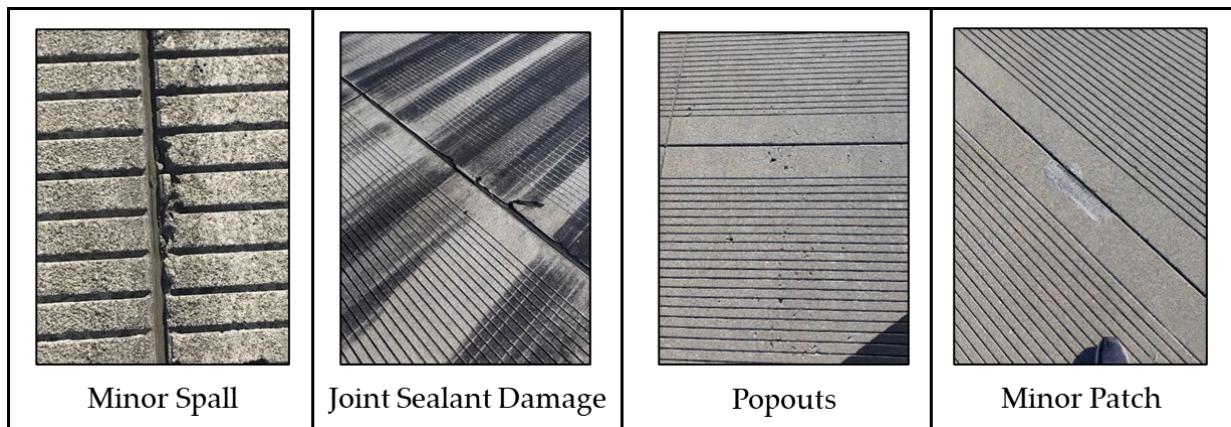
Figure I.8: Examples of Distresses on Runway 11/29, CAE

Runway 11-29 consists of three sections running parallel along its length. All three sections were in “Good” condition with very few distresses observed—primary distresses being joint sealant damage, some patches, and minor spalling. Some minor map cracking was also identified. **Table I.7** summarizes the PCI scores of this pavement area, and **Figure I.8** illustrates examples of pavement distress observed on Runway 11/29.

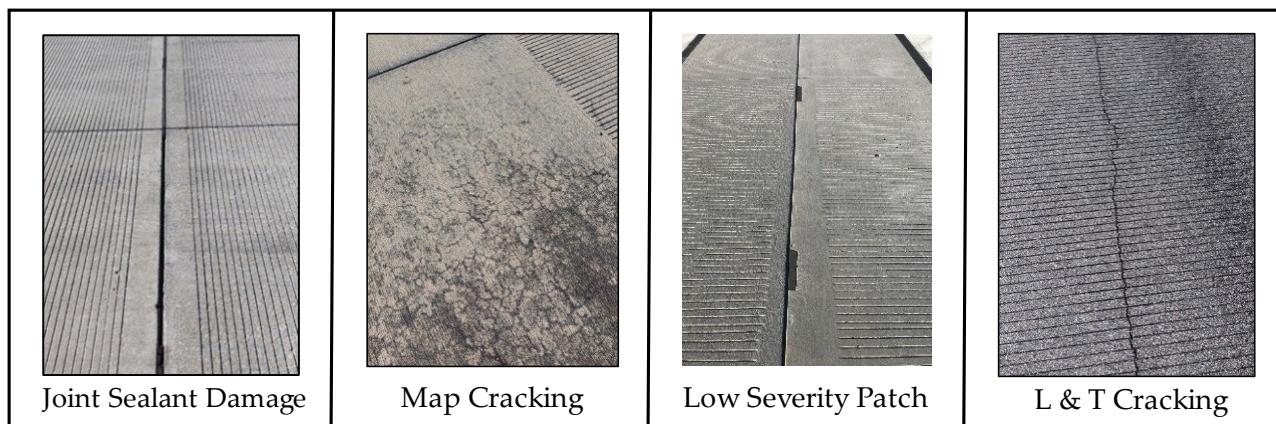
Figure I.9: Example of Distresses on Runway 5/23, CAE

Runway 5-23 consists of 19 sections – 13 PCC-surfaced and 6 AC-surfaced. Overall, the PCC-surfaced areas were in “Good” condition, with a weighted PCI average of 90. No major distresses were identified. Primary observed distresses were joint seal damage, and surface defects. The AC-surfaced areas were in “Satisfactory” condition with a weighted score of 82. The primary distresses recorded were longitudinal/transverse cracking and weathering. **Table I.8** below summarizes the PCI scores for this branch, and **Figure I.9** illustrates observations of pavement distress on Runway 5/23.

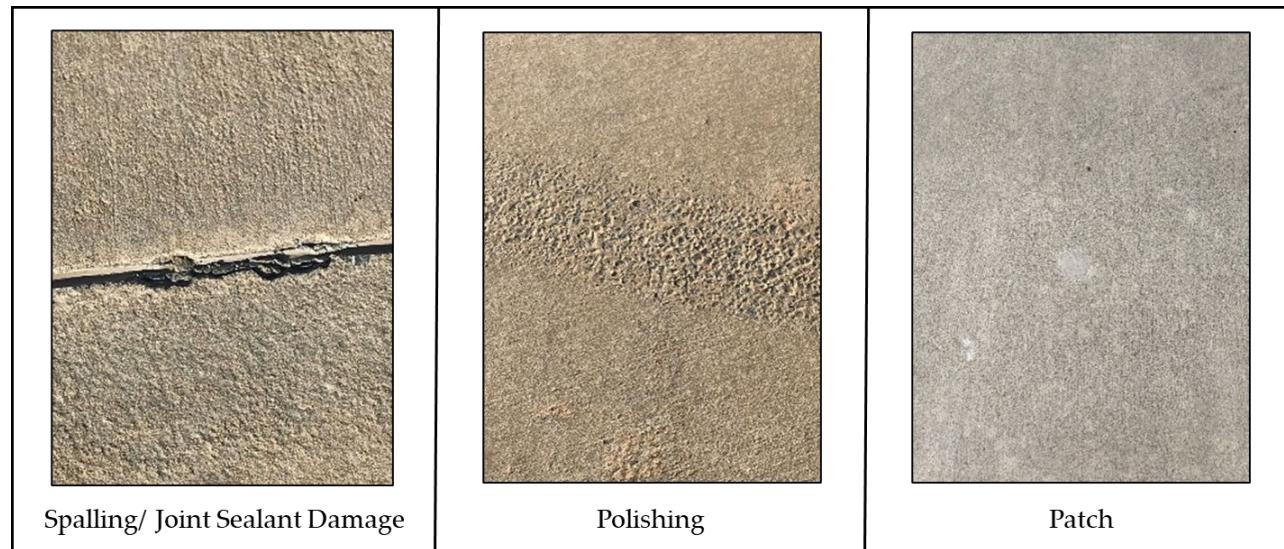
Figure I.10: Examples of Distresses on the Terminal Apron, CAE

The Terminal Apron consists entirely of PCC-surfaced area and contains six sections. With the exception of sections APRTERM-10 and APRTERM-50, all remaining areas are in "Good" condition, based on all PCI scores being higher than 86. These areas had minor spalling, patches, and surface defects.

APRTERM-10 and APRTERM-50 were in "Poor" and "Serious" condition respectively. Because these are going to be rehabilitated soon, these sections were not included in the weighted PCI score. **Table I.9** summarizes the overall condition of the Terminal Apron pavements, and **Figure I.10** depicts examples of distress types observed on the Terminal Apron at CAE.

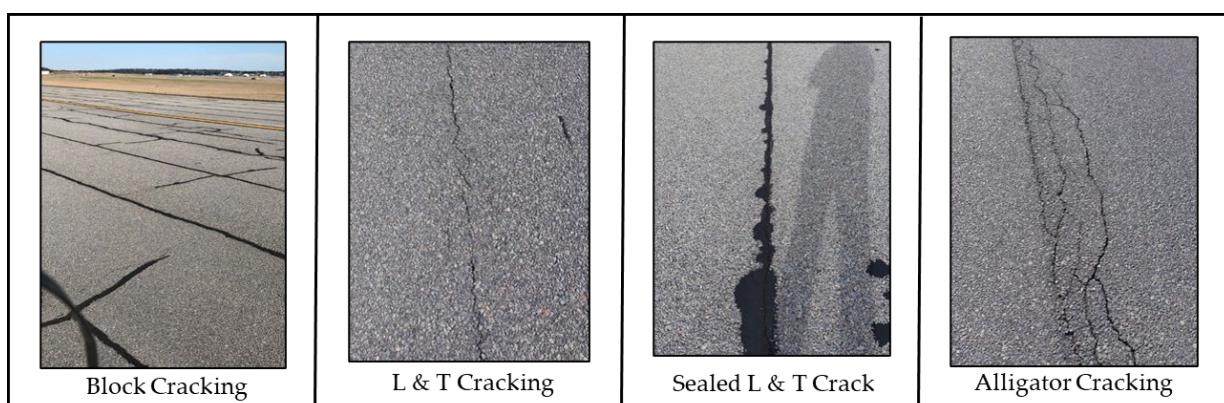
Figure I.11: Examples of Distresses on Taxiway A System, CAE

Because this area was paved within the last 5 years, the PCC pavement areas were in “Good” condition with no distresses observed—resulting in a weighted PCI average score of 100. The asphalt pavement areas, however, received a weighted average score of 60 - indicating “Fair” condition. The primary distresses identified on AC pavements were longitudinal/transverse cracking, block cracking, alligator cracking, and weathering.

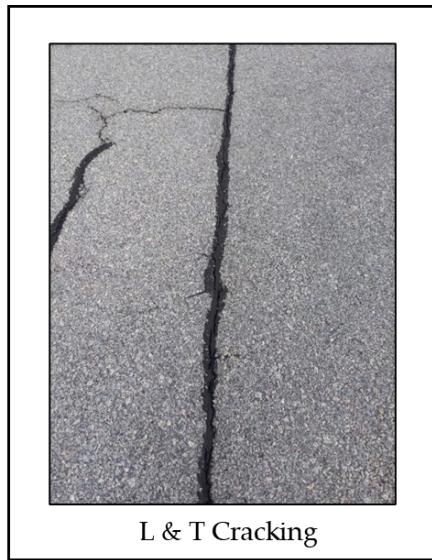
Figure I.12: Examples of Distresses on Taxiway B System, CAE

Taxiway B and its associated connectors provides access from the FBO Ramp to Runway 05-23, intersecting Runway 11-29. This entire branch is AC-surfaced, and its overall condition was classified as "Fair"—with a weighted average PCI score of 57. The primary distresses identified in this area were weathering and longitudinal/transverse cracking. **Table I.11** and **Figure I.12** summarize the PCI scores and observed distresses in this area.

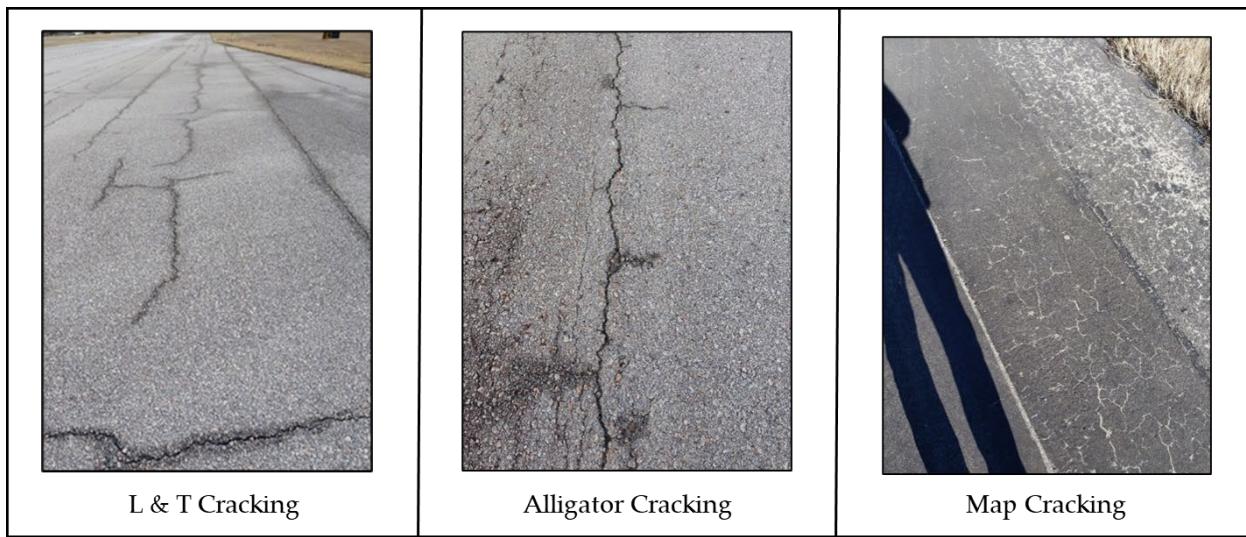
Figure I.13: Examples of Distresses on Taxiway C System, CAE

Section TWC-10 is AC-surfaced, while the remaining sections are PCC-surfaced. The overall condition of the asphalt portions of the taxiway were in “Poor” condition—having a PCI score of 48. The primary distresses observed in this section were raveling, longitudinal/transverse cracking, and block cracking. The PCC areas in contrast were reported to be in “Good” condition with a weighted PCI score of 93. Very few distresses were recorded—primarily map cracking. **Table I.12** summarizes the PCI scores, and **Figure I.13** illustrates examples of distress types in this area.

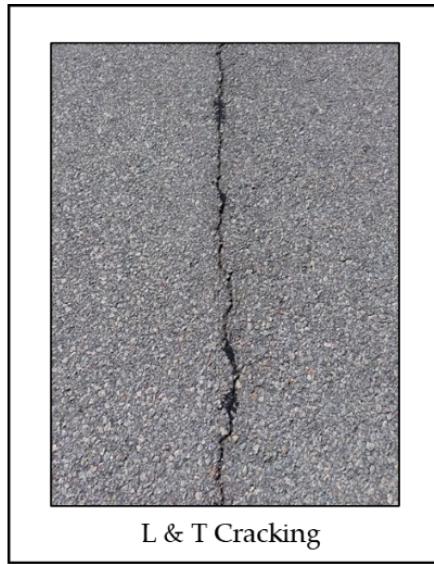
**Figure I.14: Examples of Distresses on Taxiway D System, CAE****Taxiways E, E1, E2, E3; Taxilane E**

Taxiway D runs parallel to Runway 05-23 on the east side and is comprised of 14 sections—six sections PCC-surfaced, and eight sections AC/AAC-surfaced. The overall condition of the PCC pavements in this section are “Good”, having returned a weighted PCI score of 93. Very few distresses were identified—all minor, such as map cracking, low-severity spalls, etc.

The overall condition of the AC/AAC pavements in this area are classified as “Fair”, having a weighted average of 65. The primary distresses identified the AC-surfaced pavements were weathering and longitudinal/transverse cracking. **Table I.13** summarizes the PCI scores for this area, and **Figure I.14** depicts distress types observed there.

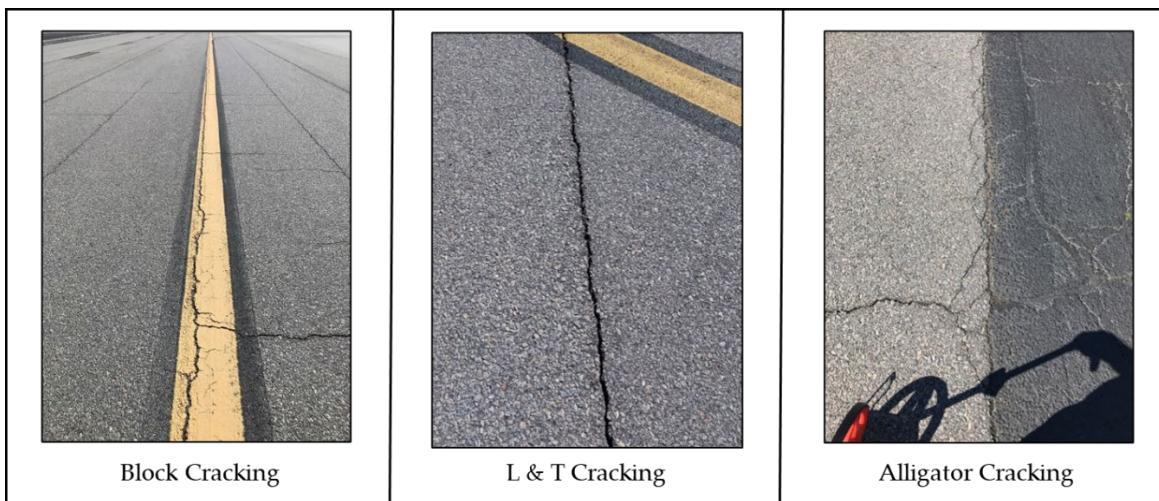
Figure I.15: Examples of Distresses on the Taxiway E System, CAE

was classified as “Fair”—with a weighted average PCI score of 58. The primary distresses identified in this area were weathering, block cracking, alligator cracking, and longitudinal/transverse cracking. **Table I.14** below summarizes the PCI scores for this area, and **Figure I.15** depicts observed distress types.

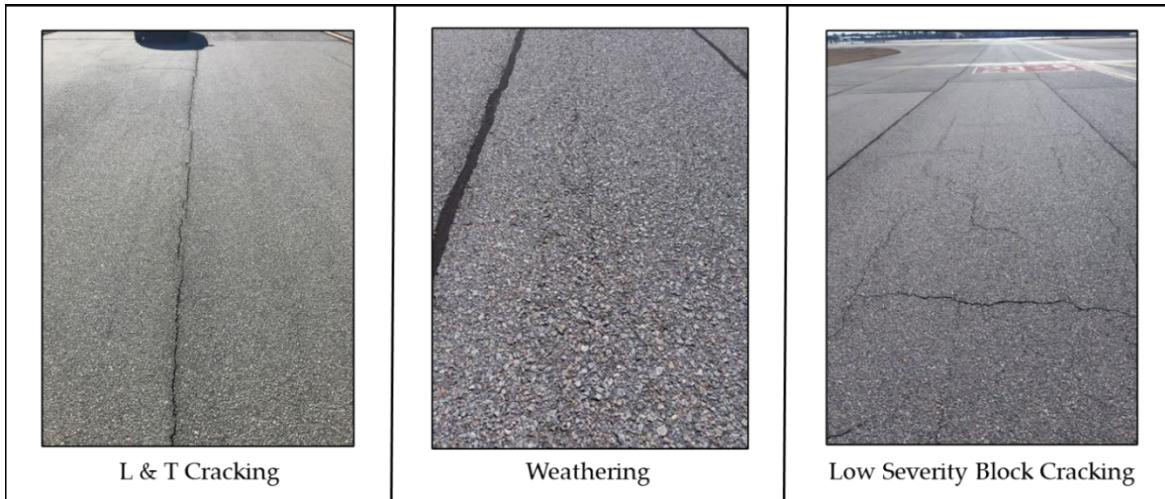
Figure I.16: Examples of Distresses on Taxiway F, CAE

Taxiway F provides access from Taxiway A to Runway 05-23, intersecting Runway 11-29 and Taxiway B. It is comprised of eight sections—six AC/APC-surfaced sections and two PCC-surfaced sections. The overall condition of the PCC pavements in this area are “Satisfactory”, having returned a weighted PCI score of 80. The primary distresses identified were joint seal damage, some longitudinal/transverse cracking, and the presence of minor map cracking.

The overall condition of the AC/APC pavements in this area are classified as "Poor", having a weighted average of 55. The primary distresses identified the AC-surfaced pavements were raveling and longitudinal/transverse cracking. **Table I.15** summarizes the PCI scores for this area, and **Figure I.16** provides examples of distress types observed here.

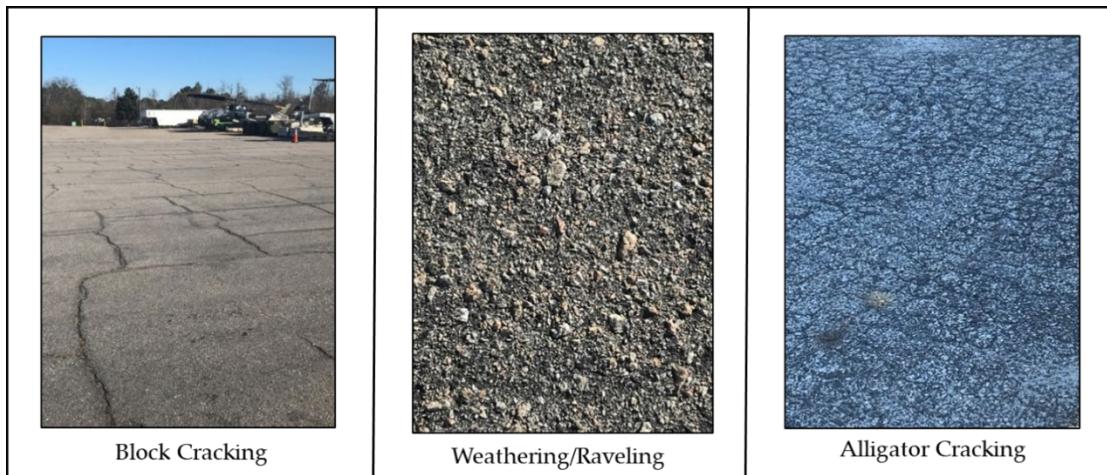
Figure I.17: Examples of Distresses on Taxiway S, CAE

Taxiway S lies on the east side of the FBO ramp and was originally comprised of 3 AC-surfaced sections providing access to Runway 11-29. In the last few years, however, sections TWS-10 and TWS-15 were demolished, with only TWS-20 remaining to continue servicing the FBO ramp. This section was in "Serious" condition, with many occurrences of block cracking, alligator cracking,

depressions, and raveling. **Table I.16** summarizes the PCI scores for this area, and **Figure I.17** depicts the distress types observed there.

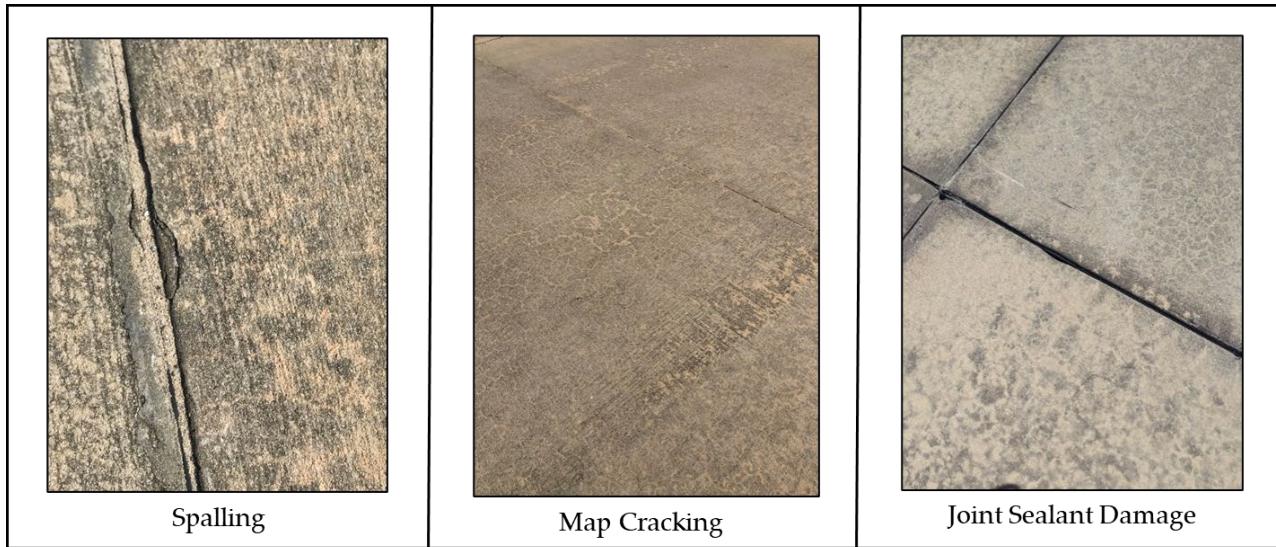
Figure I.18: Examples of Distresses on West Cargo Ramp, CAE

The West Cargo Ramp consists of 5 PCC-surface pavement sections. Its overall condition was reported to be "Satisfactory" with a returned weighted PCI score of 83. The primary distresses identified were joint seal damage, minor spalling, and map cracking. A summary of the section conditions is provided in **Table I.17**, and **Figure I.18** provides examples of distresses observed on the West Cargo Ramp.
