2022 Pavement Condition Index Report

Mount Pleasant Regional Airport

For The Charleston County Aviation Authority

Revised: December 11, 2023 Issued: November 16, 2023

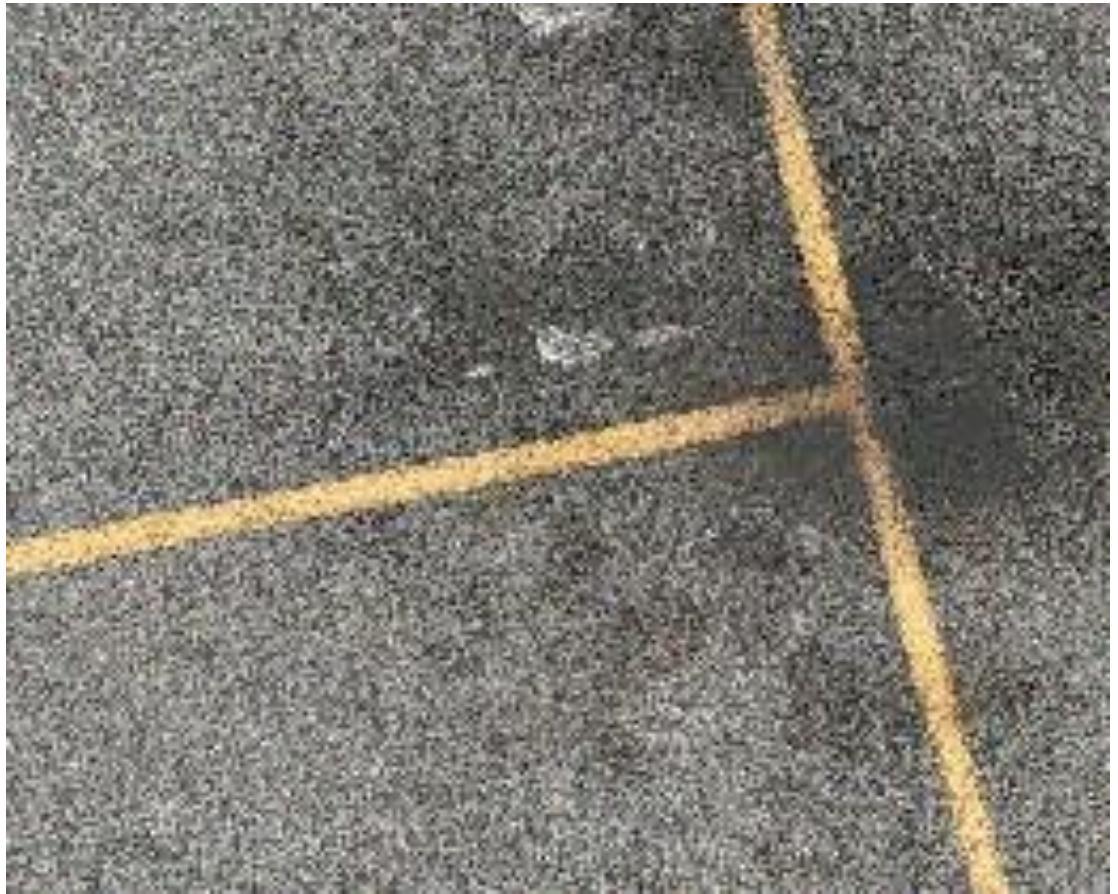
- F. Photographs Mount Pleasant Regional Airport
- LRO FBO Apron Parking Section 1 Photographs

Photograph 1: Typical Oil Spillage

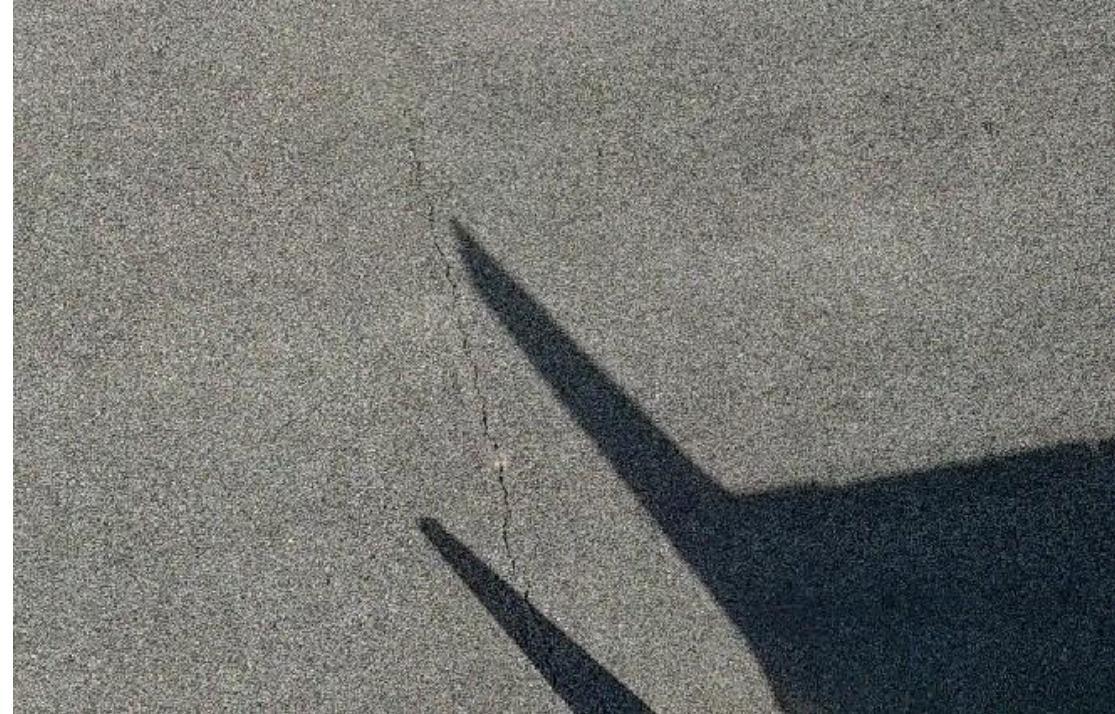
LRO – FBO Apron Parking Section 2 Photographs

Photograph 3: Typical Low Severity Cracking

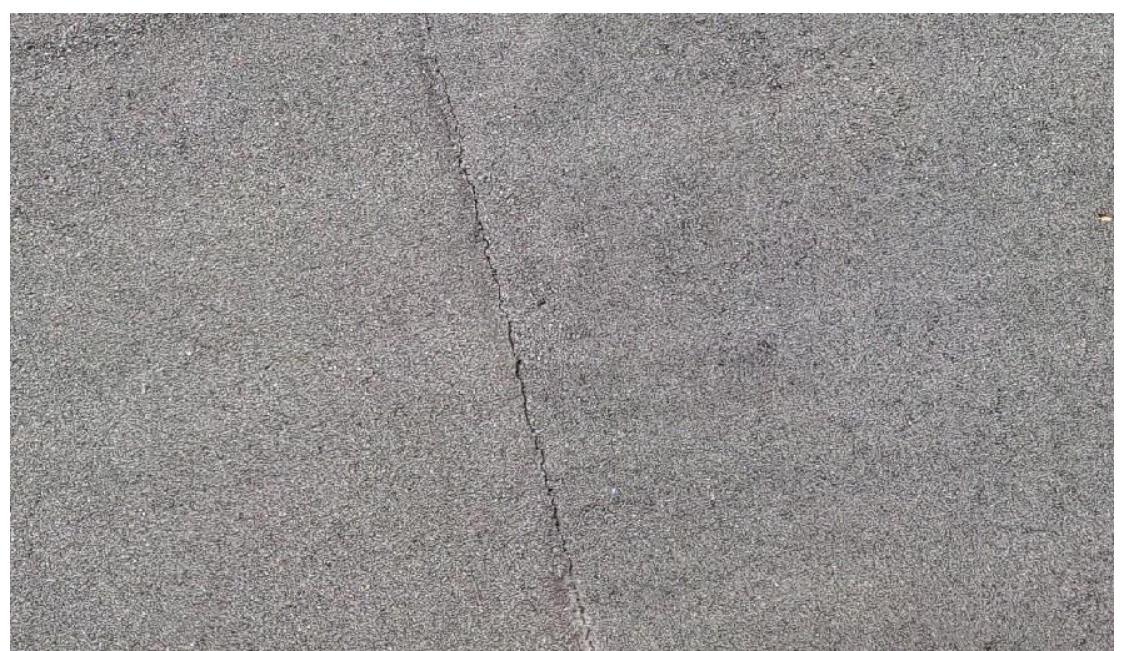
Photograph 4: Typical Medium Severity Cracking

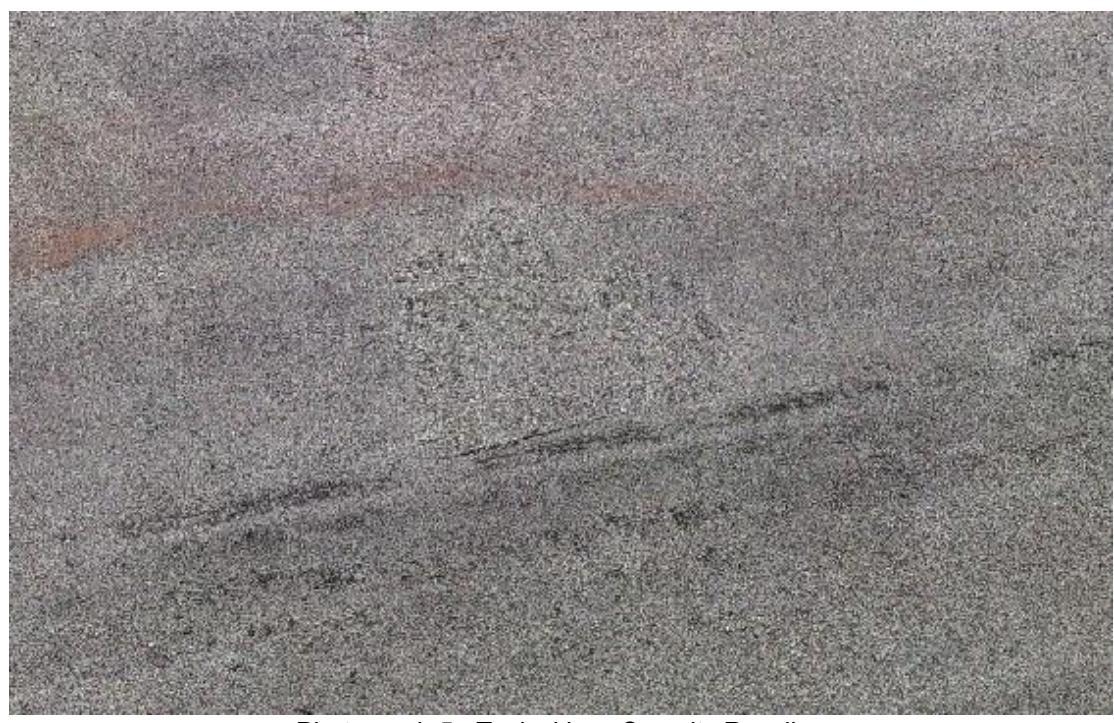
LRO – FBO Apron Parking Section 2 Photographs

Photograph 5: Typical Low Severity Raveling

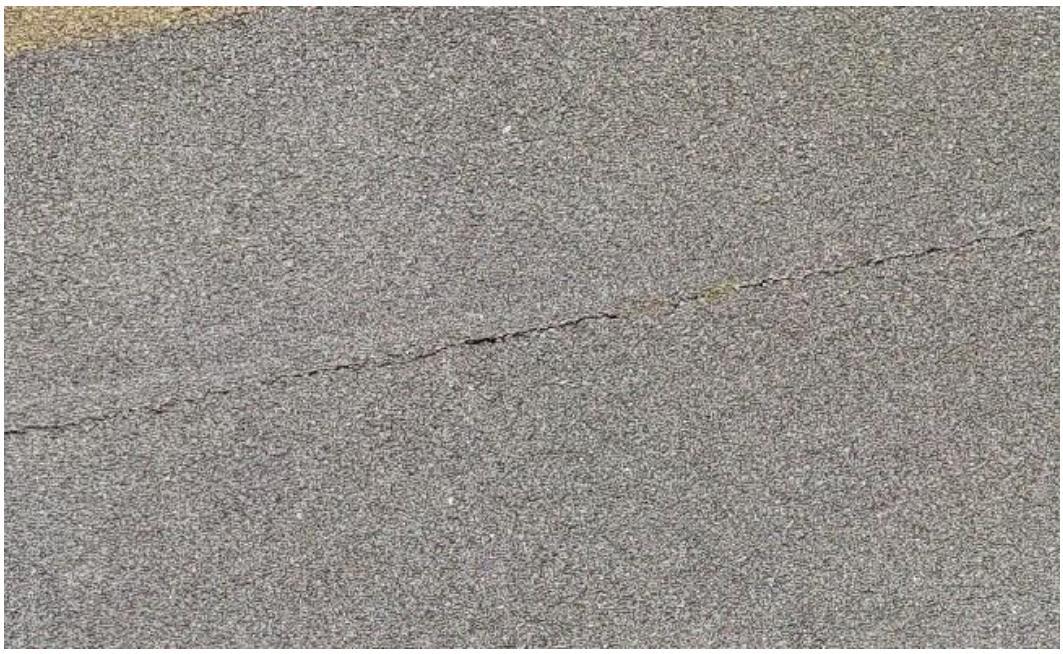
Photograph 8: Typical Medium Severity Longitudinal Cracking

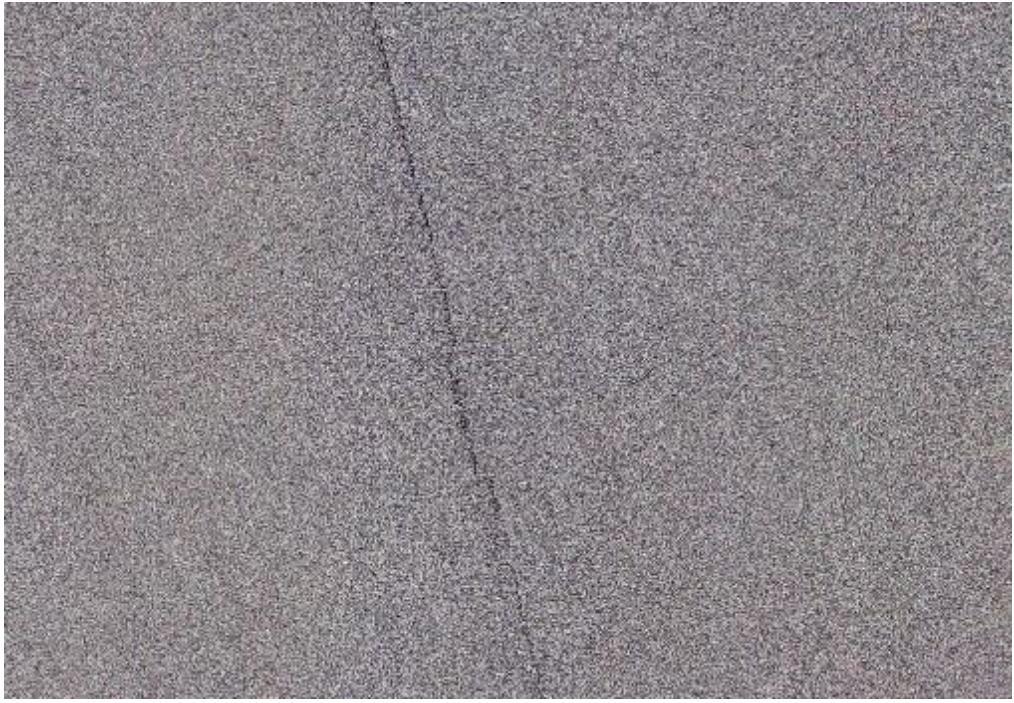
LRO – FBO Apron Taxilane Section 2 Photographs

Photograph 9: Typical Low Severity Longitudinal Crack

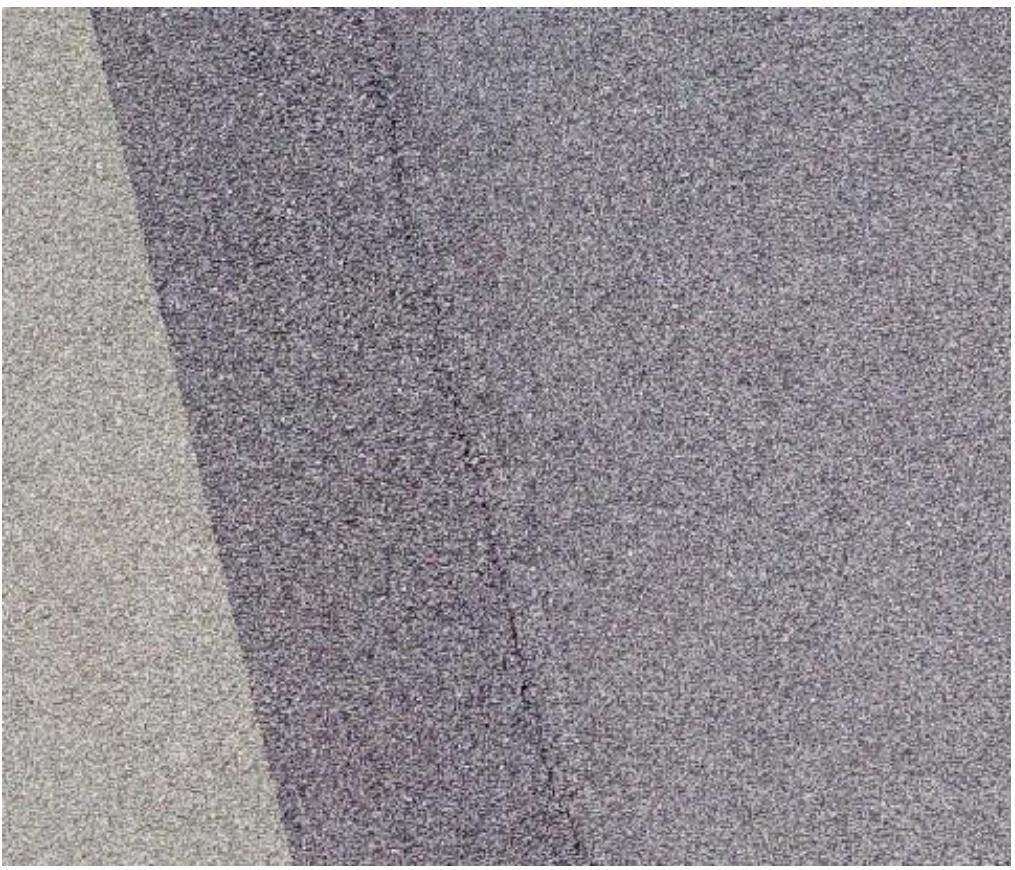
Photograph 10: Typical Medium Severity Longitudinal Crack

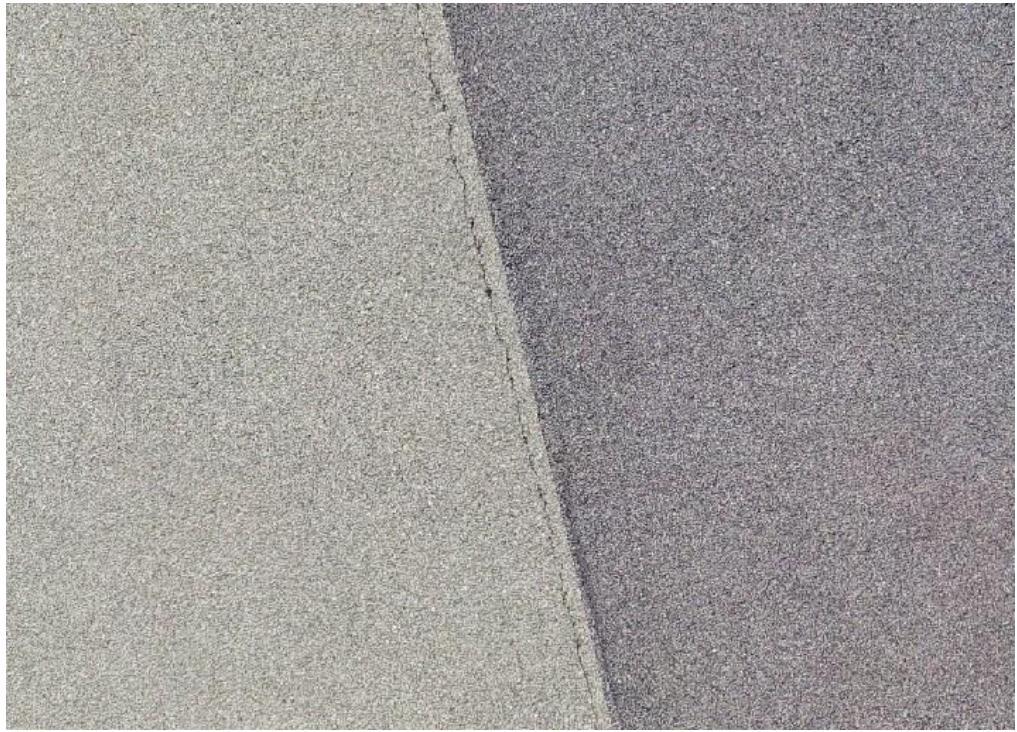
LRO – FBO Apron Taxilane Section 3 Photographs

Photograph 11: Typical Low Severity Longitudinal Crack

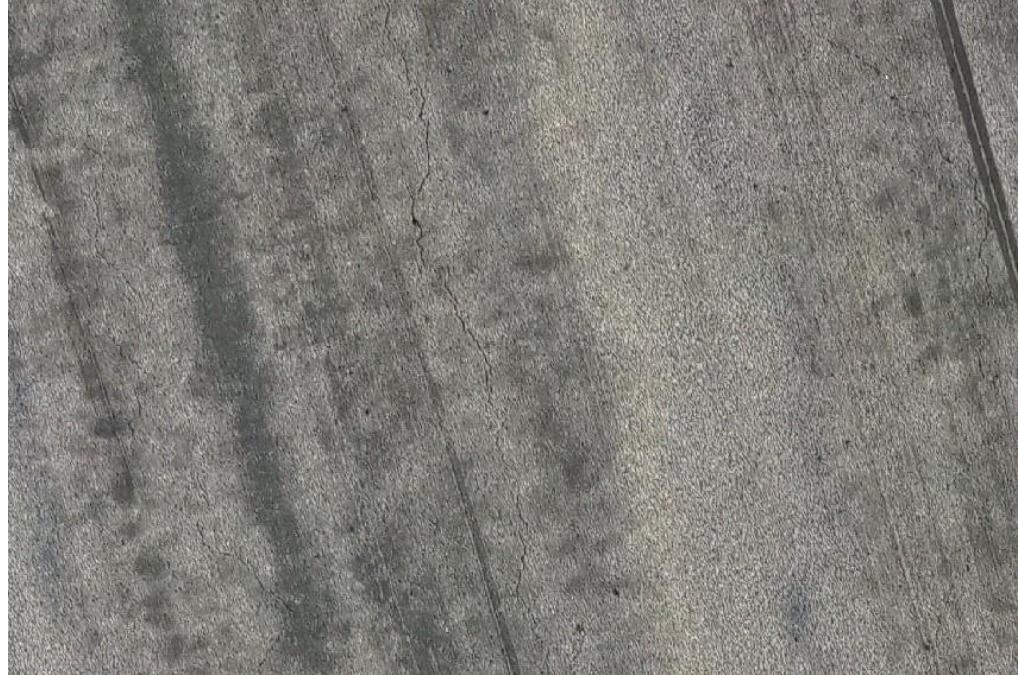
LRO – Runway 17/35 Section 1 Photographs

Photograph 13: Typical Low Severity Longitudinal Crack

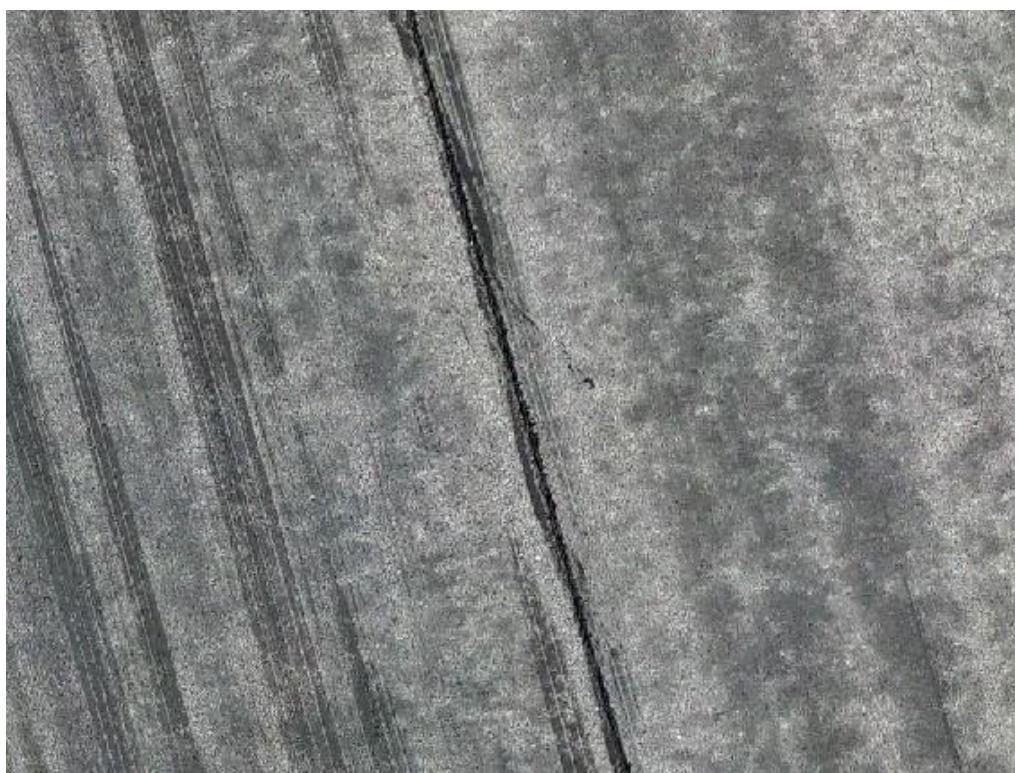
Photograph 14: Typical Low Severity Longitudinal Crack

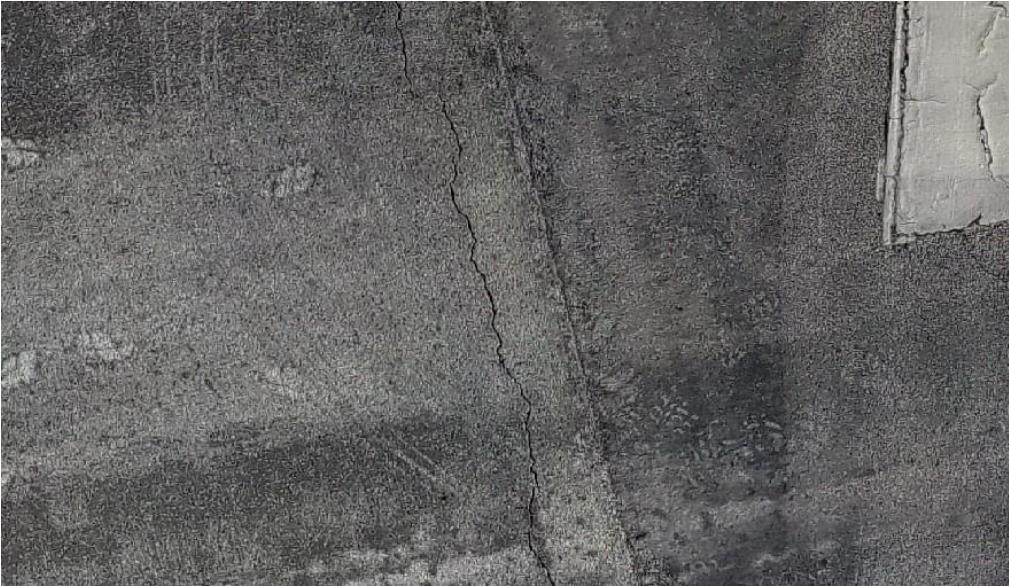
LRO – Runway 17/35 Section 1 Photographs

Photograph 15: Typical Medium Severity Longitudinal Crack

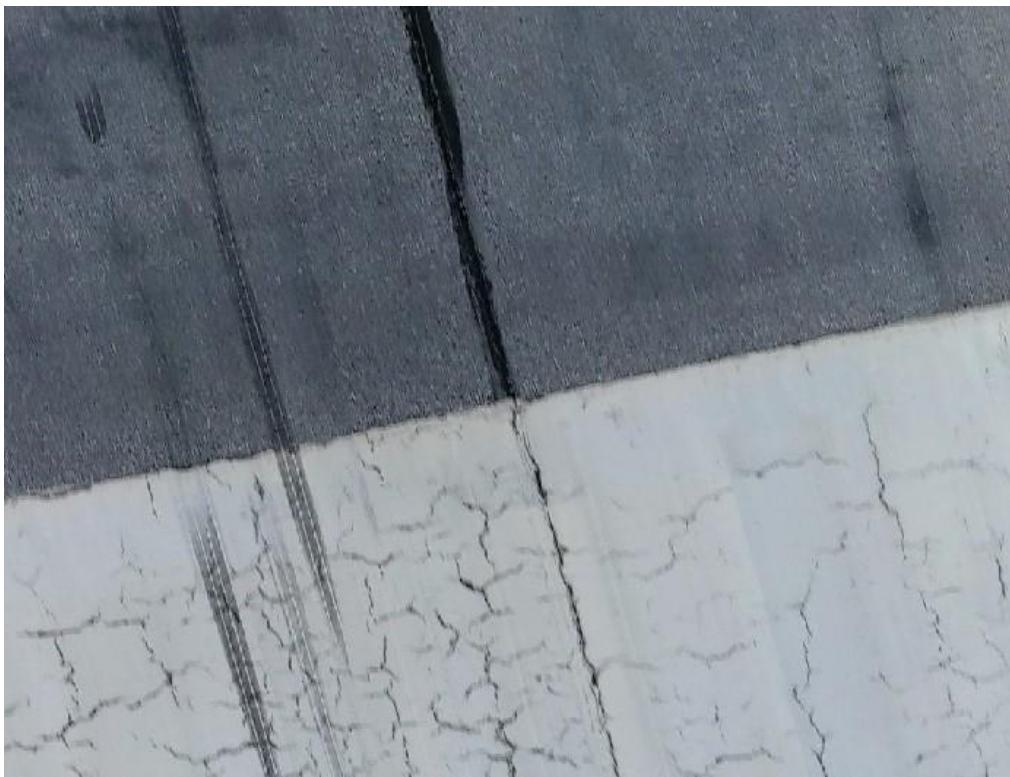
Photograph 16: Typical Medium Severity Longitudinal Crack

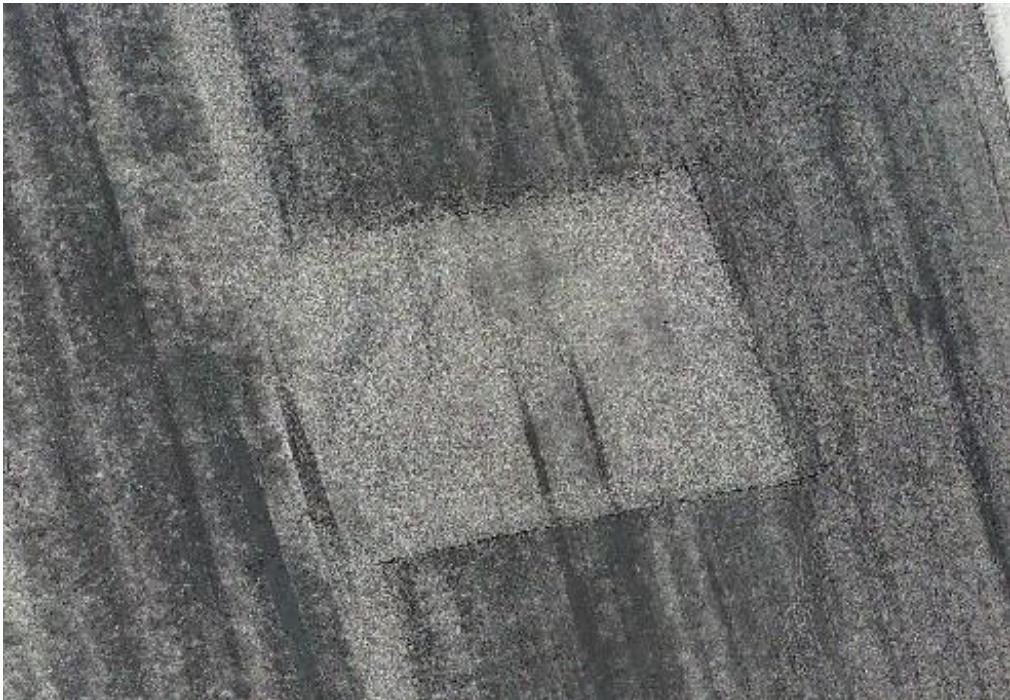
LRO – Runway 17/35 Section 1 Photographs

Photograph 17: Typical Low Severity Patch

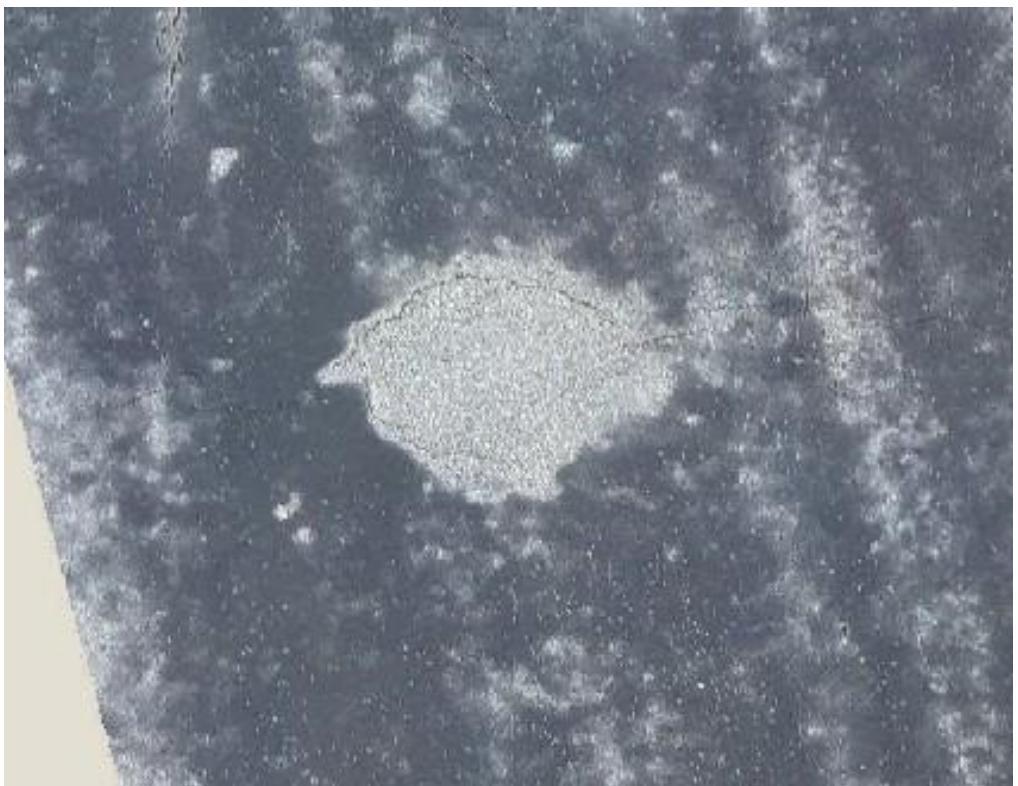
Photograph 18: Typical Low Severity Raveling

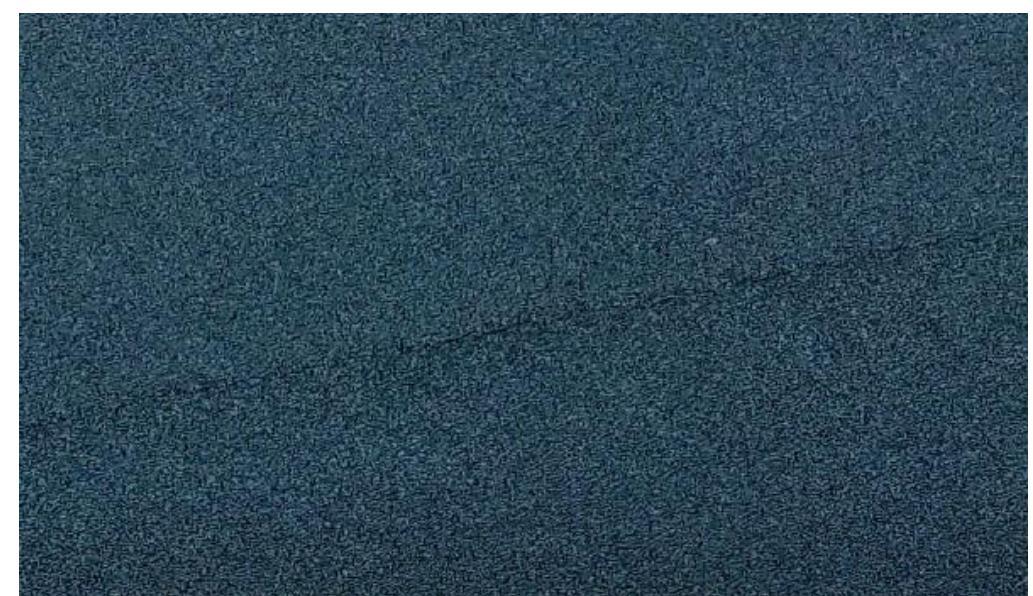
LRO – T-Hangar Apron Section 1 Photographs

Photograph 19: Typical Low Severity Longitudinal Crack

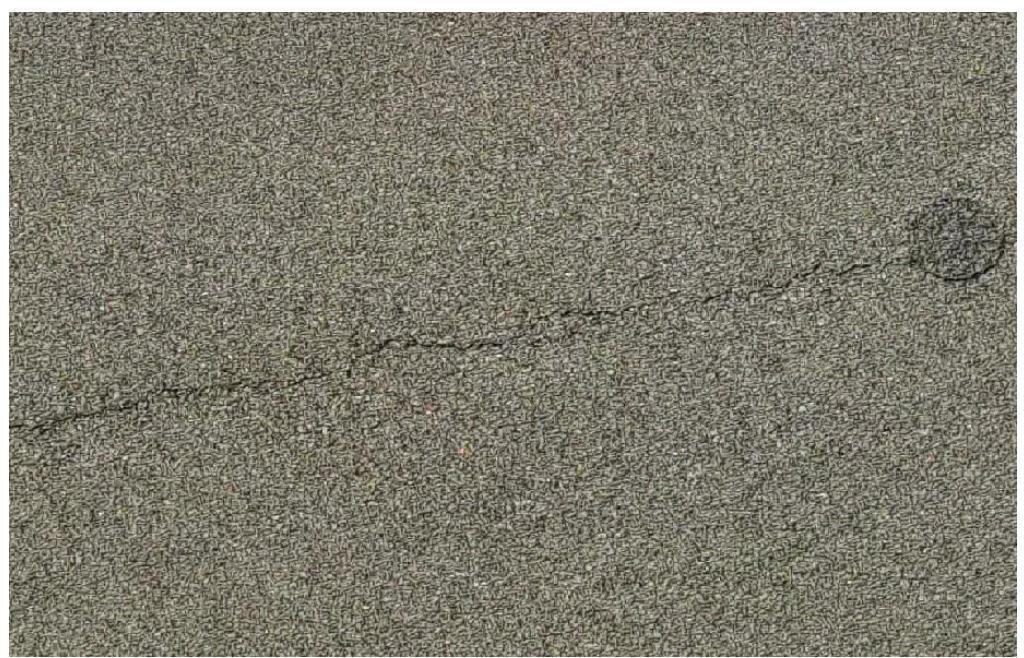
Photograph 20: Typical Low Severity Longitudinal Crack

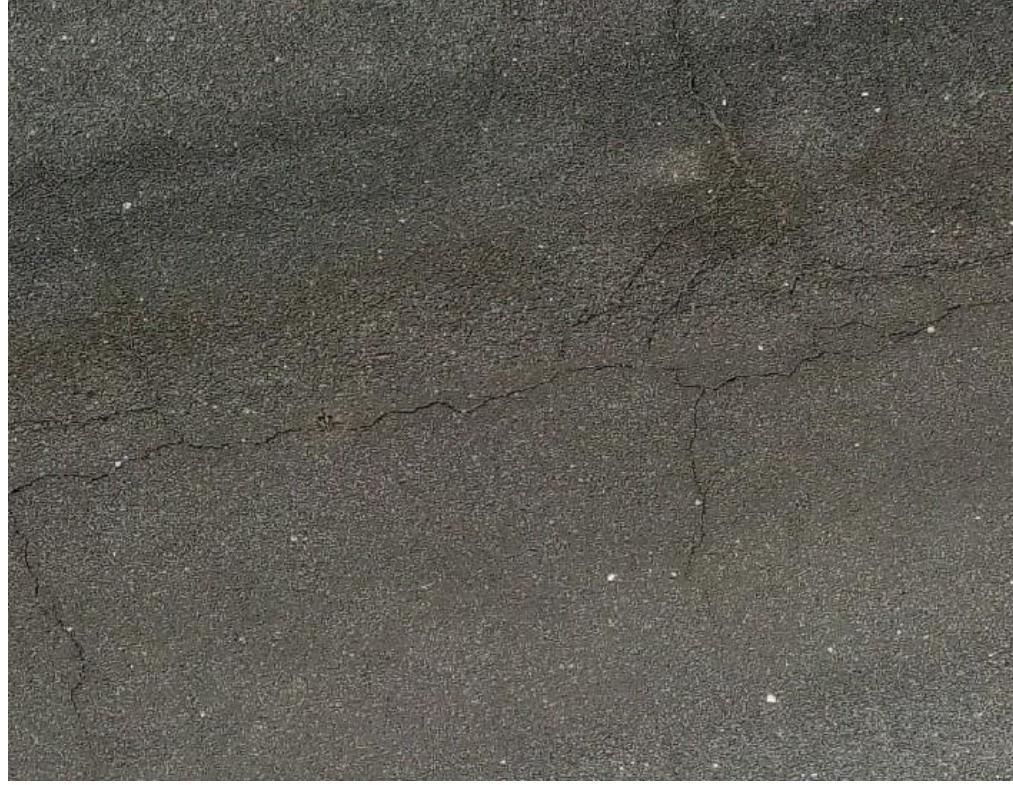
LRO – T-Hangar Apron Section 2 Photographs

Photograph 21: Low Severity Alligator Cracking

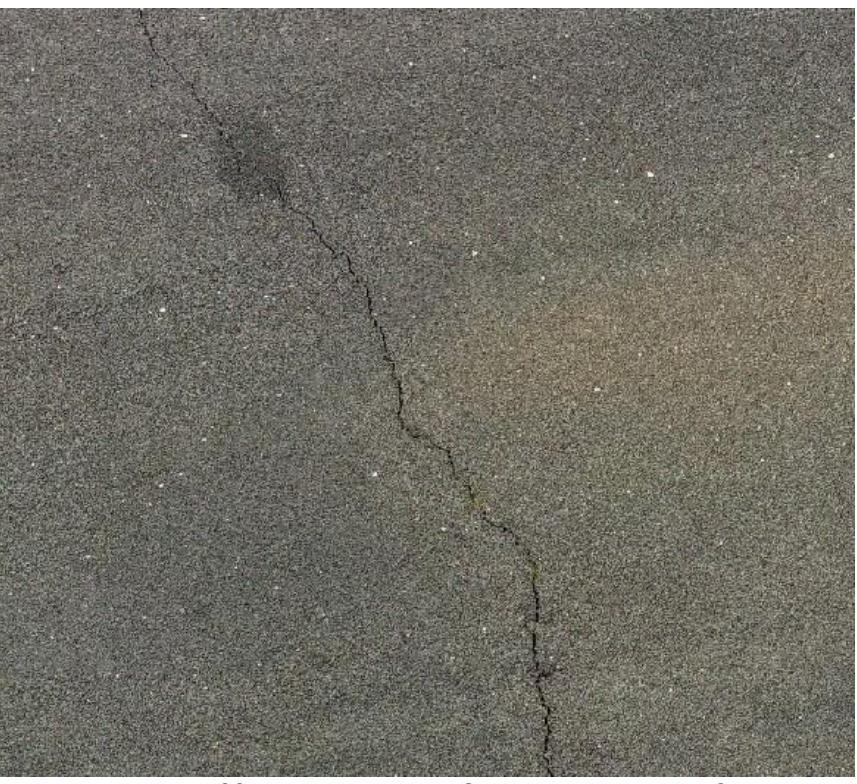
Photograph 22: Typical Medium Severity Longitudinal Crack

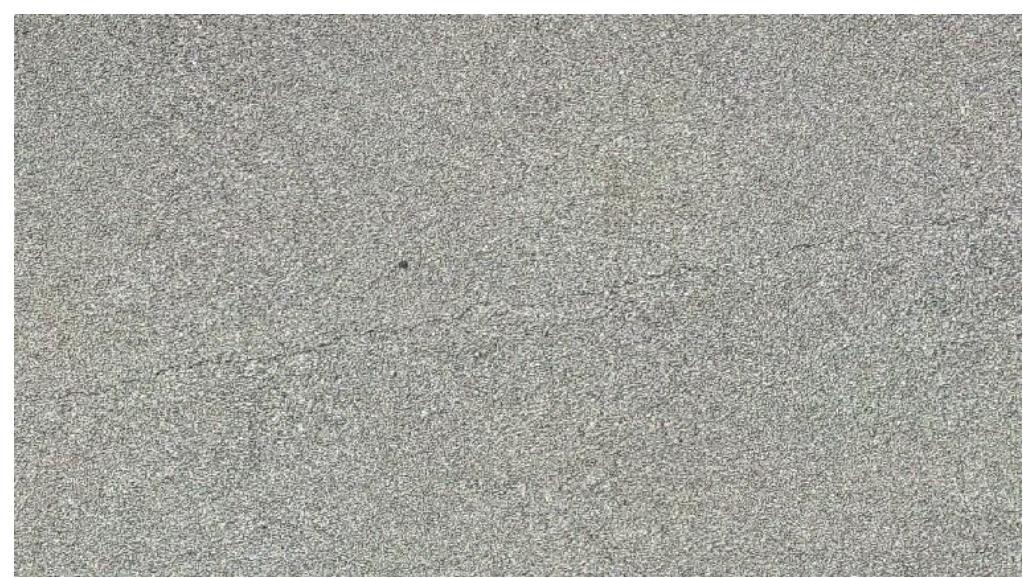
LRO – T-Hangar Taxilane Section 1 Photographs

Photograph 23: Typical Low Severity Longitudinal Crack

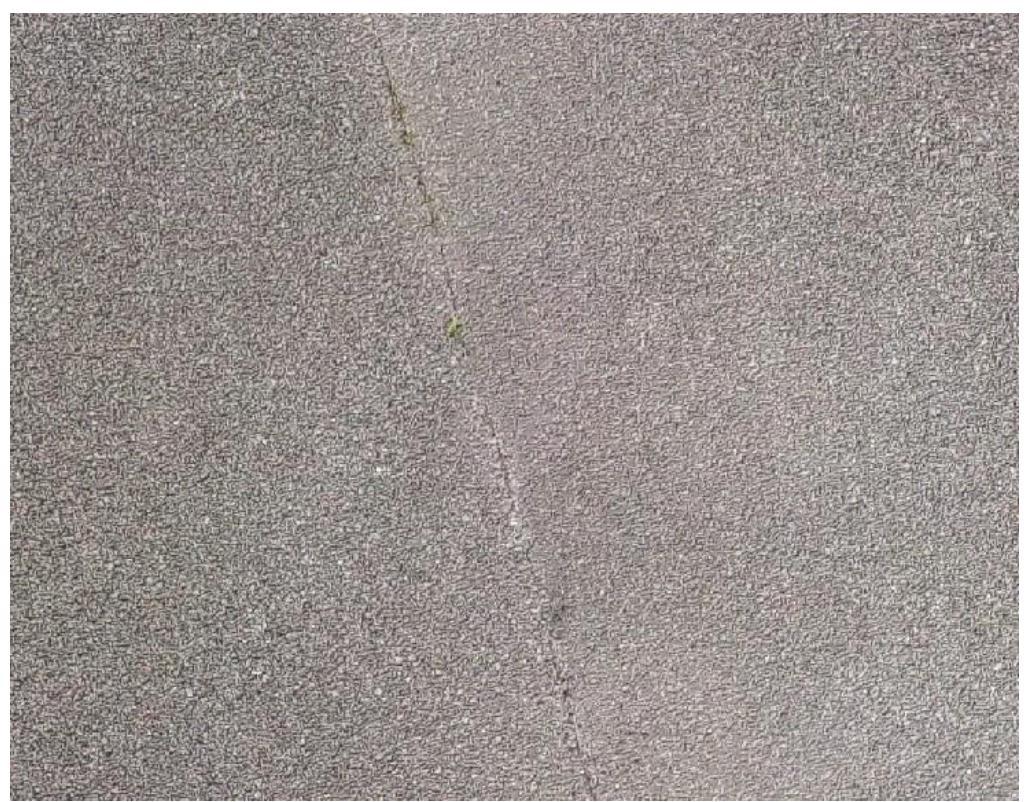
Photograph 24: Typical Medium Severity Longitudinal Crack

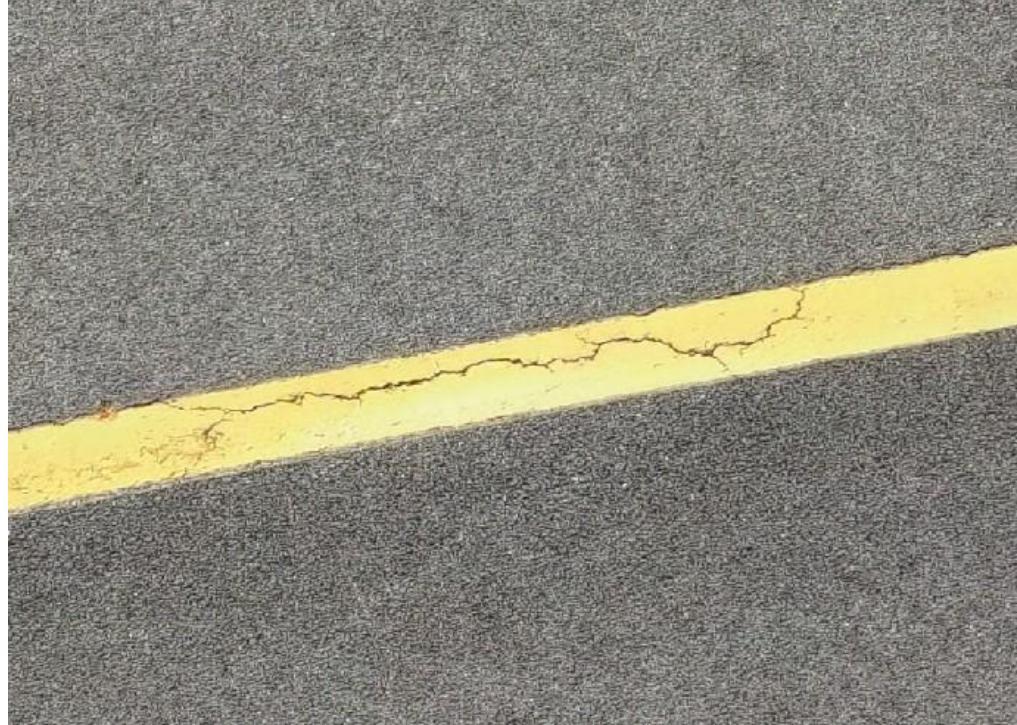
LRO – T-Hangar Apron Section 2 Photographs

Photograph 25: Typical Medium Severity Longitudinal Crack

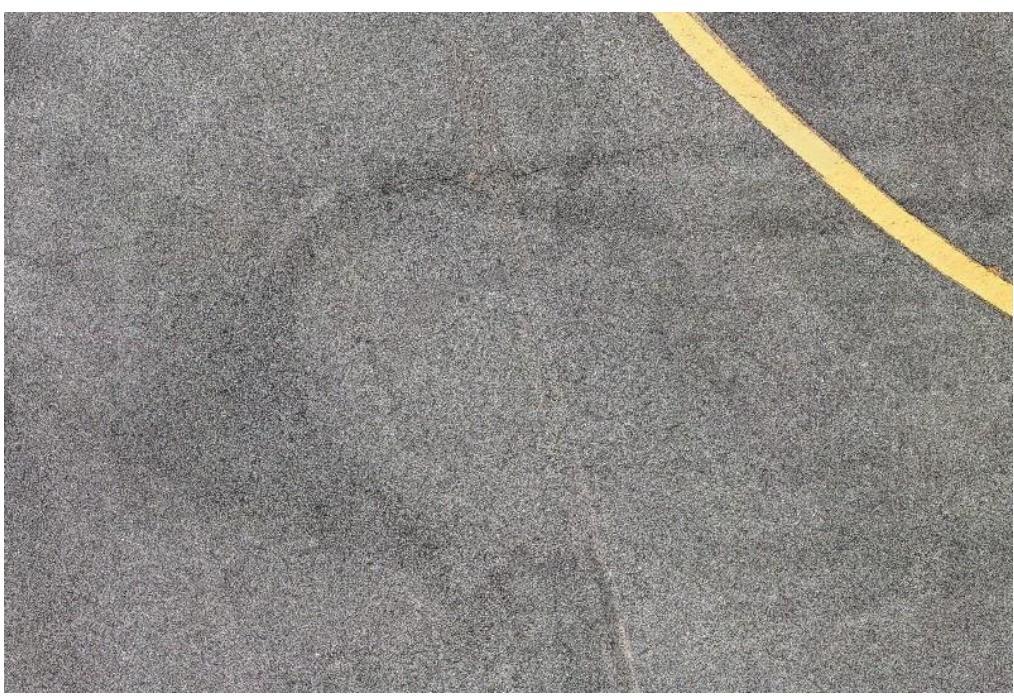
Photograph 26: Typical Low Severity Raveling

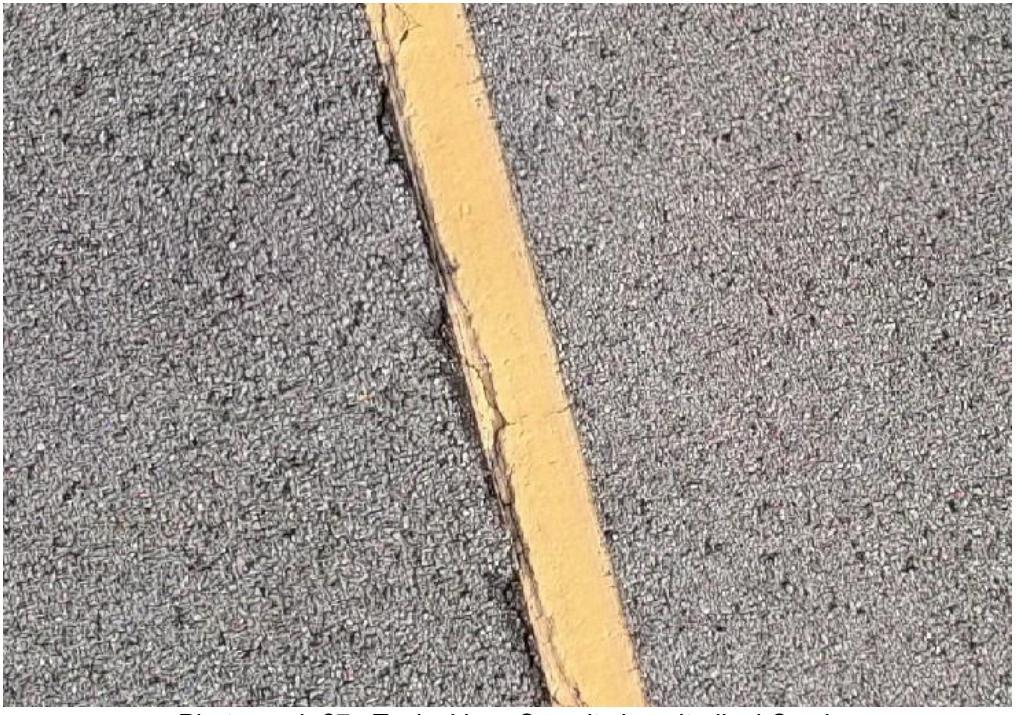
LRO – Taxiway A Section 1A Photographs

Photograph 27: Typical Low Severity Longitudinal Crack

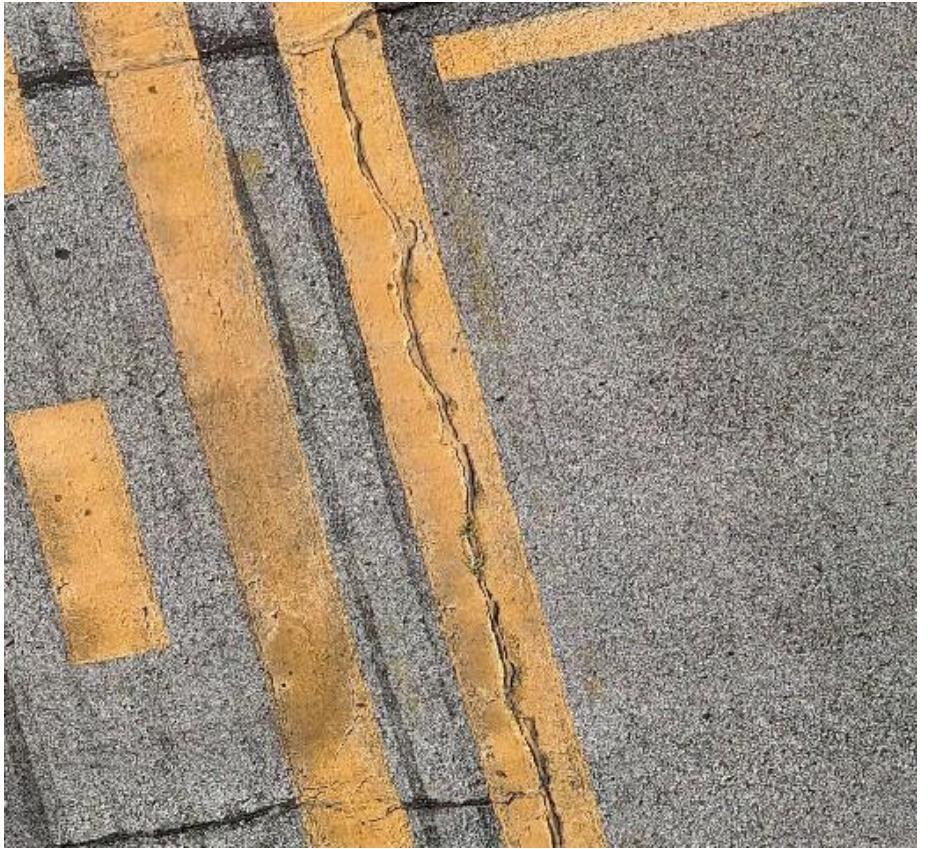
Photograph 28: Typical Medium Severity Longitudinal Crack

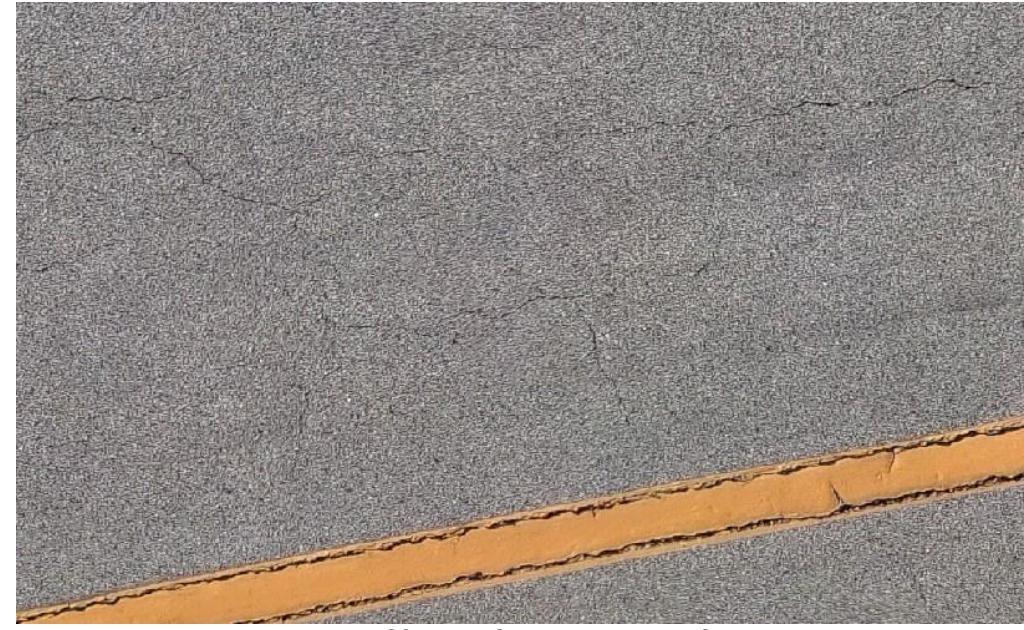
LRO – Taxiway A Section 1B Photographs

Photograph 29: Low Severity Alligator Cracking

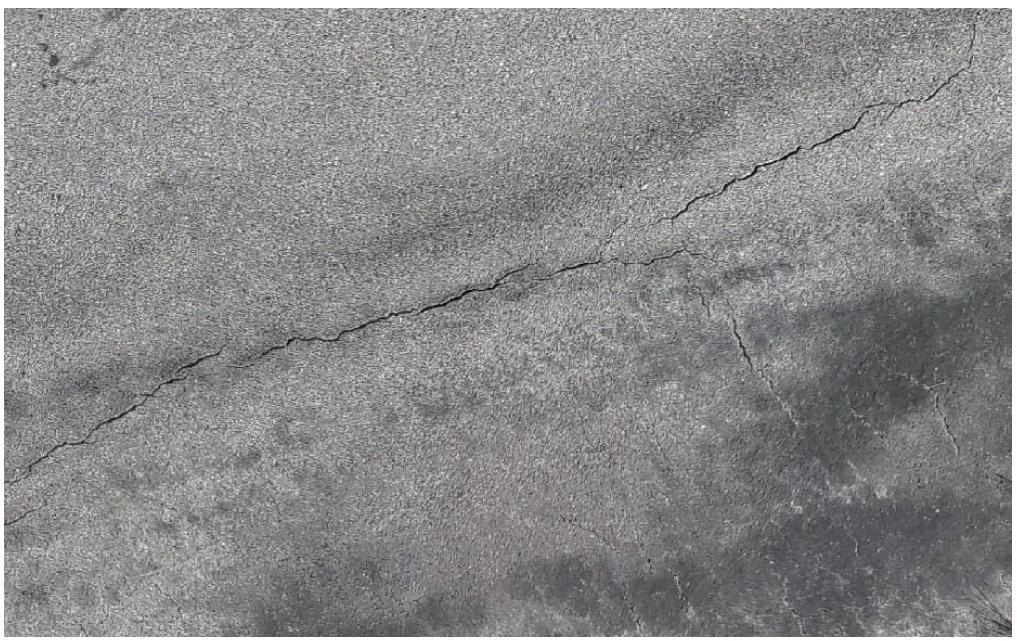
Photograph 30: Typical Medium Severity Longitudinal Crack

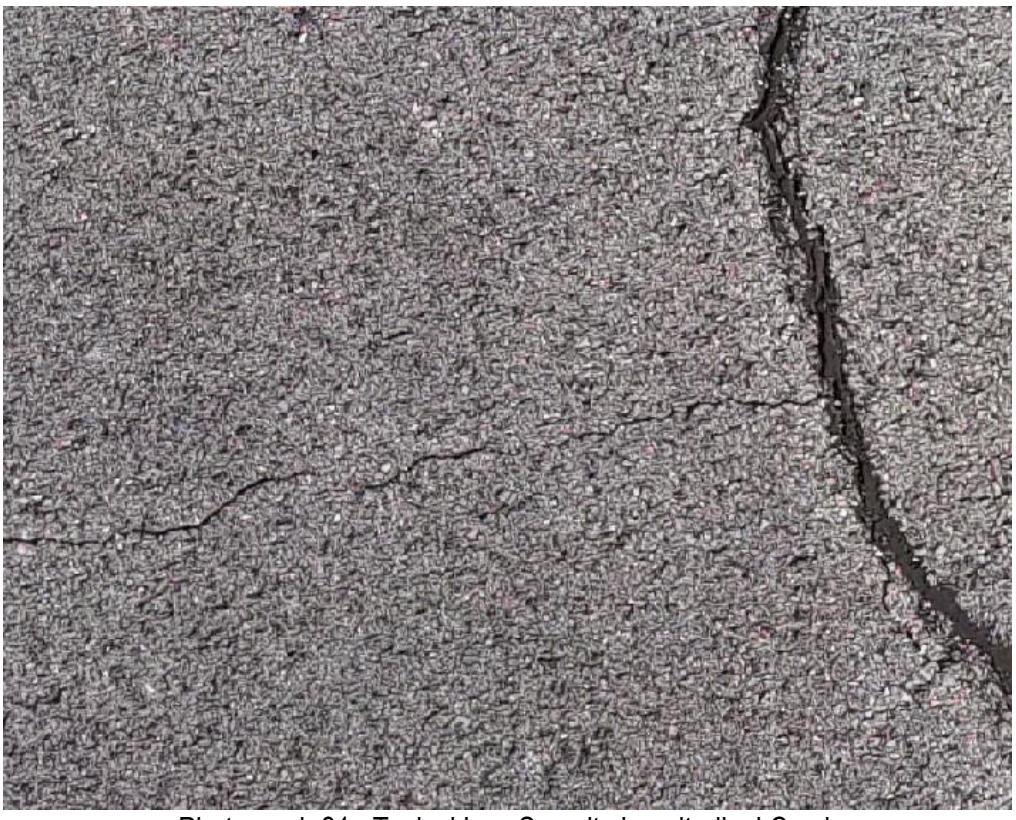
LRO – Taxiway A Section 2A Photographs

Photograph 31: Typical Low Severity Longitudinal Crack

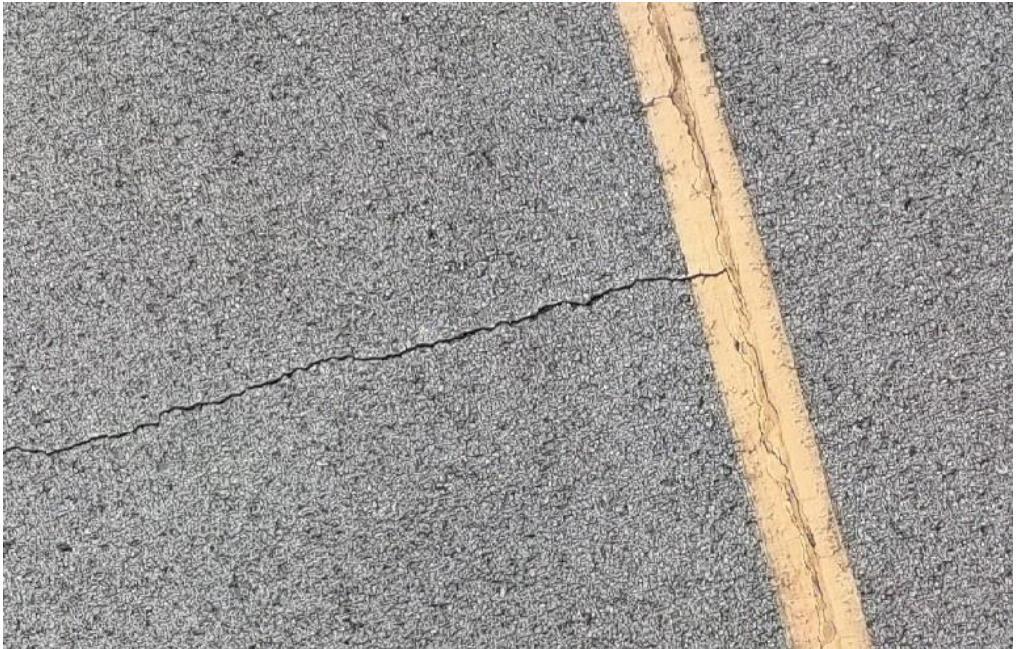
Photograph 32: Typical Medium Severity Longitudinal Crack

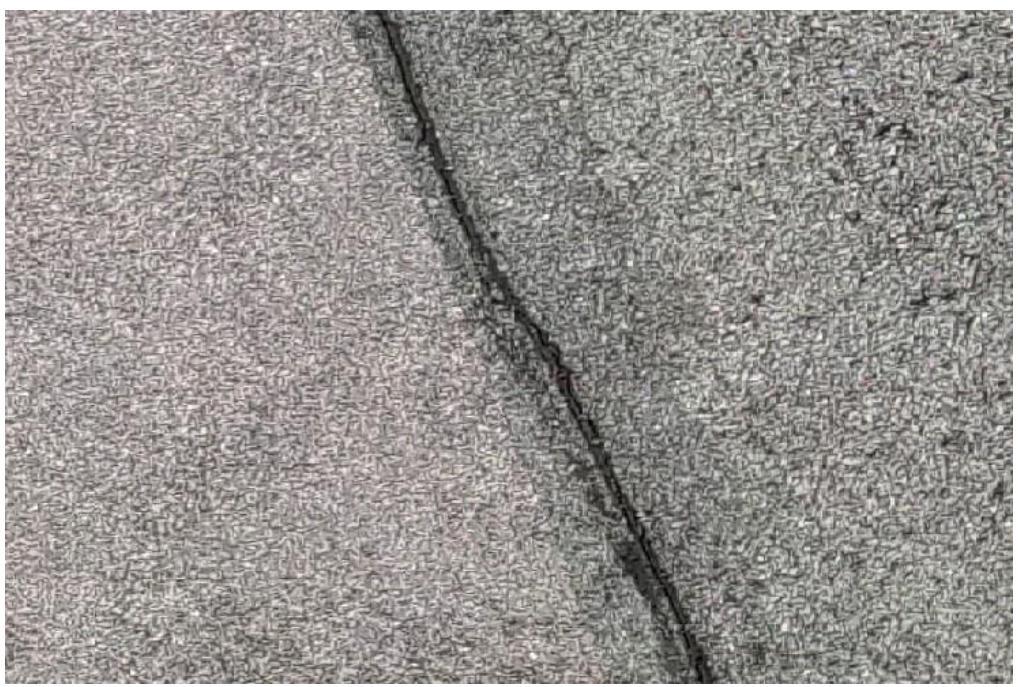
Photograph 34: Typical Medium Severity Longitudinal Crack

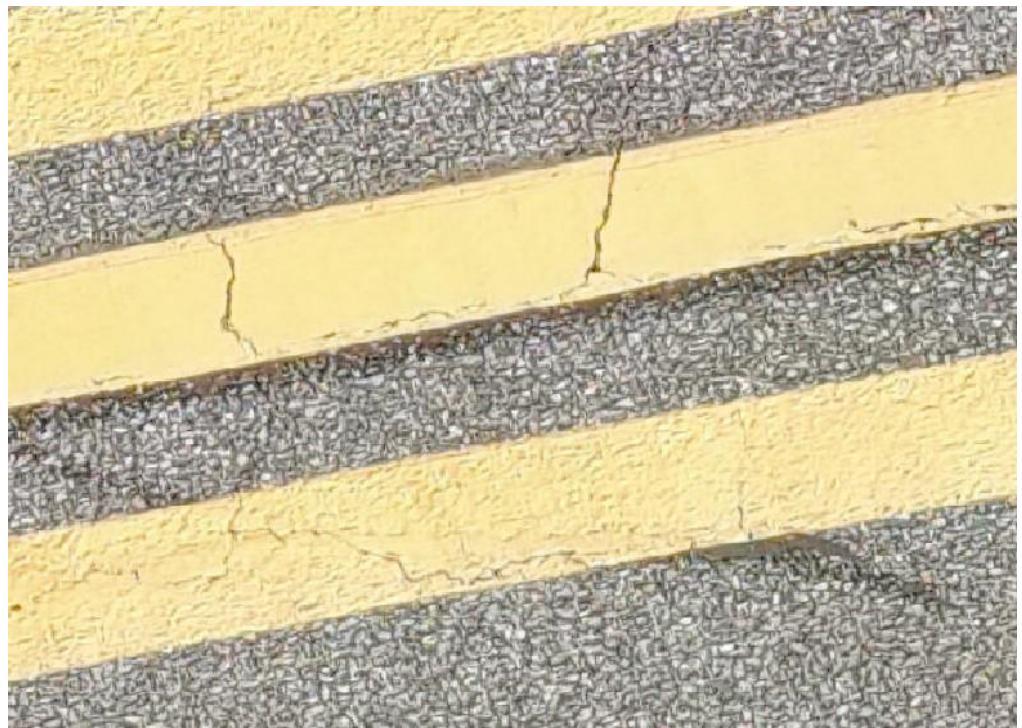
Photograph 35: Typical Low Severity Longitudinal Crack
