2022 Pavement Condition Index Report

Mount Pleasant Regional Airport

For The Charleston County Aviation Authority

Revised: December 11, 2023 Issued: November 16, 2023

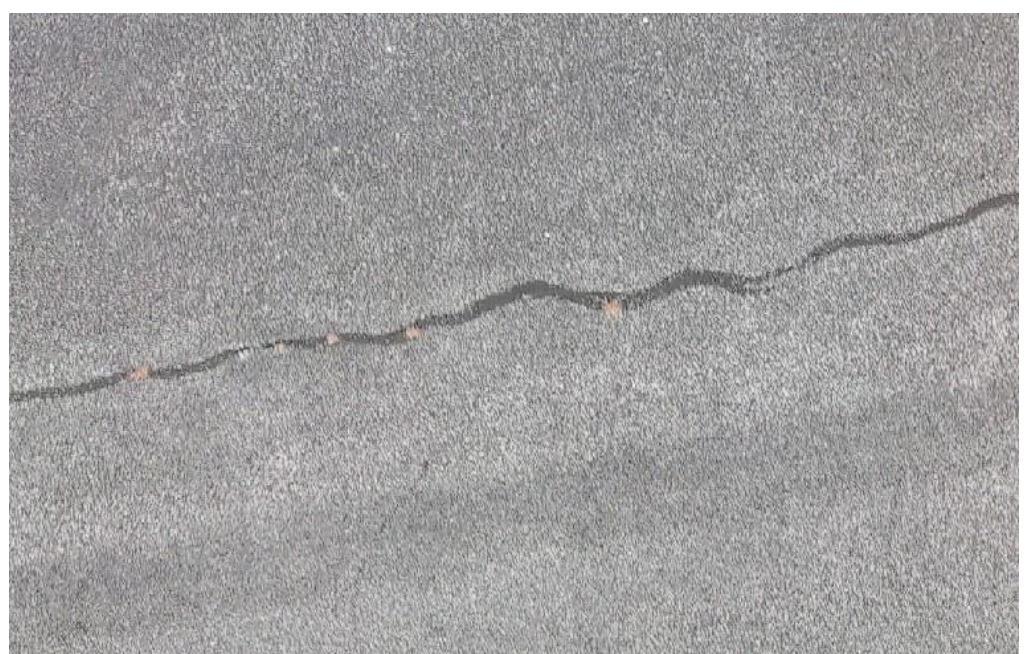
Photograph 36: Typical Medium Severity Longitudinal Crack

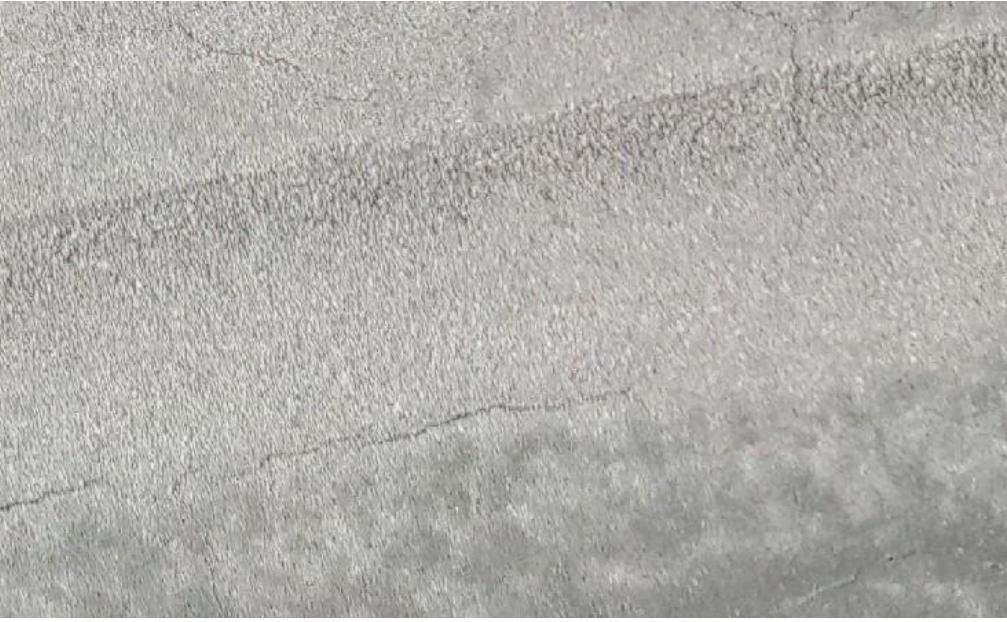
LRO – Taxiway B Section 2 Photographs

Photograph 37: Typical Low Severity Longitudinal Crack

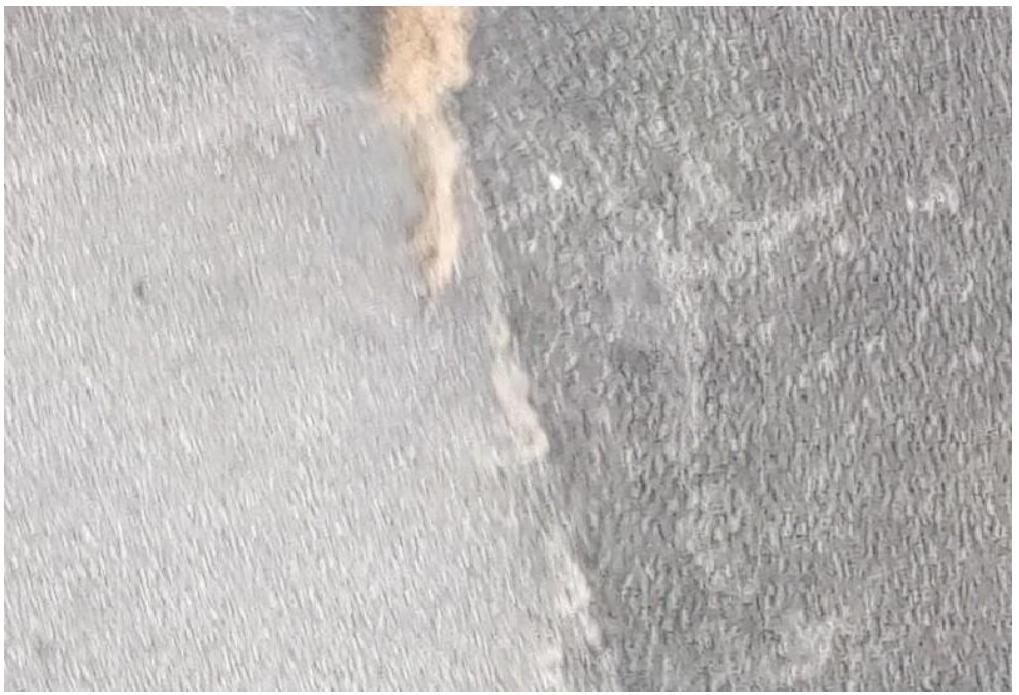
Photograph 38: Typical Medium Severity Longitudinal Crack
