SOUTH CAROLINA AERONAUTICS COMMISSION

STATEWIDE AIRFIELD PAVEMENT MANAGEMENT SYSTEM UPDATE

35A – Union County Airport, Troy Shelton Field

2022

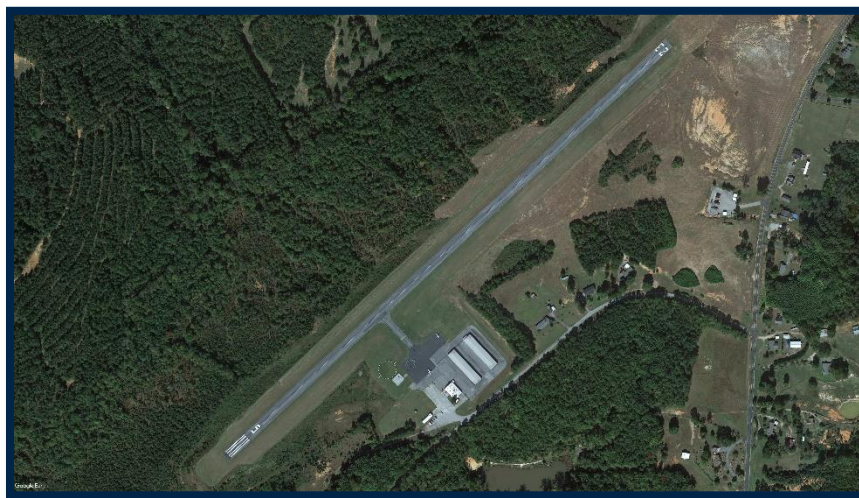
Figure 1 – Airport Layout

The pavements at Union County Airport, Troy Shelton Field (35A) include approximately 354 thousand square feet of airfield pavements consisting of runways, taxiways, and aprons. Per the guidance in the ASTM D5340-20, all pavements were divided and subdivided into pavement management units (Network, Branch, Section, Sample). The divisions are documented in the **Network Definition Exhibit** providing the name and location of each branch, section, and sample.

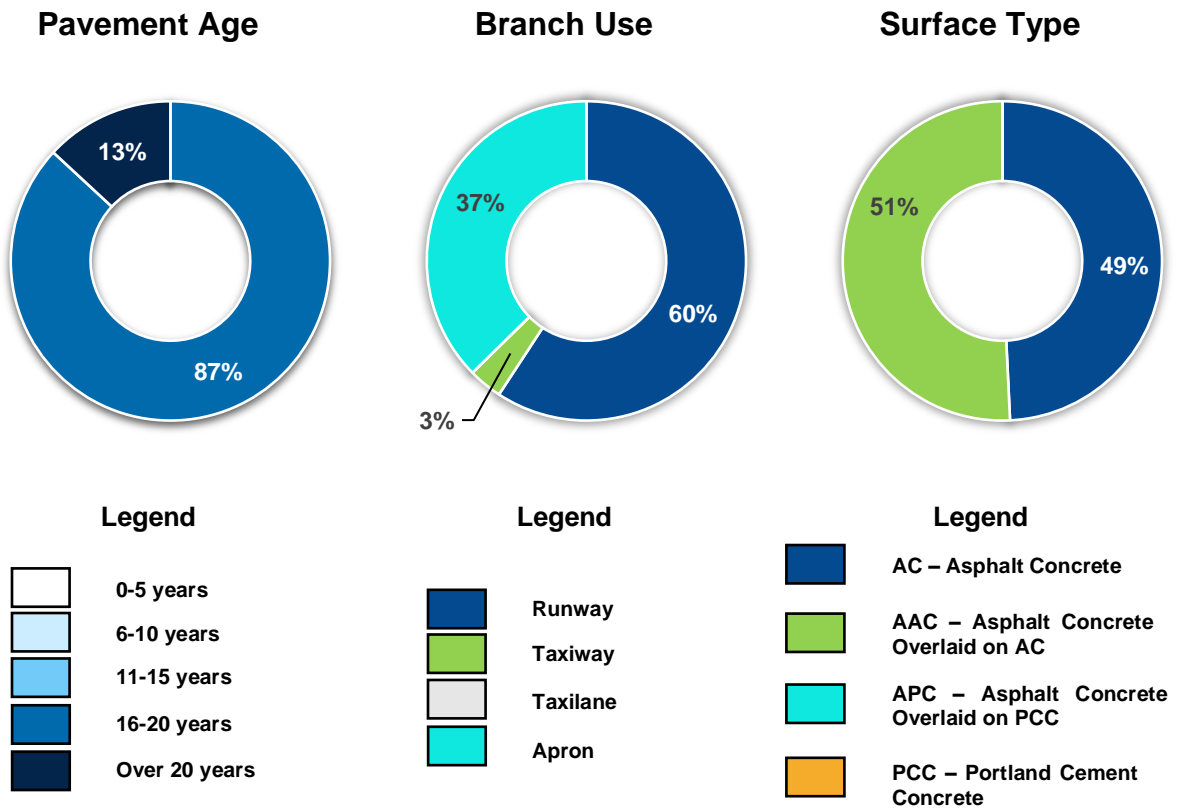
Figure 2 – System Inventory Summary

The following figure summarizes the inventory items at Union County Airport, Troy Shelton Field (35A). The **Estimated Age Exhibit** provides the last major work date for each pavement section based on the collected documentation.

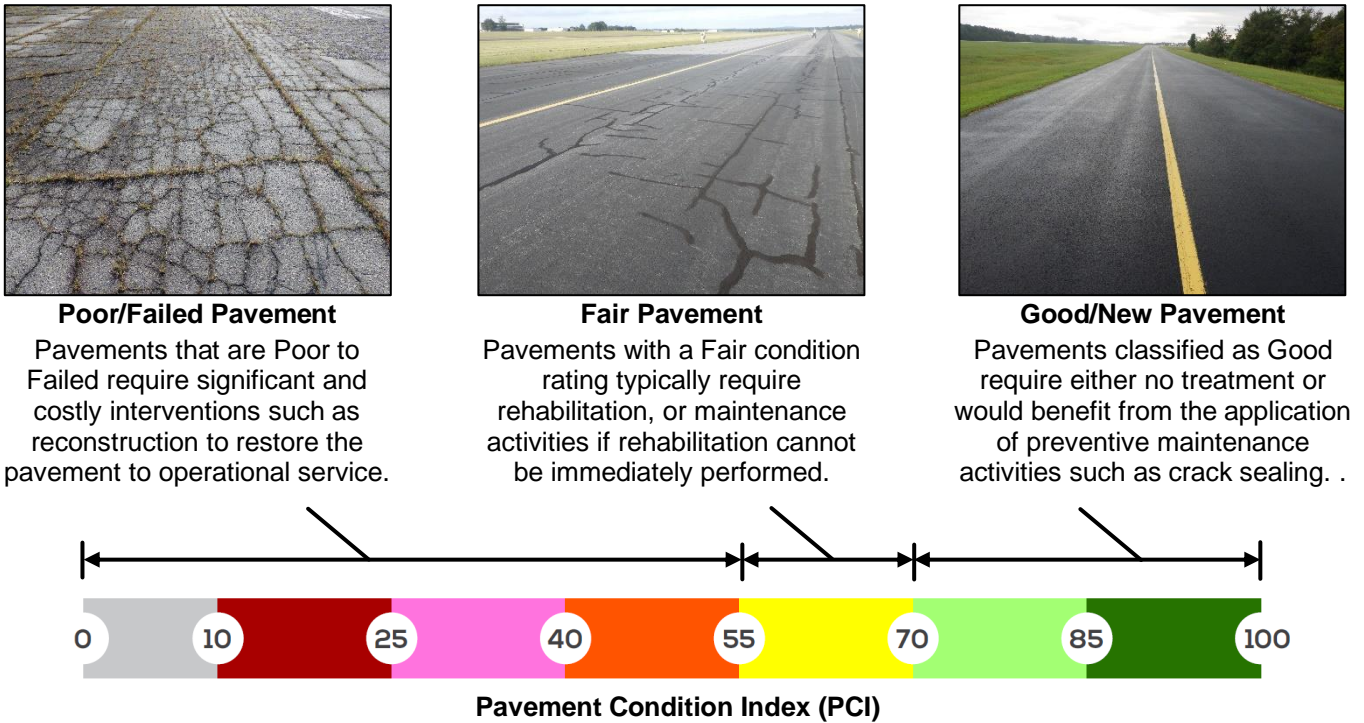
Figure 3 – Representation of Pavement Condition Index Values

Visual condition data collected during the PCI survey is analyzed and used to calculate the current PCI for each inspected sample unit and section. The PCI is a value ranging from 0 to 100, which indicates the apparent structural integrity and surface operational condition of the pavement, with **“100” indicating a pavement in new condition and “0” indicating a failed pavement section**. Pavement Condition Ratings are associated with PCI categories that range from Failed to Good. Representative photos of varying Pavement Condition Ratings are displayed in **Figure 3**.

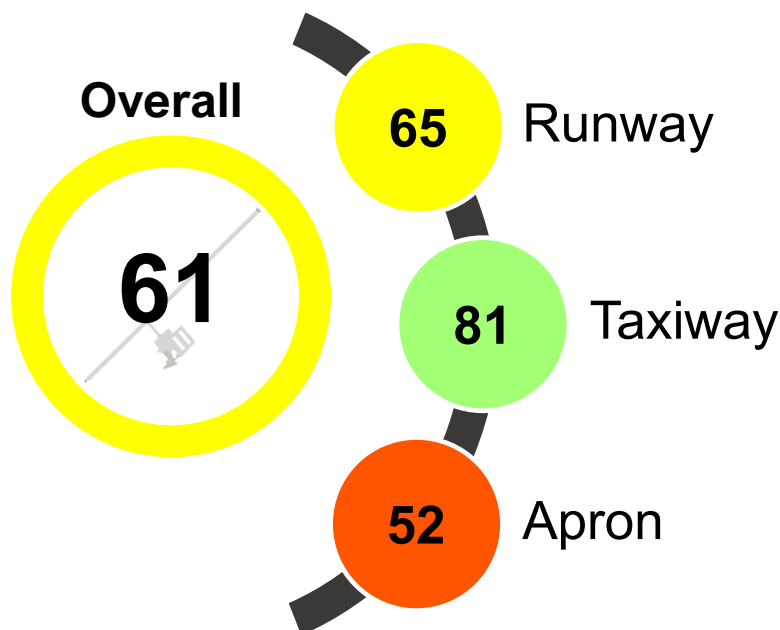
Figure 5 – Area Weighted Average Pavement Condition

The area-weighted average PCIs by branch use are summarized in the figure below. The current PCIs at a section-level are displayed graphically on the **2021 Airfield Pavement Condition Index (PCI) Exhibit** and are summarized in **Table 2**.

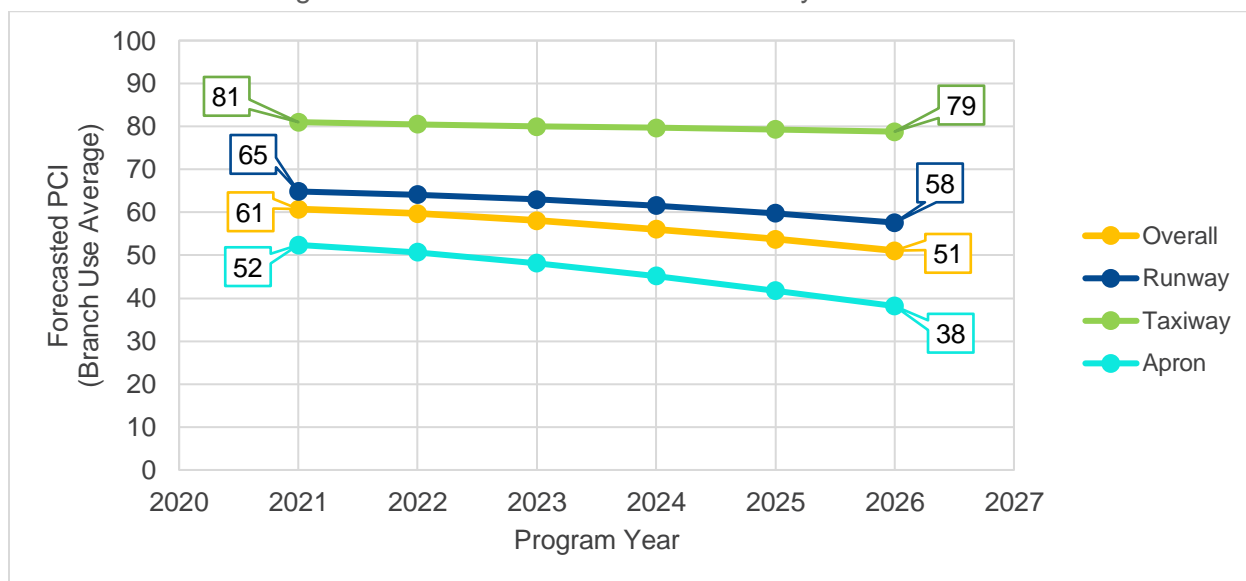
Figure 6 – Forecasted 5-Year PCI by Branch Use

A primary objective of this APMS is to estimate the future condition of each individual pavement section. PAVER™ was utilized to develop prediction curves and determine typical deterioration rates that are then used to forecast a future PCI value. This value will assist decision makers in determining at what point in time certain pavement sections will require rehabilitation. The figure below shows the current and 5-year area-weighted forecasted pavement condition distribution of each functional use (Runway, Taxiway, Taxilane, Apron) found at the Airport. The forecasted 5-year PCIs at a section-level are displayed graphically on the **2026 Forecasted Airfield Pavement Condition Index Exhibit** and are summarized in **Table 3**. All forecasts presented assume that no maintenance or rehabilitation is performed within the 5-year analysis period. **Figure 6** displays the forecasted pavement conditions at the branch-level for 35A.

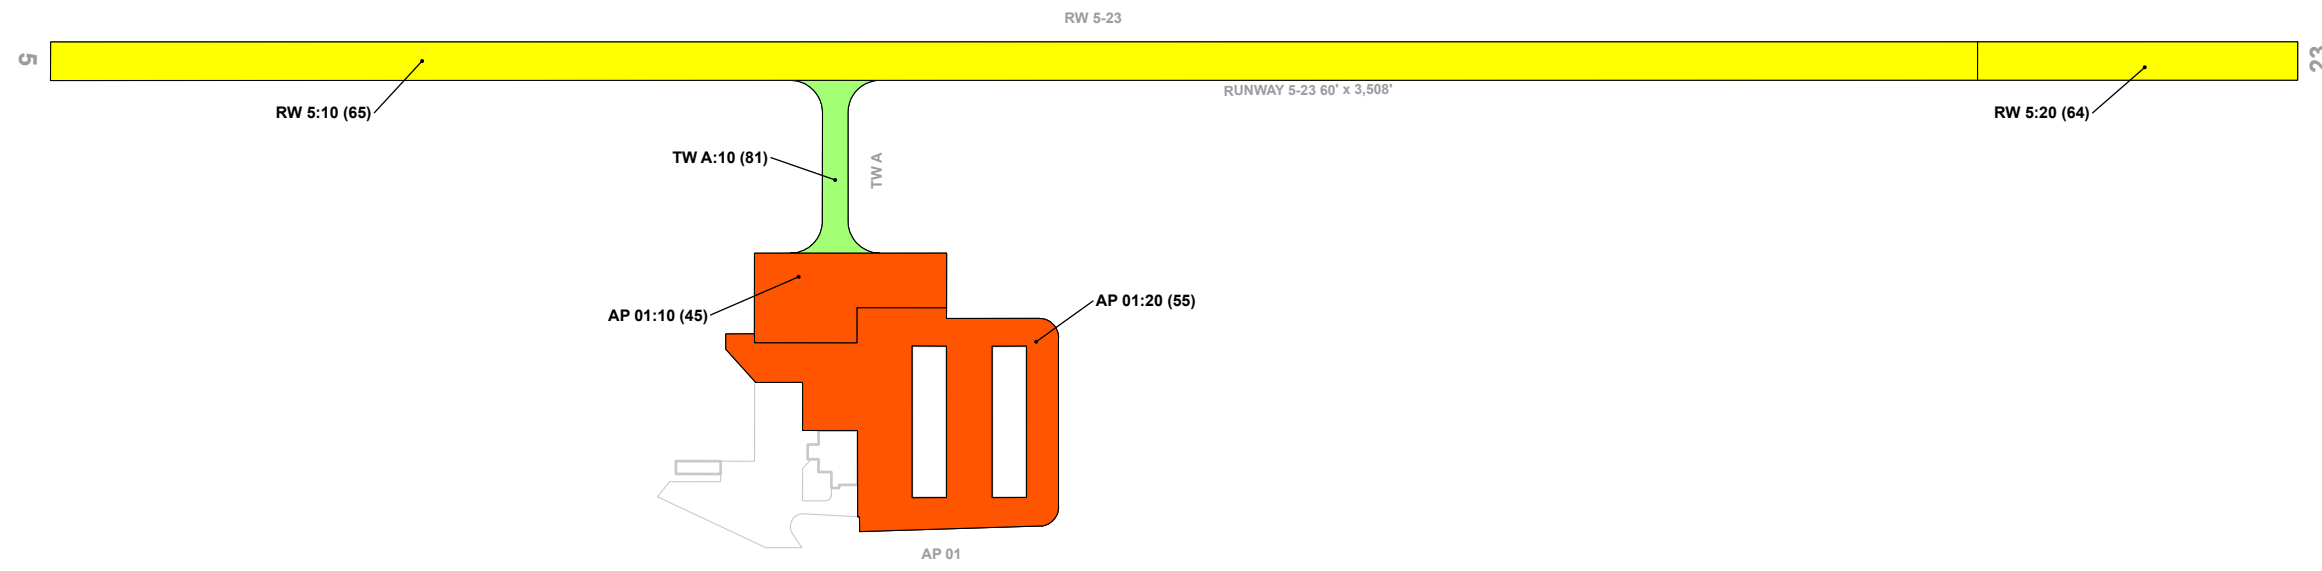
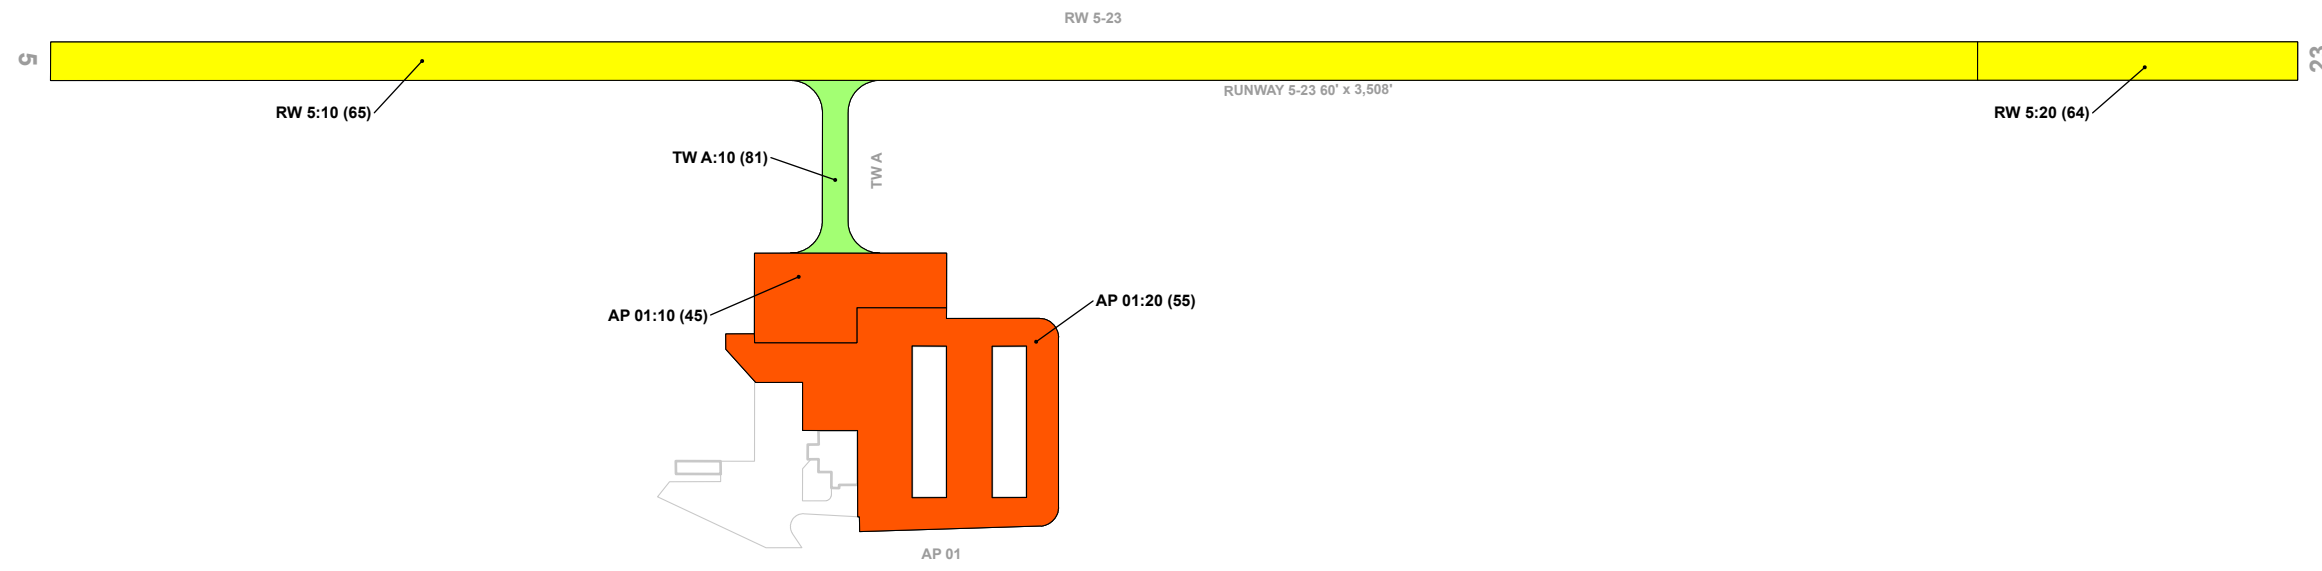
2021 Pavement Condition Index

The PCI survey for Union County Airport, Troy Shelton Field (35A) was performed in September 2021. **The overall area-weighted average PCI value of the network was 61**, representing a condition rating of **Fair**. Approximately 3% of inspected pavements are in Good or Satisfactory condition, 60% of inspected pavements are in Fair condition, and the remaining 37% are in Poor or worse condition as summarized in **Figure 4**.

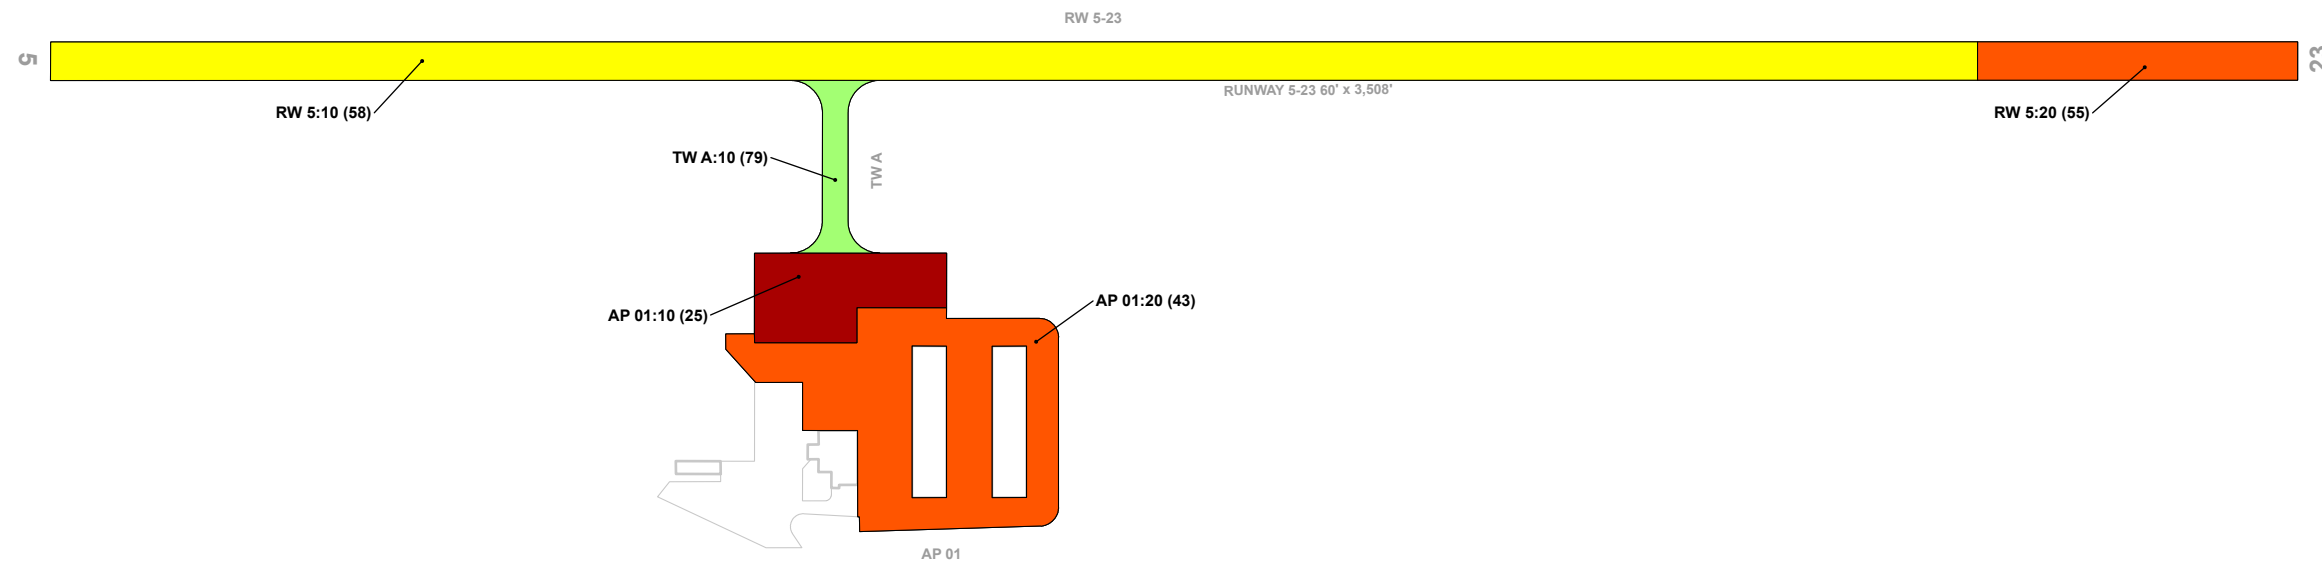
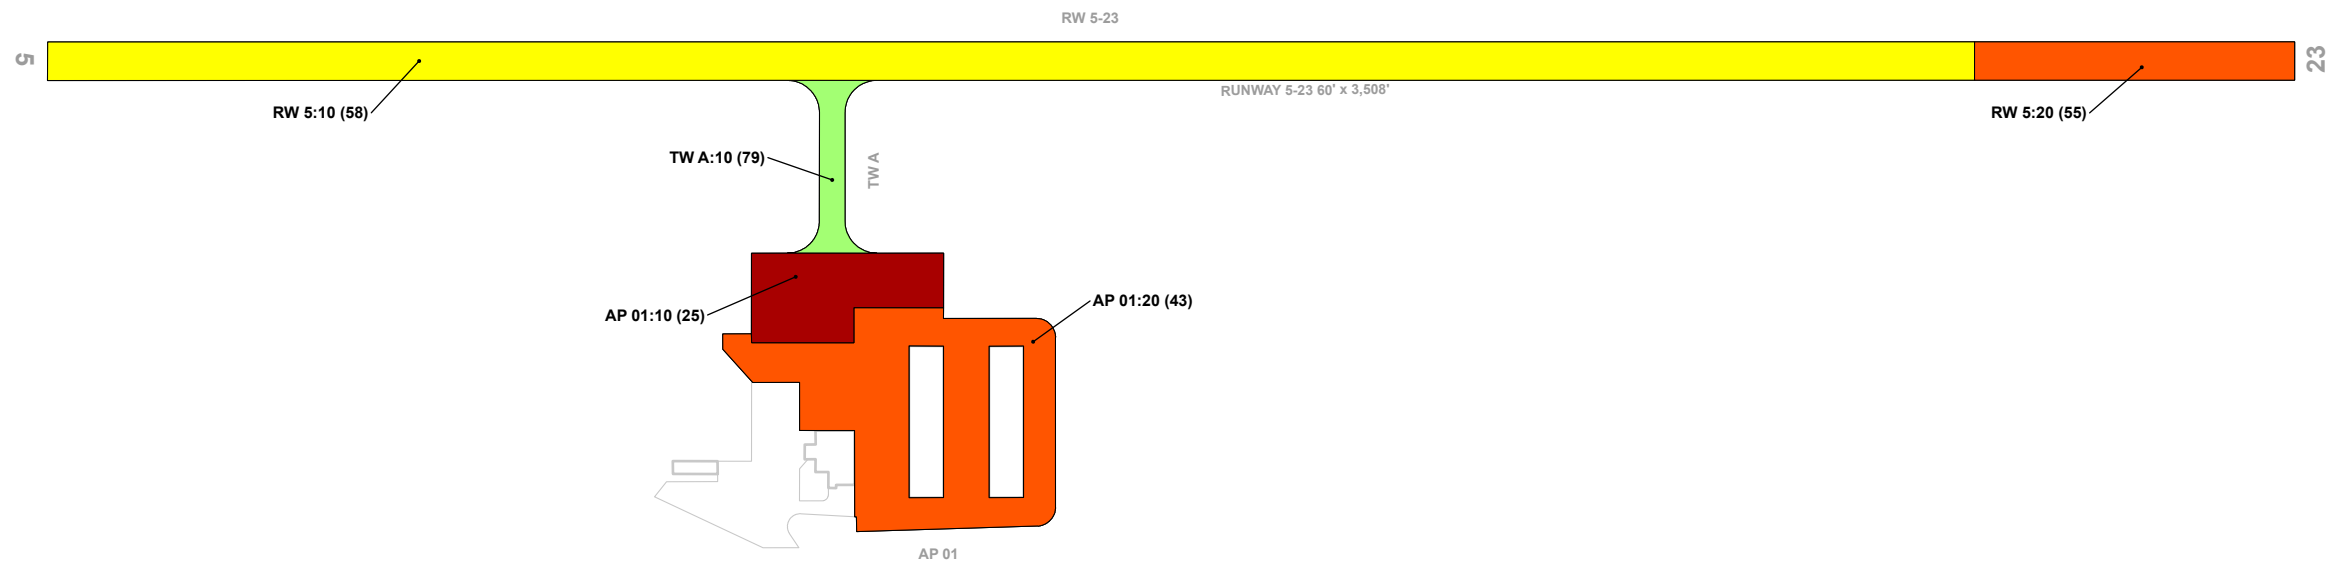
2026 Forecasted Pavement Condition Index

All condition forecasts are based on historical observations and analysis of South Carolina airfield pavements. The forecasts are not a guarantee of future PCI:- rather, they are a planning tool to aid in the timing of maintenance and rehabilitation activities.

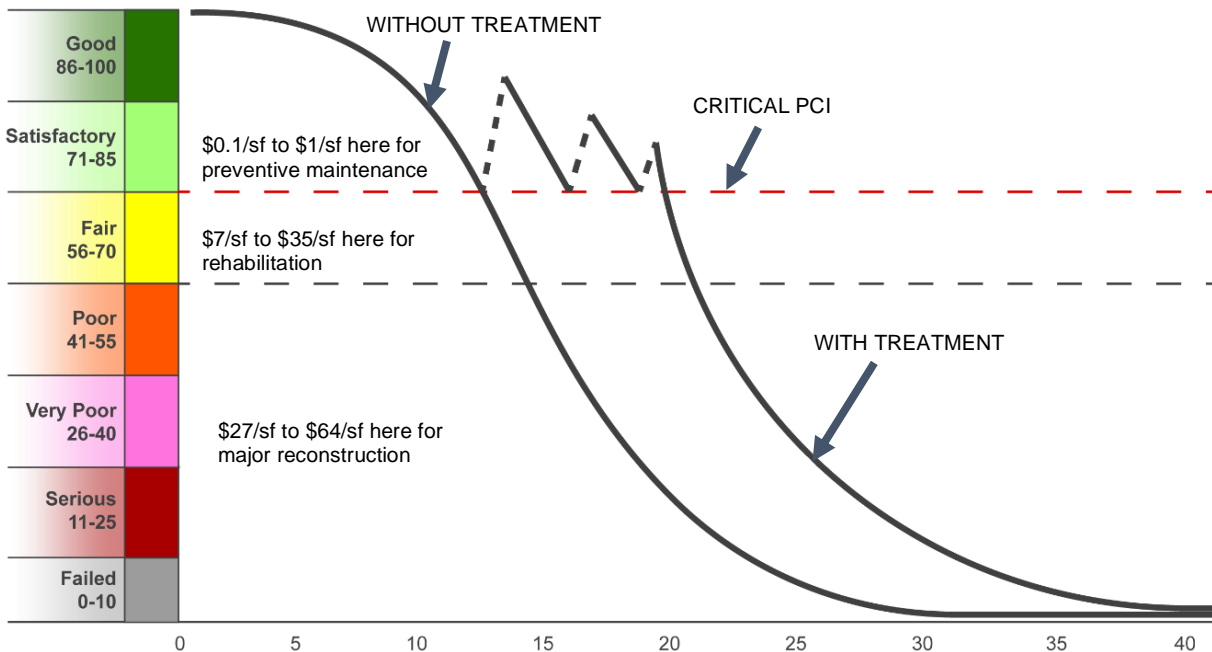
Figure 7 – Pavement Life and the Effect of Treatments

M&R planning considers various methods of repair to address the cause of the problem rather than just treating the symptom. As pavements deteriorate, repair costs can increase significantly. Once pavements have deteriorated below a certain condition threshold (the Critical PCI value), the pavement benefits more from substantial rehabilitation in lieu of maintenance activities. The figure below illustrates how the cost of pavement repairs can exponentially increase if M&R activities are delayed.

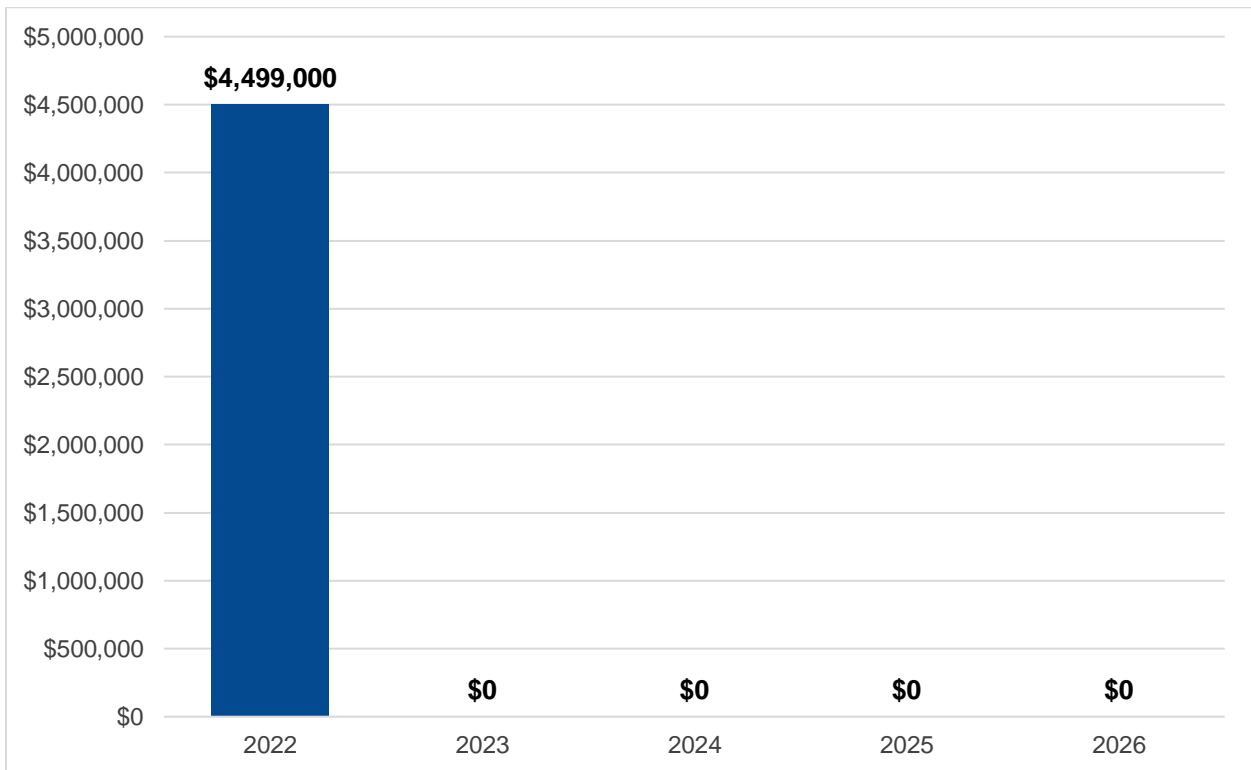
Figure 8 – 5-Year Major Rehabilitation Needs by Program Year

The 5-year major rehabilitation needs analysis at 35A results in a total 5-year cost of \$4.50M. The **5-Year Major Rehabilitation Needs Exhibit** graphically depicts the major

rehabilitation needs at a section-level which are also summarized in **Table 5** with rounded costs. Annual needs are displayed graphically in **Figure 8**.

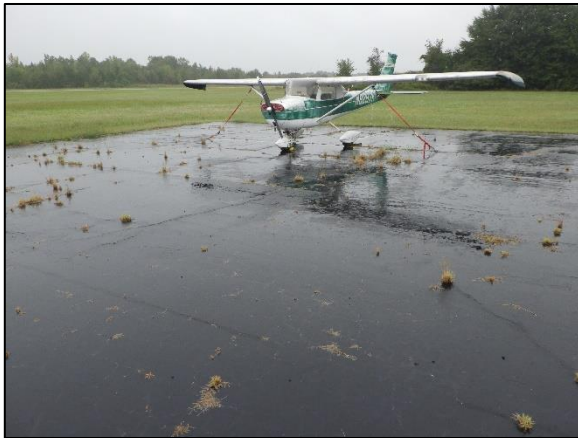
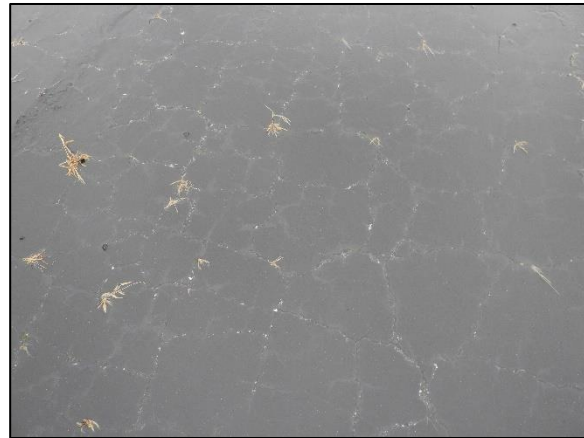
AP 01-10

Section ID	Area (SF)	Surface	Est. Last Major Work Year	Est. Last Global Treatment Year	PCI	Condition Rating	PCI % Climate	PCI % Load	PCI % Other
10	34,300	AC	1979	2011	45	Poor	54	46	0
20	98,113	AC	2004	2011	55	Poor	100	0	0

41	ALLIGATOR CR	M	646.00	SqFt
43	BLOCK CR	L	1326.00	SqFt
52	RAVELING	L	5950.00	SqFt

Program Year	Network ID	Branch ID	Section ID	Surface	Area (SF)	PCI Before	Rehabilitation Type	Planning Cost Estimate
2022	35A	AP 01	10	AC	34,300	42	AC Reconstruction	\$ 798,000
2022	35A	AP 01	20	AC	98,113	54	AC Reconstruction	\$ 2,282,000
2022	35A	RW 5	10	AAC	180,000	64	AC Rehabilitation	\$ 1,216,000
2022	35A	RW 5	20	AC	30,000	63	AC Rehabilitation	\$ 203,000
Total 5-Year Major Rehabilitation Needs =								\$ 4,499,000

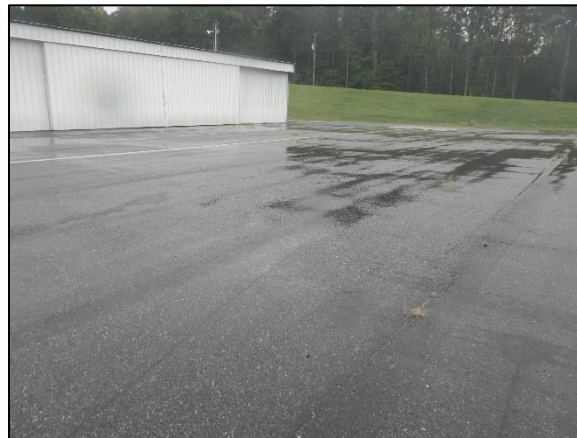
AP 01-20

43 BLOCK CR L 160.00 SqFt
48 L & T CR L 36.00 Ft
48 L & T CR M 225.00 Ft
48 L & T CR H 20.00 Ft
50 PATCHING L 136.00 SqFt
50 PATCHING M 584.00 SqFt
52 RAVELING H 12.00 SqFt
57 WEATHERING L 2774.00 SqFt
57 WEATHERING M 694.00 SqFt

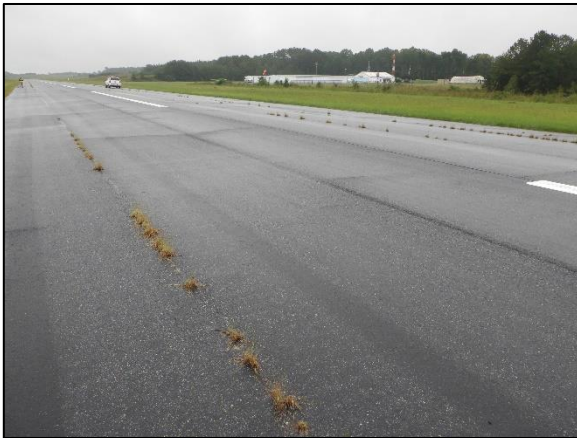
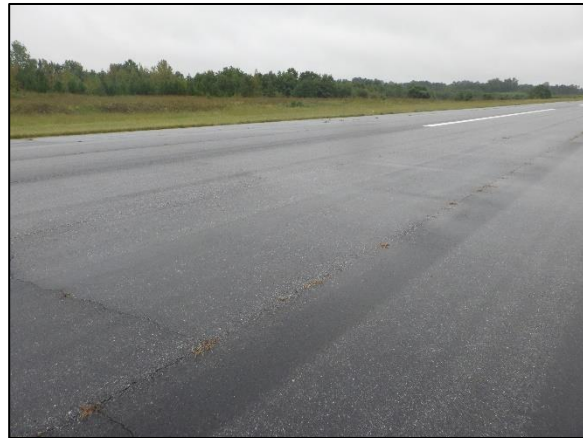
RW 5-10

35A	RW 5	10	RAVELING	Medium	1,631	SF	0.9%	Stopgap	Surface Seal	1,631	SF	\$ 0.90	\$ 1,470
35A	RW 5	20	L & T CR	Medium	1,278	LF	4.3%	Stopgap	AC Crack Sealing Narrow	1,278	LF	\$ 4.00	\$ 5,120
35A	RW 5	20	RAVELING	Medium	47	SF	0.2%	Stopgap	Surface Seal	47	SF	\$ 0.90	\$ 50

Section ID	Area (SF)	Surface	Est. Last Major Work Year	Est. Last Global Treatment Year	PCI	Condition Rating	PCI % Climate	PCI % Load	PCI % Other
10	180,000	AAC	2005	2011	65	Fair	100	0	0
20	30,000	AC	2005	2011	64	Fair	100	0	0
