SOUTH CAROLINA AERONAUTICS COMMISSION

STATEWIDE AIRFIELD PAVEMENT MANAGEMENT SYSTEM UPDATE

CQW - Cheraw Municipal Airport/Lynch Bellinger Field

2023

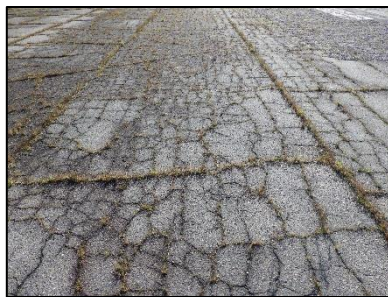
Poor/Failed Pavement

Pavements that are Poor to Failed require significant and costly interventions such as reconstruction to restore the pavement to operational service.

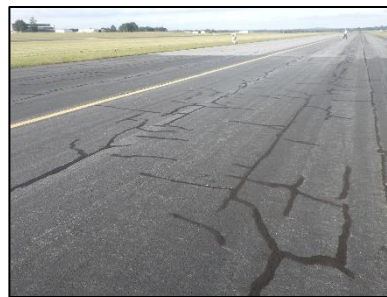
Fair Pavement

Pavements with a Fair condition rating typically require rehabilitation, or maintenance activities if rehabilitation cannot be immediately performed.

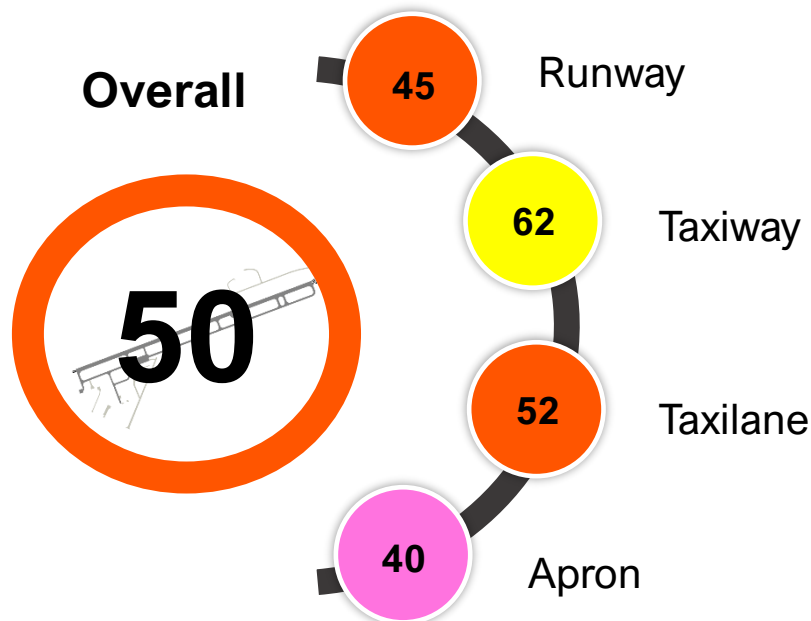
Figure 5 – Area Weighted Average Pavement Condition

The area-weighted average PCIs by branch use are summarized in the figure below. The current PCIs at a section-level are displayed graphically on the **2023 Airfield Pavement Condition Index Exhibit** and are summarized in **Table 2**.

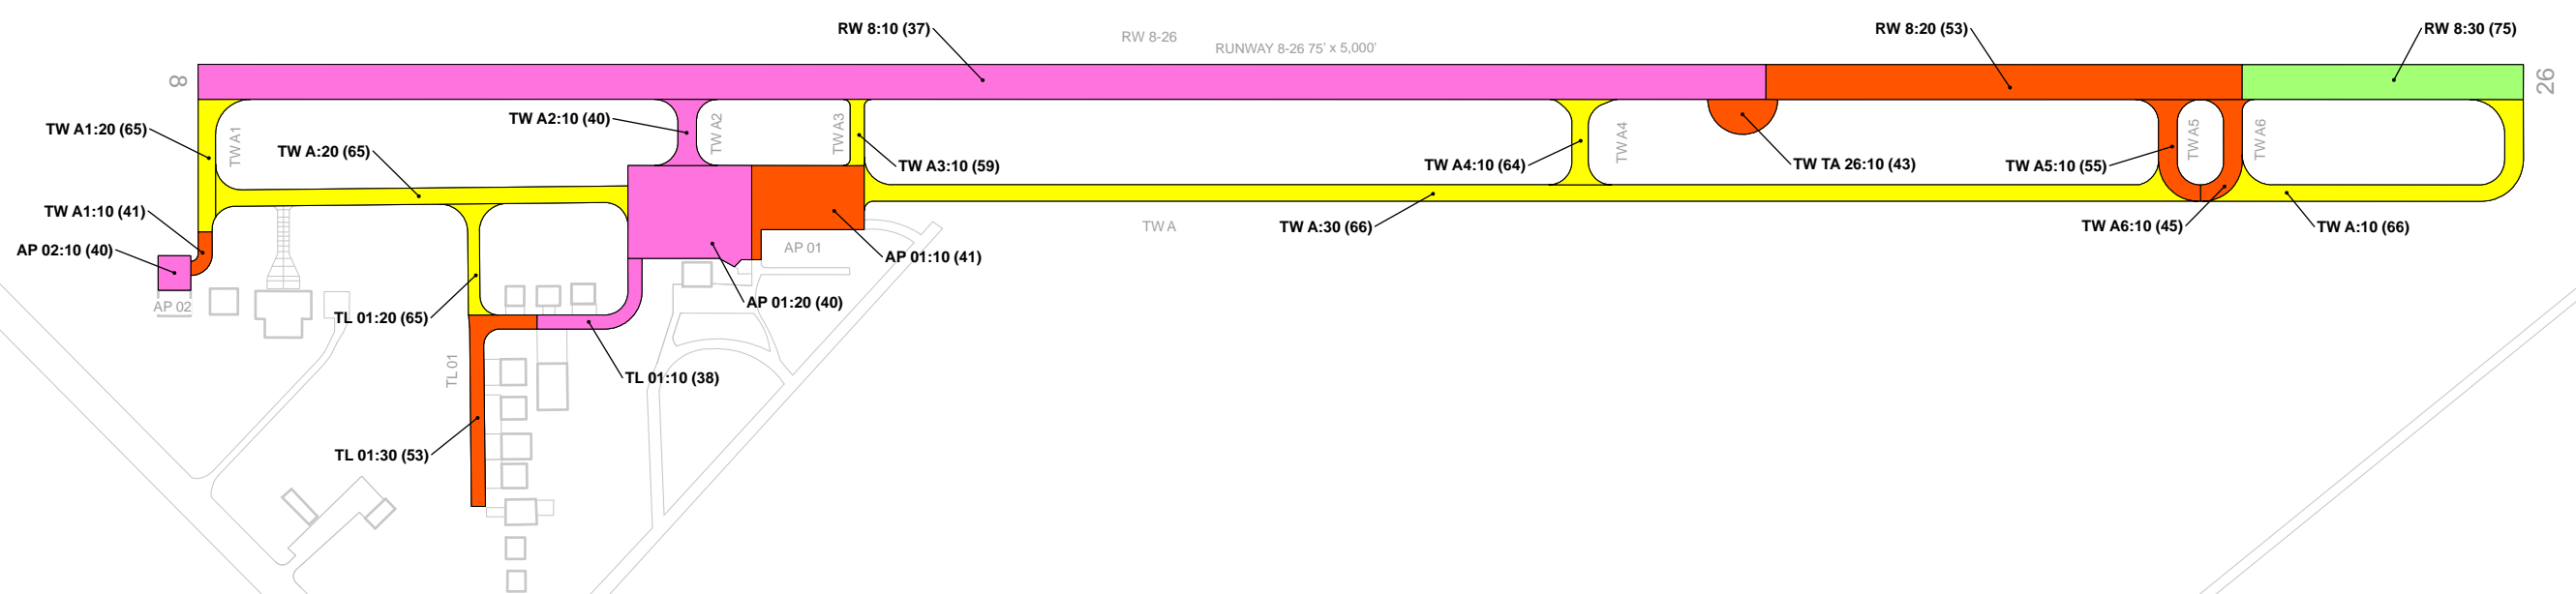
2023 Pavement Condition Index

The PCI survey for Cheraw Municipal Airport/Lynch Bellinger Field (CQW) was performed in February 2023. **The overall area-weighted average PCI value of the network was 50**, representing a condition rating of **Poor**. Approximately 6% of inspected pavements are in Good or Satisfactory condition, 27% of inspected pavements are in Fair condition, and the remaining 67% are in Poor or worse condition as summarized in **Figure 4**.

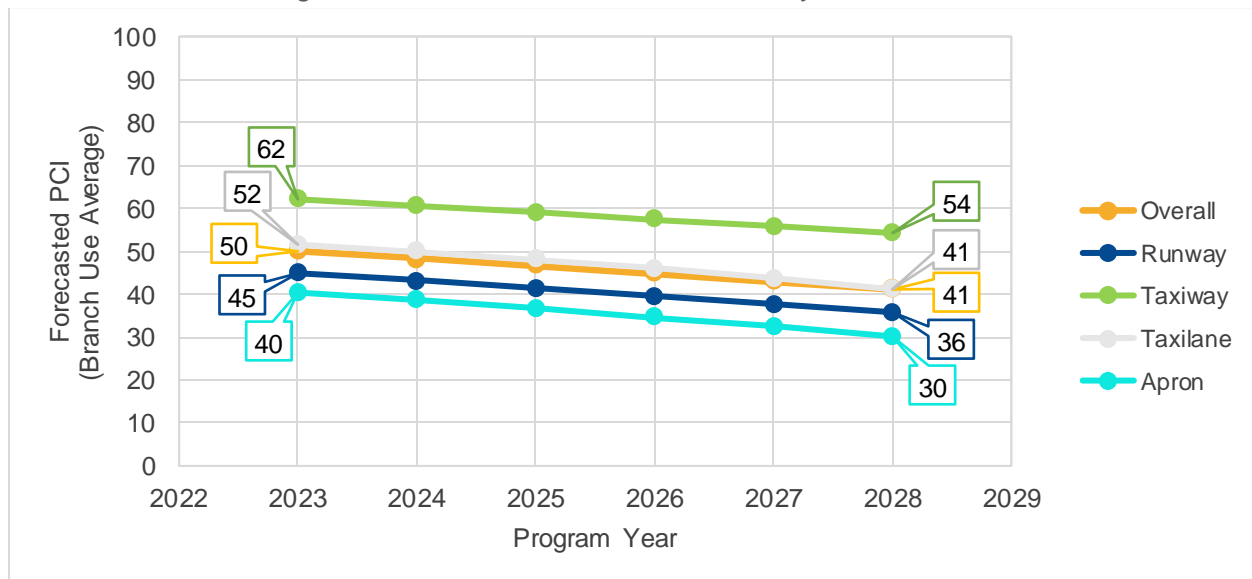
Figure 6 – Forecasted 5-Year PCI by Branch Use

A primary objective of this APMS is to estimate the future condition of each individual pavement section. PAVER™ was utilized to develop prediction curves and determine typical deterioration rates that are then used to forecast a future PCI value. This value will assist decision makers in determining at what point in time certain pavement sections will require rehabilitation. The figure below shows the current and 5-year area-weighted forecasted pavement condition distribution of each functional use (Runway, Taxiway, Taxilane, Apron) found at the Airport. The forecasted 5-year PCIs at a section-level are displayed graphically on the **2028 Forecasted Airfield Pavement Condition Index Exhibit** and are summarized in **Table 3**. All forecasts presented assume that no maintenance or rehabilitation is performed within the 5-year analysis period. **Figure 6** displays the forecasted pavement conditions at the branch-level for CQW.

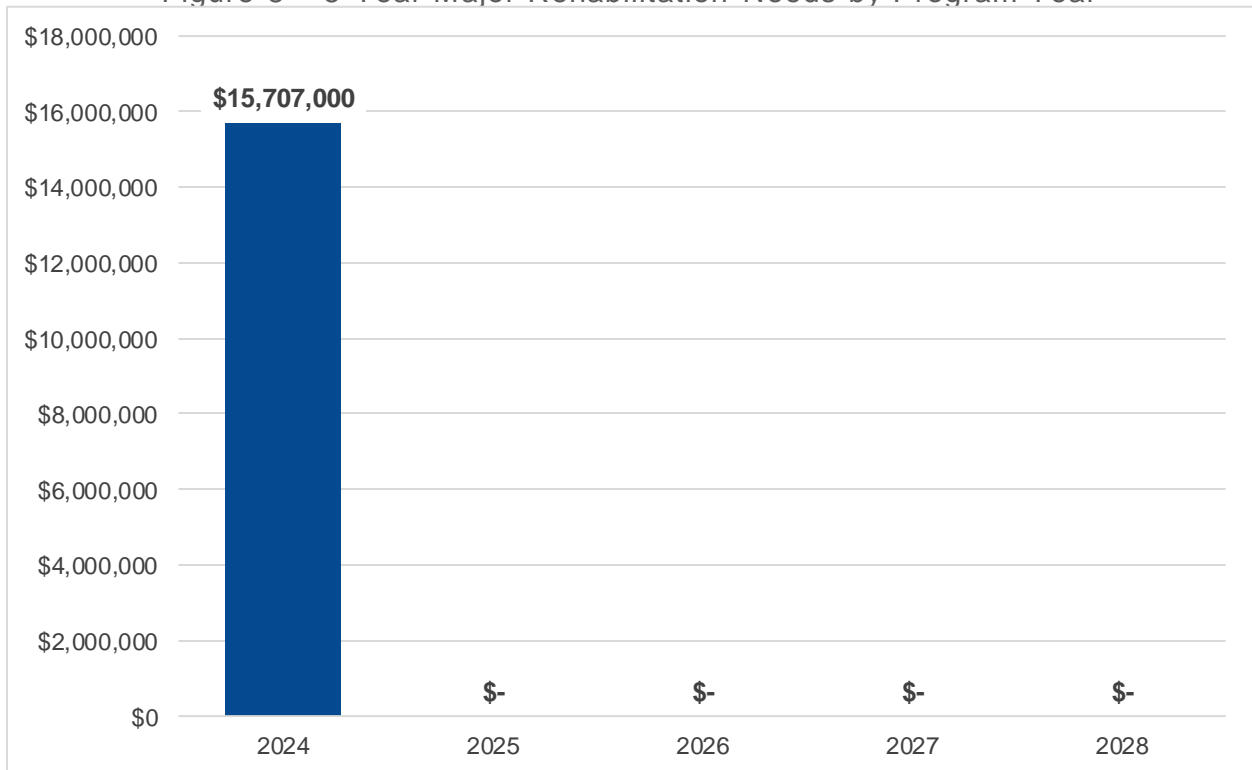
Figure 8 – 5-Year Major Rehabilitation Needs by Program Year

Major rehabilitation needs are identified by analyzing the Airport’s pavement condition in relationship to the Critical PCI value, density of load-related distresses, and major rehabilitation policies, assuming there are no budget constraints. The needs analysis is performed over a 5-year analysis period. Major rehabilitation is divided into two policy categories:

- **Intermediate Major Rehabilitation (PCI 56 to 70)** –
 - **AC:** Milling of the upper surface course and replacing with new AC with isolated areas of full-depth reconstruction
 - **PCC:** Combination of crack sealing, joint seal replacement, limited patching, and slab replacement
- **Full-Depth Reconstruction (PCI 0 to 55)** – Removal and replacement of the existing pavement section down to the subgrade

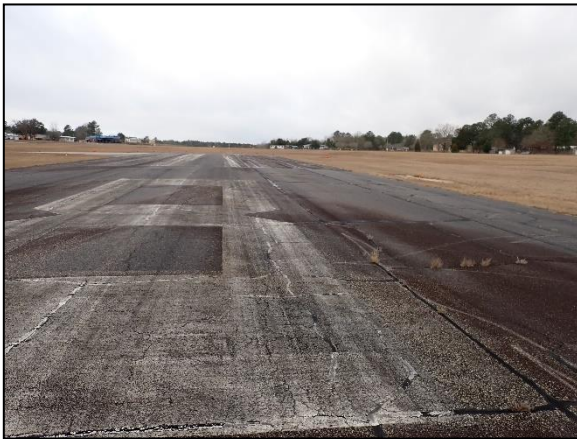
RW 8-10

Section ID	Area (SF)	Surface	Est. Last Major Work Year	Est. Last Global Treatment Year	PCI	Condition Rating	PCI % Climate	PCI % Load	PCI % Other
10	253,050	AAC	1980	-	37	Very Poor	88	12	0
20	76,875	AC	1990	-	53	Poor	100	0	0
30	45,375	AC	2004	-	75	Satisfactory	100	0	0

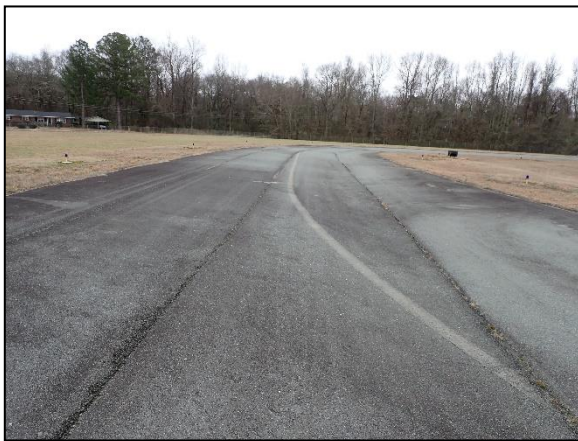
TW A-10

Section ID	Area (SF)	Surface	Est. Last Major Work Year	Est. Last Global Treatment Year	PCI	Condition Rating	PCI % Climate	PCI % Load	PCI % Other
10	31,110	AC	2004	-	66	Fair	100	0	0
20	32,564	AC	2007	-	65	Fair	100	0	0
30	100,480	AC	2012	-	66	Fair	100	0	0

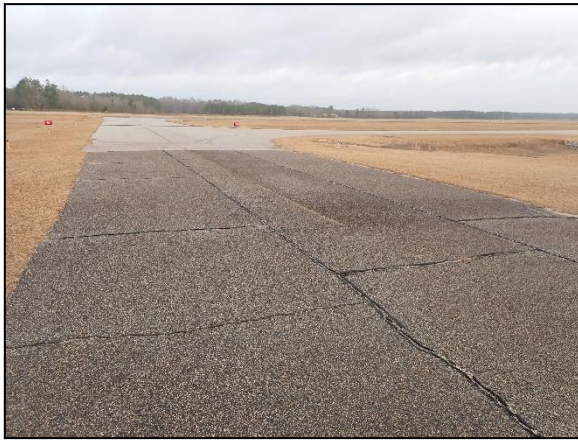
TW A1-10

Section ID	Area (SF)	Surface	Est. Last Major Work Year	Est. Last Global Treatment Year	PCI	Condition Rating	PCI % Climate	PCI % Load	PCI % Other
10	2,915	AAC	1980	-	41	Poor	100	0	0
20	11,730	AC	2007	-	65	Fair	100	0	0

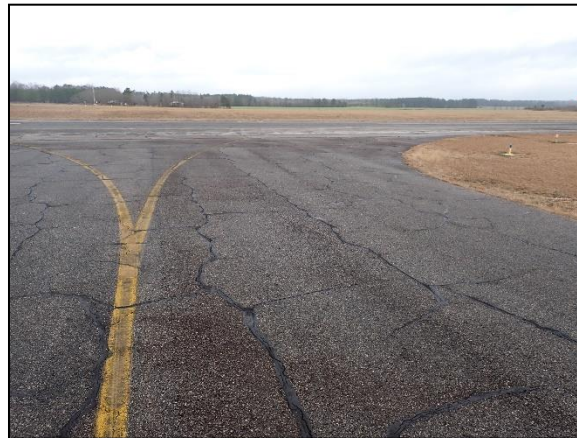
TW A2-10

Section ID	Area (SF)	Surface	Est. Last Major Work Year	Est. Last Global Treatment Year	PCI	Condition Rating	PCI % Climate	PCI % Load	PCI % Other
10	7,642	AAC	1980	-	40	Very Poor	100	0	0

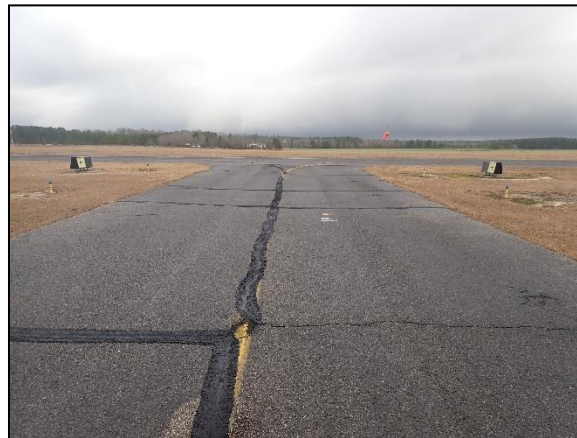
TW A3-10

Section ID	Area (SF)	Surface	Est. Last Major Work Year	Est. Last Global Treatment Year	PCI	Condition Rating	PCI % Climate	PCI % Load	PCI % Other
10	4,420	AC	1980	-	59	Fair	100	0	0

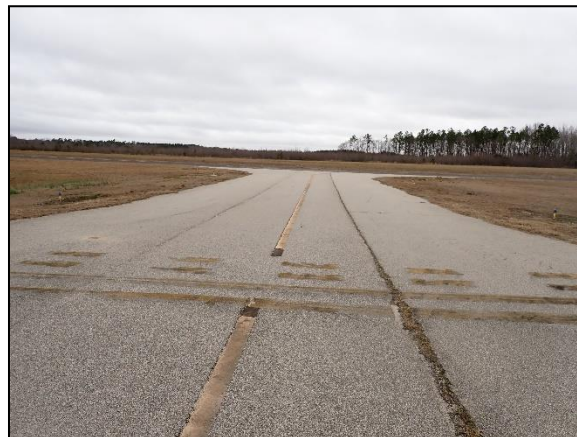
TW A4-10

Section ID	Area (SF)	Surface	Est. Last Major Work Year	Est. Last Global Treatment Year	PCI	Condition Rating	PCI % Climate	PCI % Load	PCI % Other
10	8,980	AC	2012	-	64	Fair	100	0	0

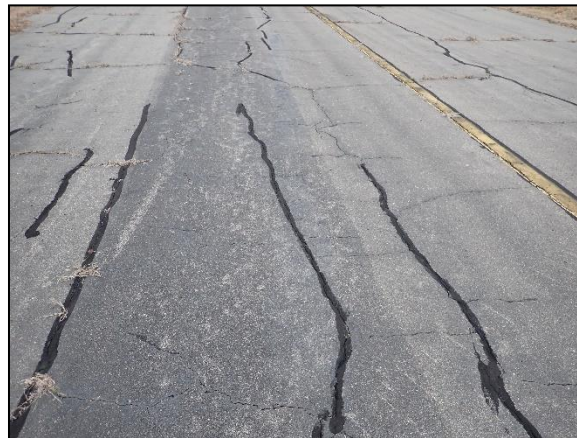
TW A6-10

Section ID	Area (SF)	Surface	Est. Last Major Work Year	Est. Last Global Treatment Year	PCI	Condition Rating	PCI % Climate	PCI % Load	PCI % Other
10	10,569	AC	1990	-	55	Poor	100	0	0

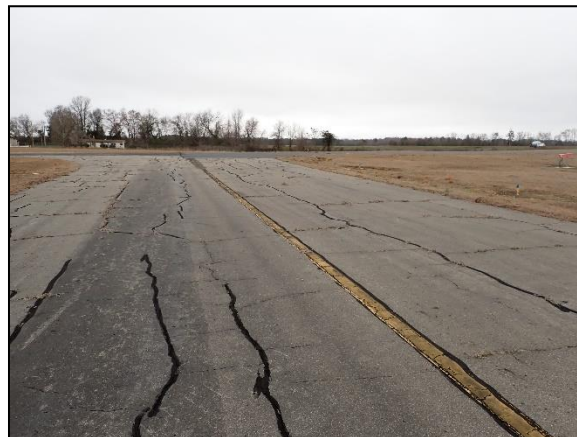
TW A6-10

Section ID	Area (SF)	Surface	Est. Last Major Work Year	Est. Last Global Treatment Year	PCI	Condition Rating	PCI % Climate	PCI % Load	PCI % Other
10	10,167	AC	1990	-	45	Poor	100	0	0

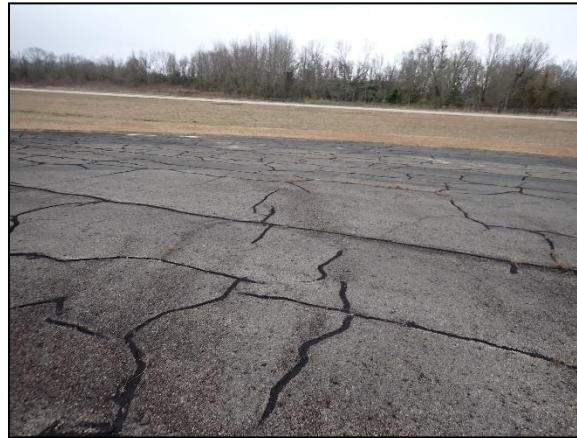
TW TA 26-10

Section ID	Area (SF)	Surface	Est. Last Major Work Year	Est. Last Global Treatment Year	PCI	Condition Rating	PCI % Climate	PCI % Load	PCI % Other
10	8,835	AAC	1980	-	43	Poor	100	0	0

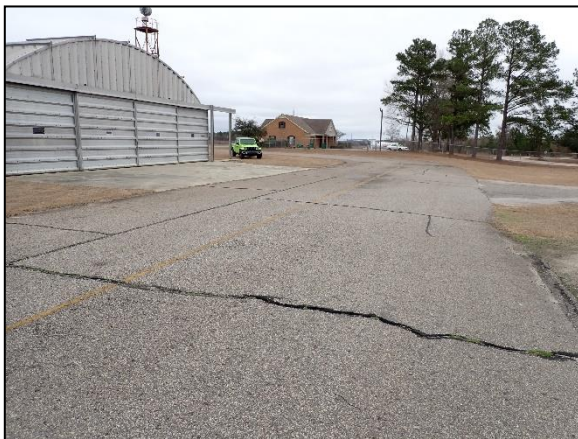
TL 01-10

Section ID	Area (SF)	Surface	Est. Last Major Work Year	Est. Last Global Treatment Year	PCI	Condition Rating	PCI % Climate	PCI % Load	PCI % Other
10	9,593	AC	1980	-	38	Very Poor	85	0	15
20	7,870	AC	2007	-	65	Fair	100	0	0
30	16,118	AC	1998	-	53	Poor	100	0	0

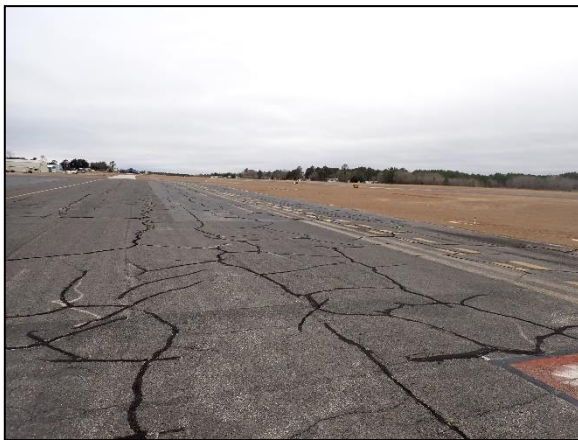
AP 01-10

Section ID	Area (SF)	Surface	Est. Last Major Work Year	Est. Last Global Treatment Year	PCI	Condition Rating	PCI % Climate	PCI % Load	PCI % Other
10	34,696	AC	1980	-	41	Poor	100	0	0
20	53,815	AAC	1980	-	40	Very Poor	89	11	0

CQW	AP 01	20	RAVELING	Medium	897	SF	1.7%	Stopgap	Surface Seal	897	SF	\$ 1.65	\$ 1,480
CQW	AP 02	10	L & T CR	Medium	569	LF	11.0%	Stopgap	AC Crack Sealing Narrow	569	LF	\$ 3.50	\$ 2,000
CQW	AP 02	10	RAVELING	Medium	1,295	SF	25.0%	Stopgap	Surface Seal	1,295	SF	\$ 1.65	\$ 2,140
CQW	RW 8	10	ALLIGATOR CR	Medium	54	SF	0.0%	Stopgap	AC Full-Depth Patching	87	SF	\$ 17.75	\$ 1,560
CQW	RW 8	10	BLOCK CR	Medium	52,529	SF	20.8%	Stopgap	AC Crack Sealing Narrow	16,011	LF	\$ 3.50	\$ 56,040
CQW	RW 8	10	L & T CR	Medium	2,221	LF	0.9%	Stopgap	AC Crack Sealing Narrow	2,221	LF	\$ 3.50	\$ 7,780
CQW	RW 8	10	RAVELING	Medium	23,217	SF	9.2%	Stopgap	Surface Seal	23,217	SF	\$ 1.65	\$ 38,310
CQW	RW 8	20	RAVELING	Medium	1,920	SF	2.5%	Stopgap	Surface Seal	1,920	SF	\$ 1.65	\$ 3,170
CQW	TL 01	10	BLOCK CR	Medium	782	SF	8.2%	Stopgap	AC Crack Sealing Narrow	239	LF	\$ 3.50	\$ 840
CQW	TL 01	10	L & T CR	Medium	453	LF	4.7%	Stopgap	AC Crack Sealing Narrow	453	LF	\$ 3.50	\$ 1,590
