SOUTH CAROLINA AERONAUTICS COMMISSION

STATEWIDE AIRFIELD PAVEMENT MANAGEMENT SYSTEM UPDATE

FDW - Fairfield County Airport

2022

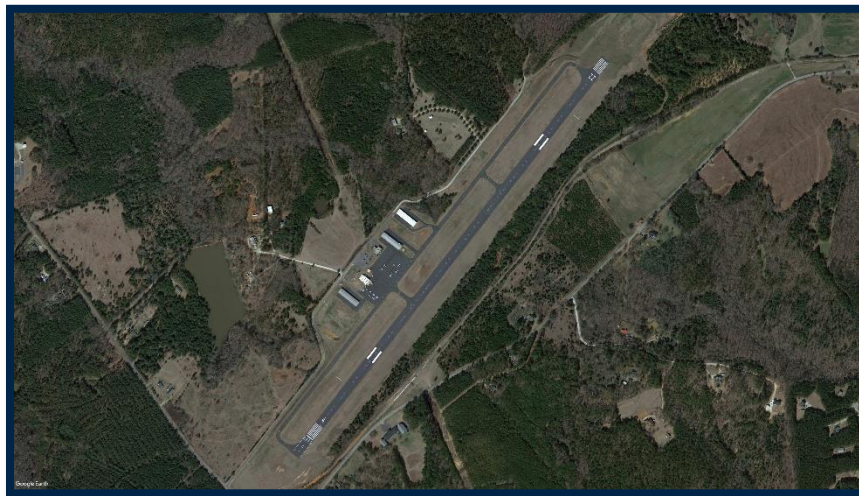
Figure 1 – Airport Layout

Project elements performed for the 2021-2024 program update included the development and update of pavement inventories, documentation of pavement conditions, performance modeling, and maintenance and rehabilitation (M&R) needs for all participating airports. This report summarizes the results of the SCAC pavement management program update at Fairfield County Airport (FDW).

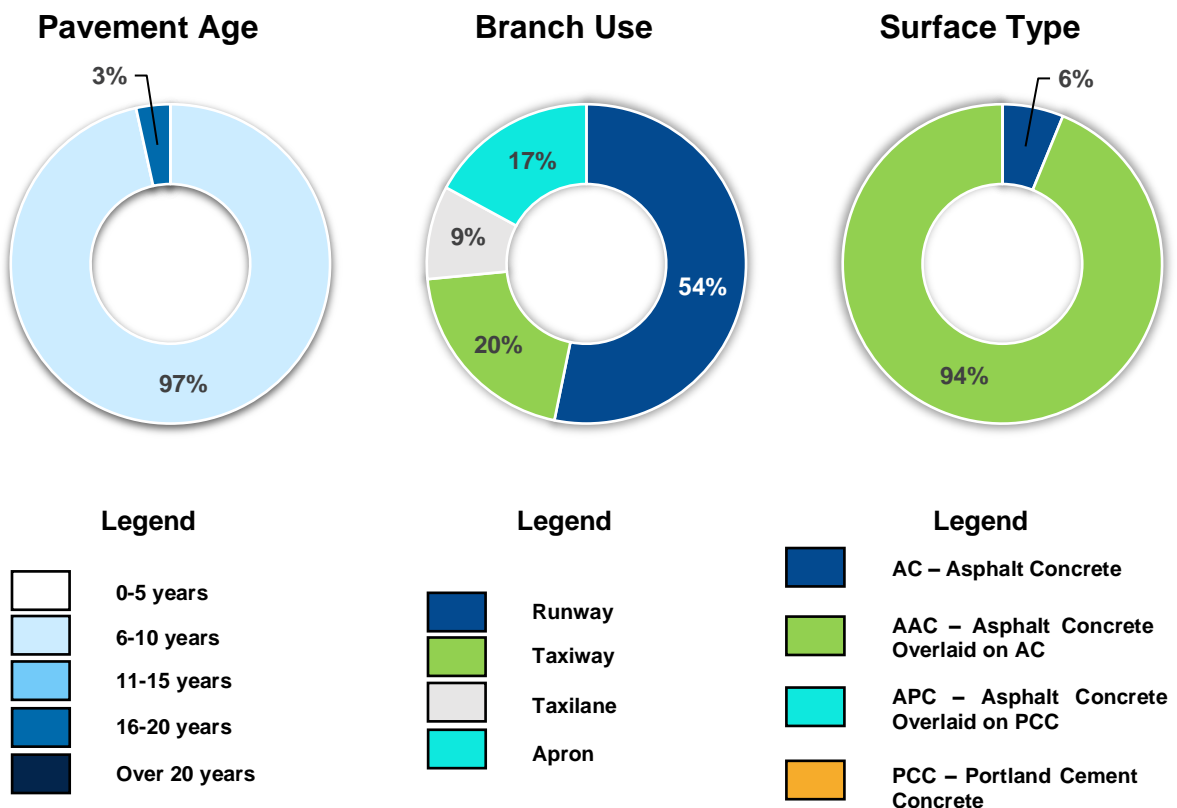
Figure 2 – System Inventory Summary

The following figure summarizes the inventory items at Fairfield County Airport (FDW). The **Estimated Age Exhibit** provides the last major work date for each pavement section based on the collected documentation.

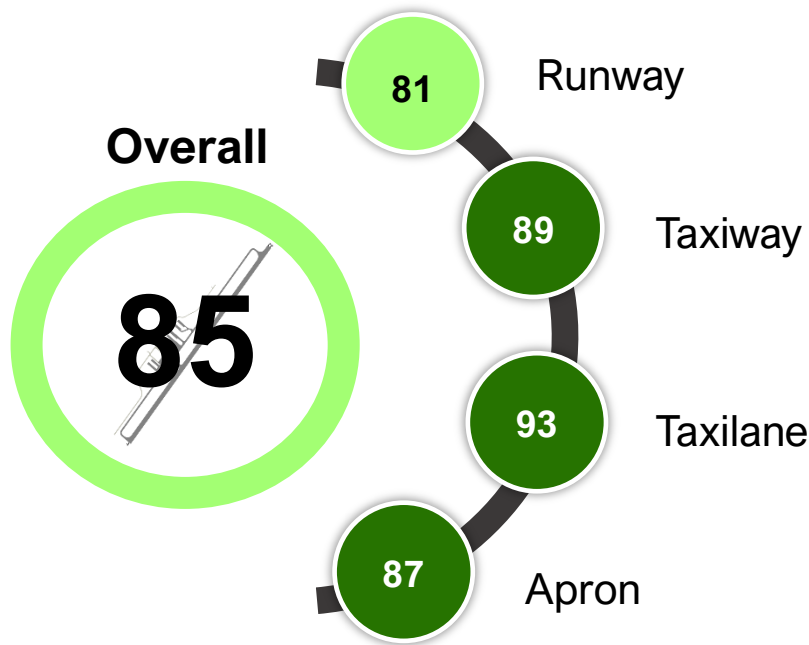
Figure 5 – Area Weighted Average Pavement Condition

The area-weighted average PCIs by branch use are summarized in the figure below. The current PCIs at a section-level are displayed graphically on the **2021 Airfield Pavement Condition Index (PCI) Exhibit** and are summarized in **Table 2**.

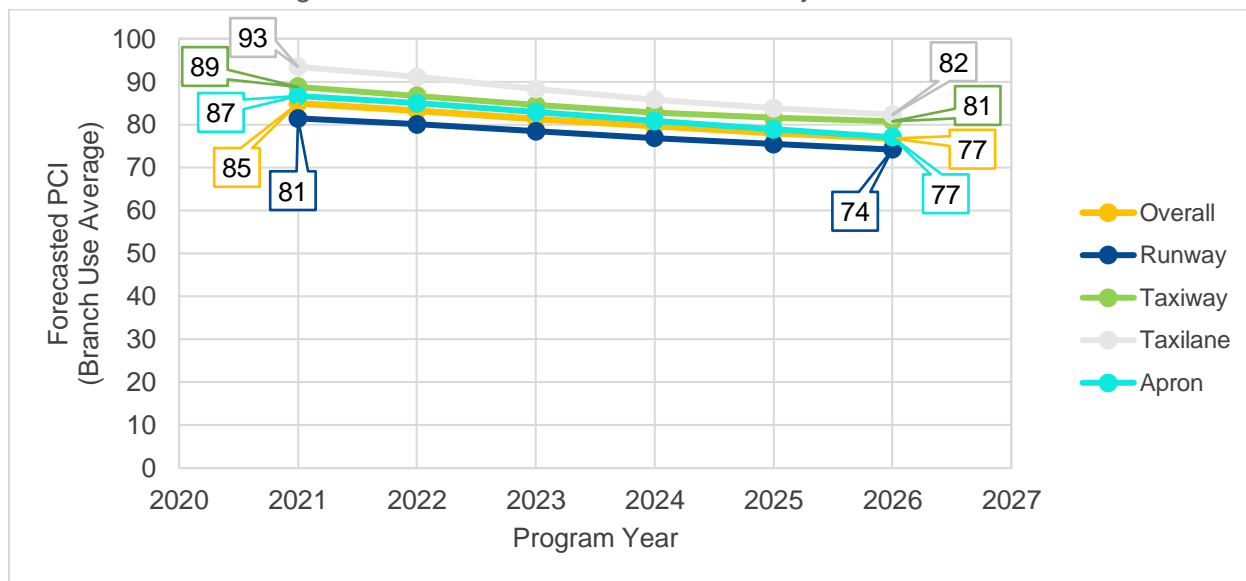
Figure 6 – Forecasted 5-Year PCI by Branch Use

A primary objective of this APMS is to estimate the future condition of each individual pavement section. PAVER™ was utilized to develop prediction curves and determine typical deterioration rates that are then used to forecast a future PCI value. This value will assist decision makers in determining at what point in time certain pavement sections will require rehabilitation. The figure below shows the current and 5-year area-weighted forecasted pavement condition distribution of each functional use (Runway, Taxiway, Taxilane, Apron) found at the Airport. The forecasted 5-year PCIs at a section-level are displayed graphically on the **2026 Forecasted Airfield Pavement Condition Index Exhibit** and are summarized in **Table 3**. All forecasts presented assume that no maintenance or rehabilitation is performed within the 5-year analysis period. **Figure 6** displays the forecasted pavement conditions at the branch-level for FDW.

All condition forecasts are based on historical observations and analysis of South Carolina airfield pavements. The forecasts are not a guarantee of future PCI:- rather, they are a planning tool to aid in the timing of maintenance and rehabilitation activities.

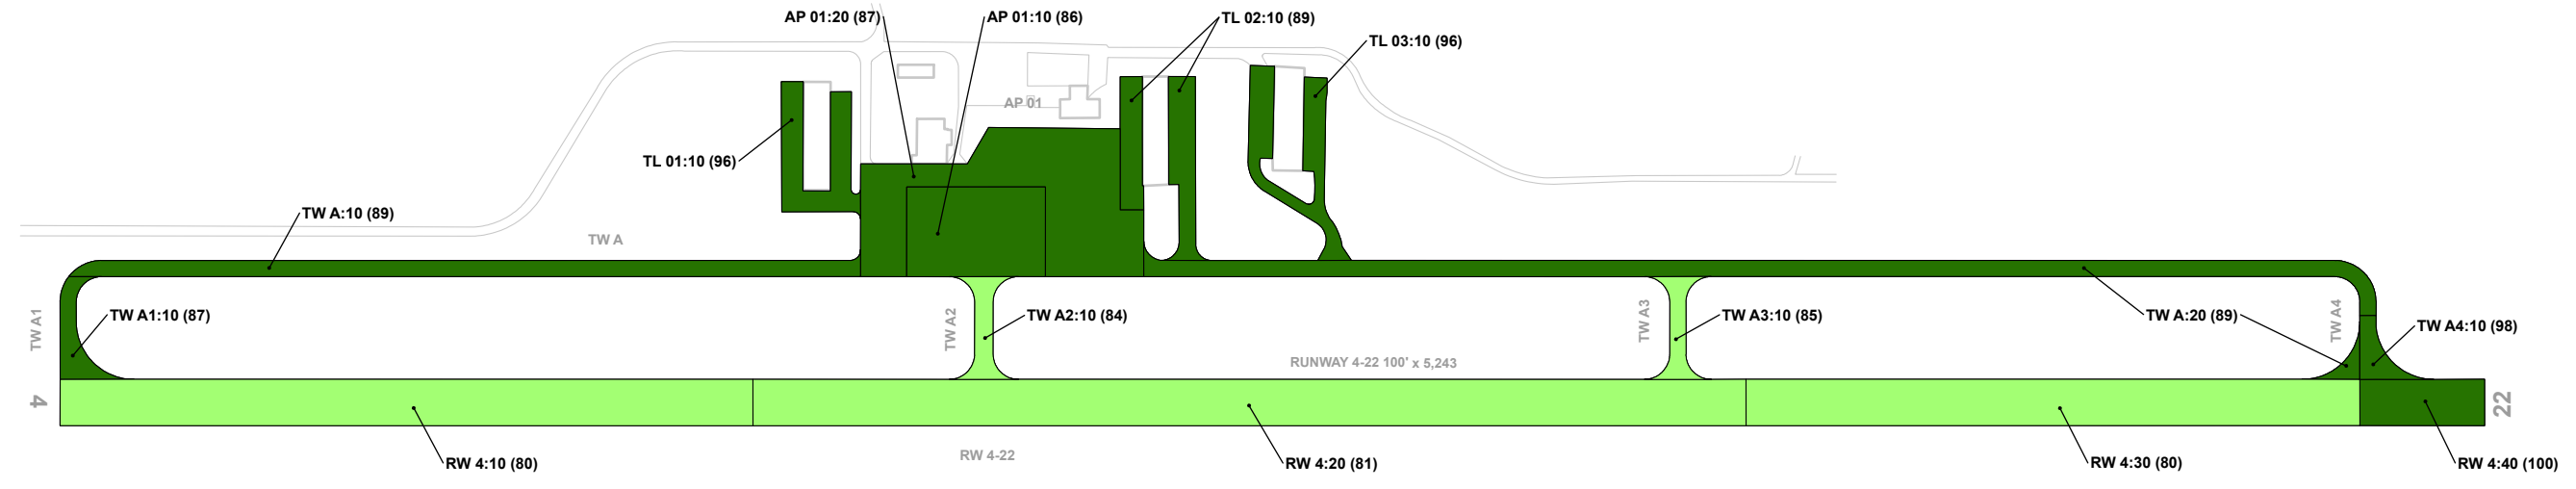
2021 Pavement Condition Index

- PCI 86-100 Good
- PCI 71-85 Satisfactory
- PCI 56-70 Fair
- PCI 41-55 Poor
- PCI 26-40 Very Poor
- PCI 11-25 Serious
- PCI 0-10 Failed

— BRANCH IDENTIFIER
 — SECTION IDENTIFIER
TWA:20 (84)
 — PCI

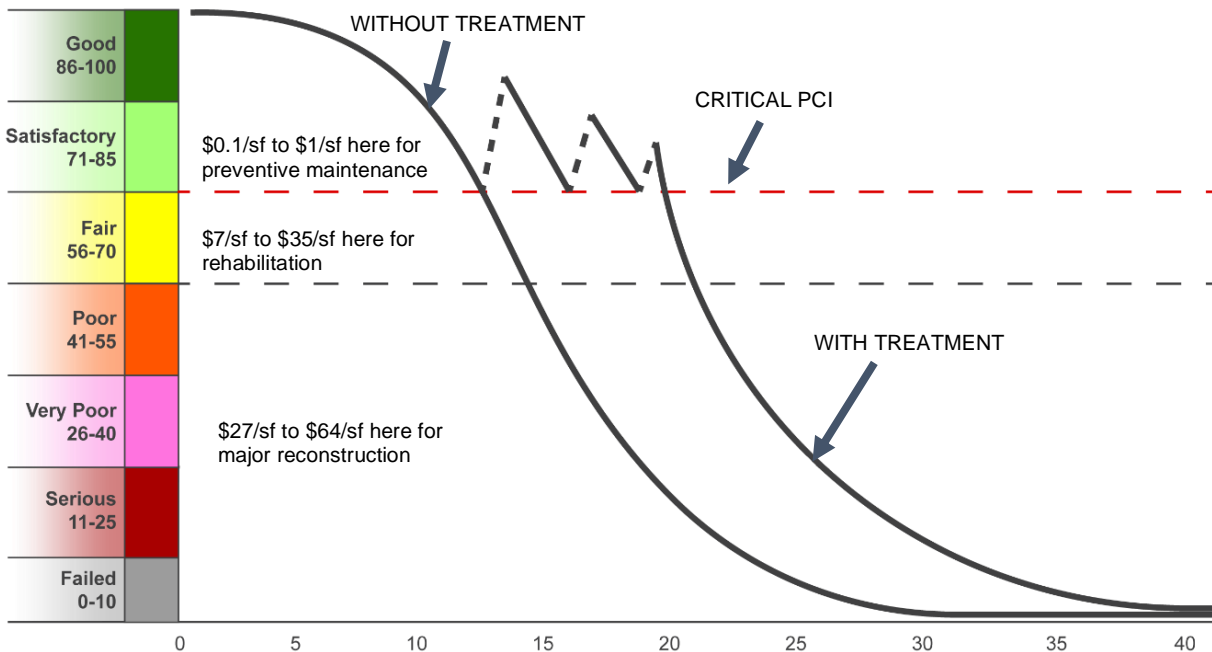
Figure 7 – Pavement Life and the Effect of Treatments

M&R planning considers various methods of repair to address the cause of the problem rather than just treating the symptom. As pavements deteriorate, repair costs can increase significantly. Once pavements have deteriorated below a certain condition threshold (the Critical PCI value), the pavement benefits more from substantial rehabilitation in lieu of maintenance activities. The figure below illustrates how the cost of pavement repairs can exponentially increase if M&R activities are delayed.

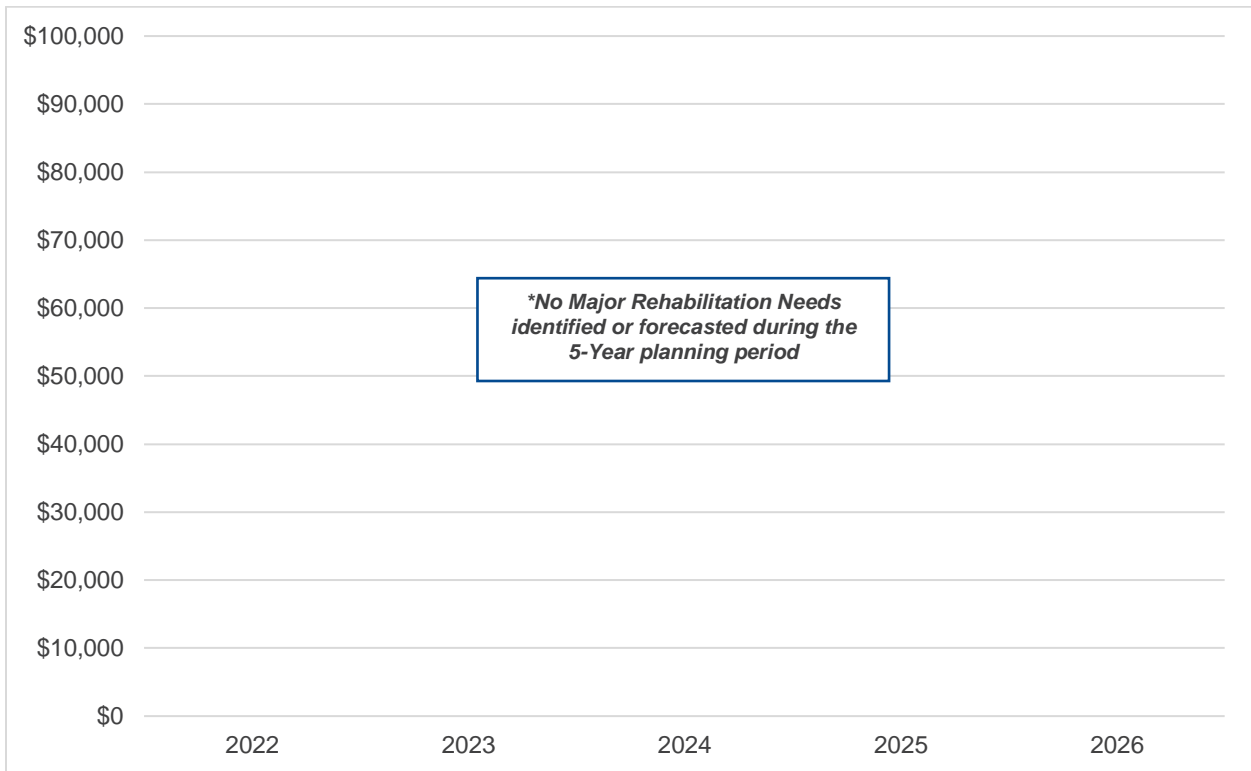
Figure 8 – 5-Year Major Rehabilitation Needs by Program Year

The 5-year major rehabilitation needs analysis at FDW resulted in no major rehabilitation needs for the 5-year analysis duration. The **5-Year Major Rehabilitation Needs Exhibit** graphically depicts the major rehabilitation needs at a section-level which are also summarized in **Table 5** with rounded costs. Annual needs are displayed graphically in **Figure 8**.

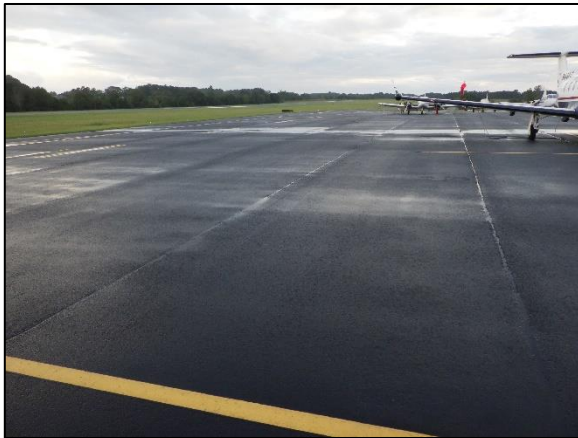
AP 01-10

Section ID	Area (SF)	Surface	Est. Last Major Work Year	Est. Last Global Treatment Year	PCI	Condition Rating	PCI % Climate	PCI % Load	PCI % Other
10	58,200	AAC	2012	2020	86	Good	100	0	0
20	110,143	AAC	2012	2020	87	Good	84	0	16

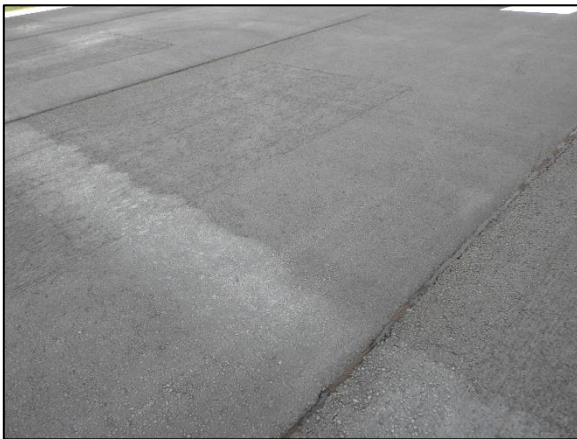
RW 4-10

Section ID	Area (SF)	Surface	Est. Last Major Work Year	Est. Last Global Treatment Year	PCI	Condition Rating	PCI % Climate	PCI % Load	PCI % Other
10	150,000	AAC	2012	2020	80	Satisfactory	100	0	0
20	215,000	AAC	2012	2020	81	Satisfactory	95	0	5
30	132,900	AAC	2012	2020	80	Satisfactory	100	0	0
40	27,000	AC	2015	2020	100	Good	42	58	0

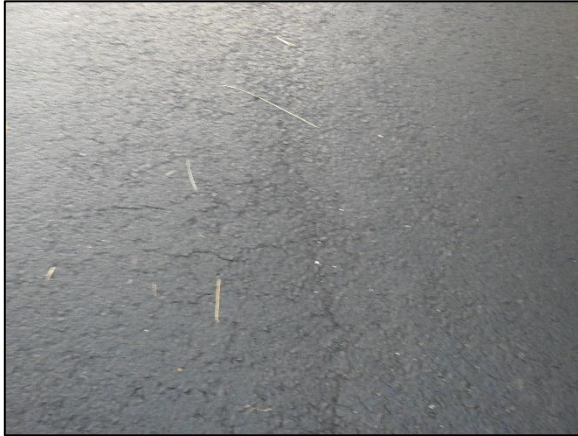
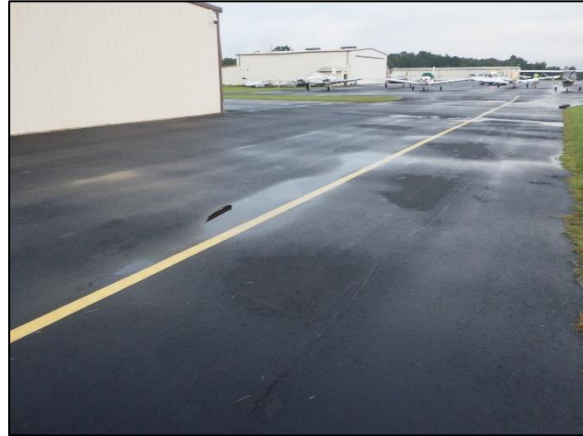
TL 01-10

Section ID	Area (SF)	Surface	Est. Last Major Work Year	Est. Last Global Treatment Year	PCI	Condition Rating	PCI % Climate	PCI % Load	PCI % Other
10	28,404	AAC	2012	2020	96	Good	100	0	0

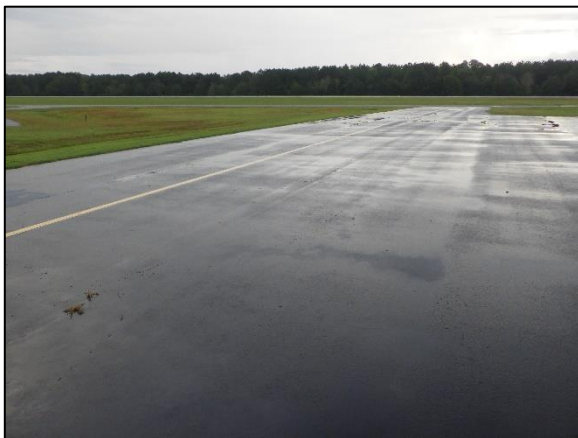
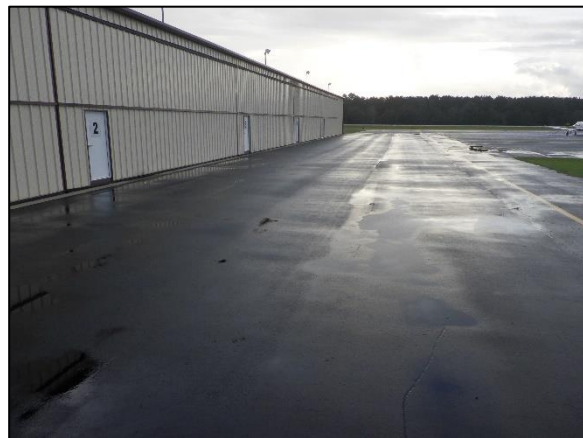
TL 02-10

Section ID	Area (SF)	Surface	Est. Last Major Work Year	Est. Last Global Treatment Year	PCI	Condition Rating	PCI % Climate	PCI % Load	PCI % Other
10	34,079	AC	2006	2020	89	Good	64	0	36

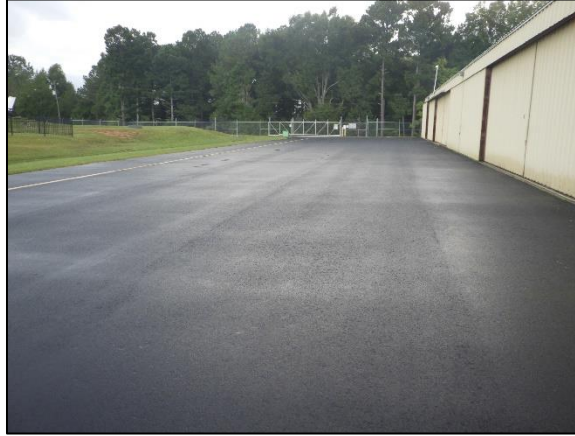
TL 03-10

Section ID	Area (SF)	Surface	Est. Last Major Work Year	Est. Last Global Treatment Year	PCI	Condition Rating	PCI % Climate	PCI % Load	PCI % Other
10	30,812	AAC	2012	2020	96	Good	100	0	0

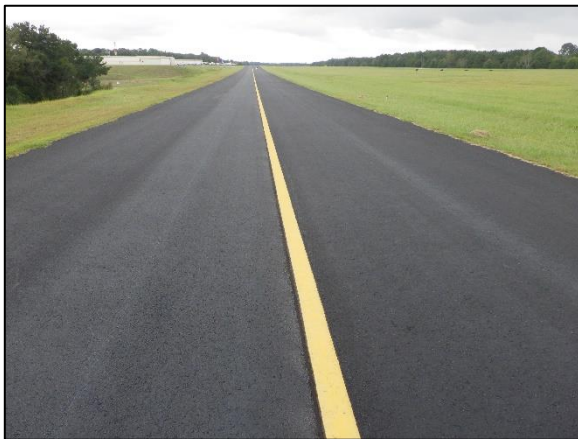
TW A-10

Section ID	Area (SF)	Surface	Est. Last Major Work Year	Est. Last Global Treatment Year	PCI	Condition Rating	PCI % Climate	PCI % Load	PCI % Other
10	59,359	AAC	2012	2020	89	Good	100	0	0
20	98,987	AAC	2012	2020	89	Good	100	0	0

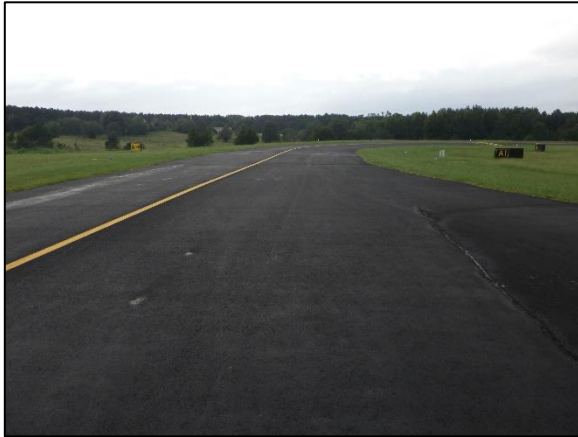
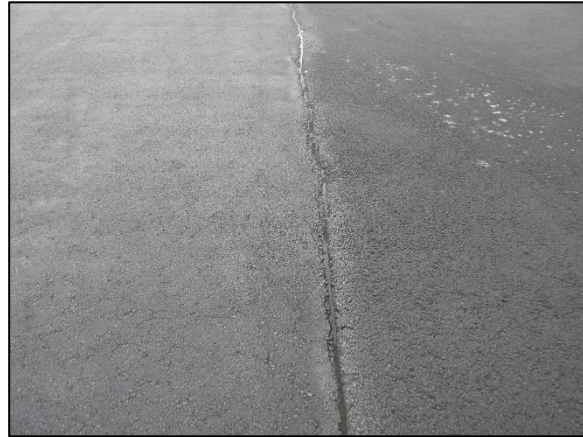
TW A1-10

Section ID	Area (SF)	Surface	Est. Last Major Work Year	Est. Last Global Treatment Year	PCI	Condition Rating	PCI % Climate	PCI % Load	PCI % Other
10	11,462	AAC	2012	2020	87	Good	100	0	0

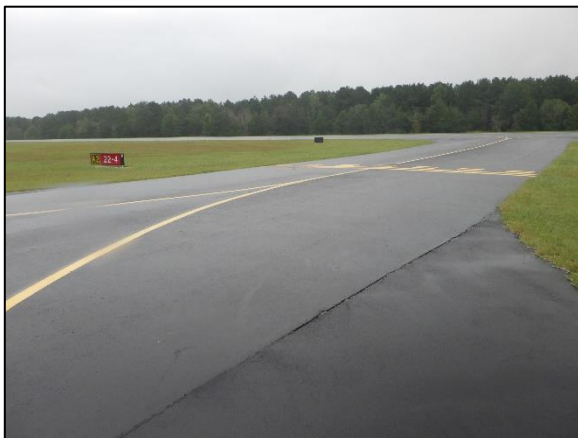
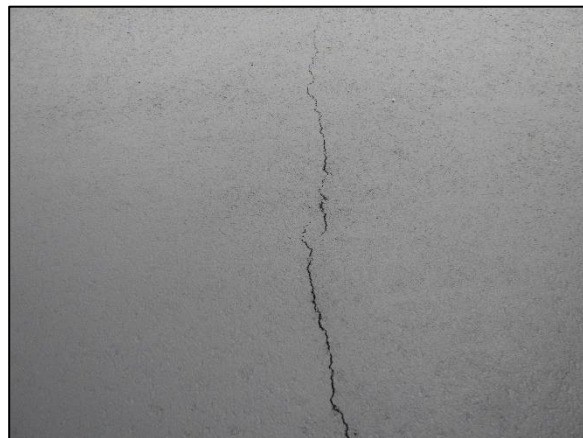
TW A2-10

Section ID	Area (SF)	Surface	Est. Last Major Work Year	Est. Last Global Treatment Year	PCI	Condition Rating	PCI % Climate	PCI % Load	PCI % Other
10	11,497	AAC	2012	2020	84	Satisfactory	91	0	9

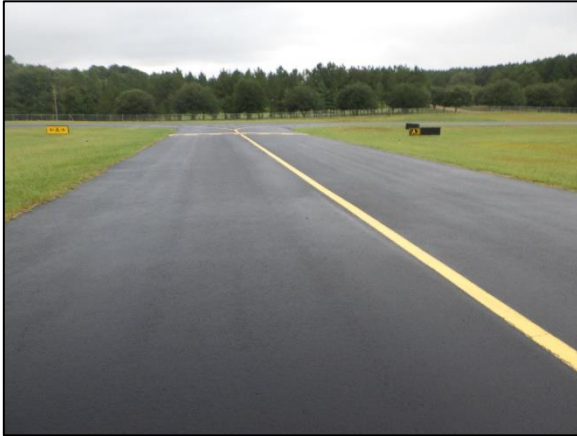
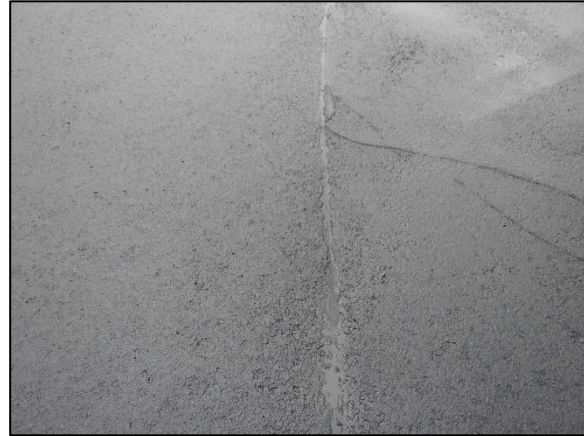
TW A3-10

Section ID	Area (SF)	Surface	Est. Last Major Work Year	Est. Last Global Treatment Year	PCI	Condition Rating	PCI % Climate	PCI % Load	PCI % Other
10	10,384	AAC	2012	2020	85	Satisfactory	100	0	0
