SOUTH CAROLINA AERONAUTICS COMMISSION

STATEWIDE AIRFIELD PAVEMENT MANAGEMENT SYSTEM UPDATE

GMU - Greenville Downtown Airport

2022

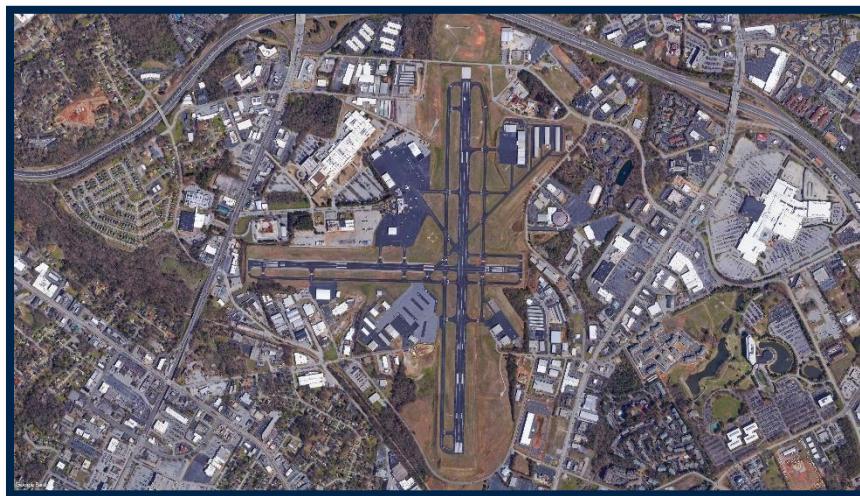
Figure 1 – Airport Layout

Project elements performed for the 2021-2024 program update included the development and update of pavement inventories, documentation of pavement conditions, performance modeling, and maintenance and rehabilitation (M&R) needs for all participating airports. This report summarizes the results of the SCAC pavement management program update at Greenville Downtown Airport (GMU).

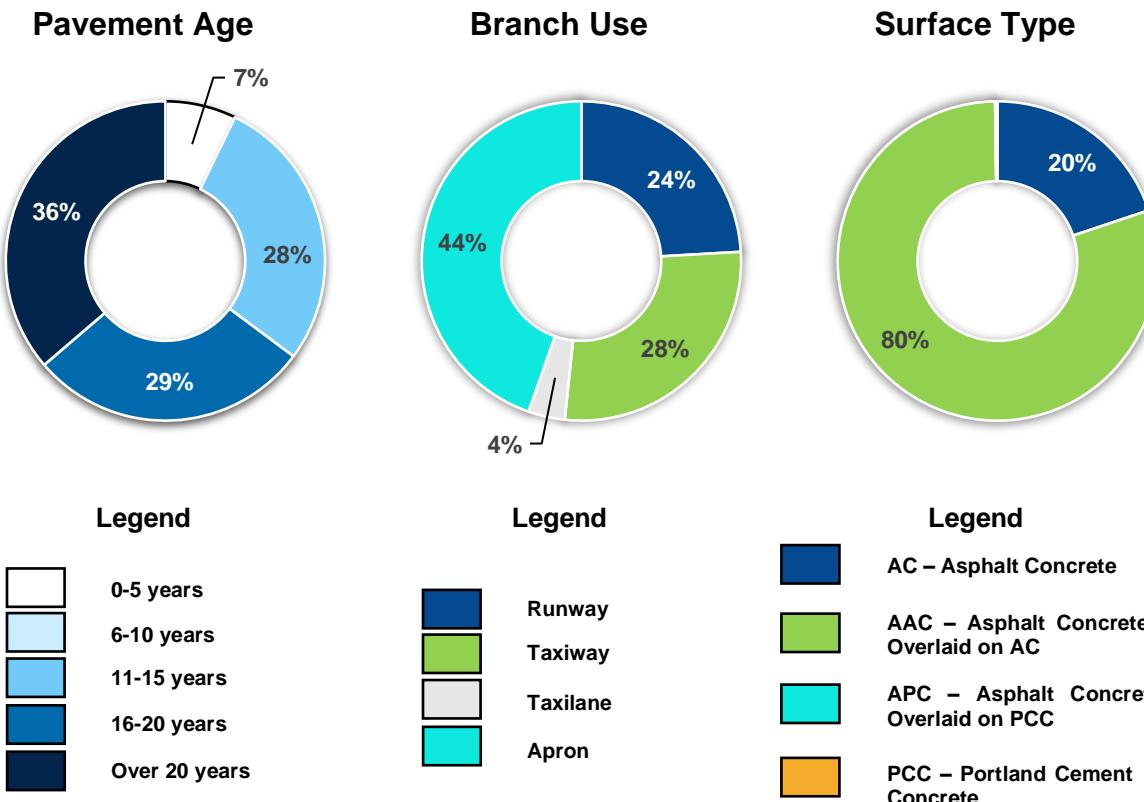
Figure 2 – System Inventory Summary

The following figure summarizes the inventory items at Greenville Downtown Airport (GMU). The **Estimated Age Exhibit** provides the last major work date for each pavement section based on the collected documentation.

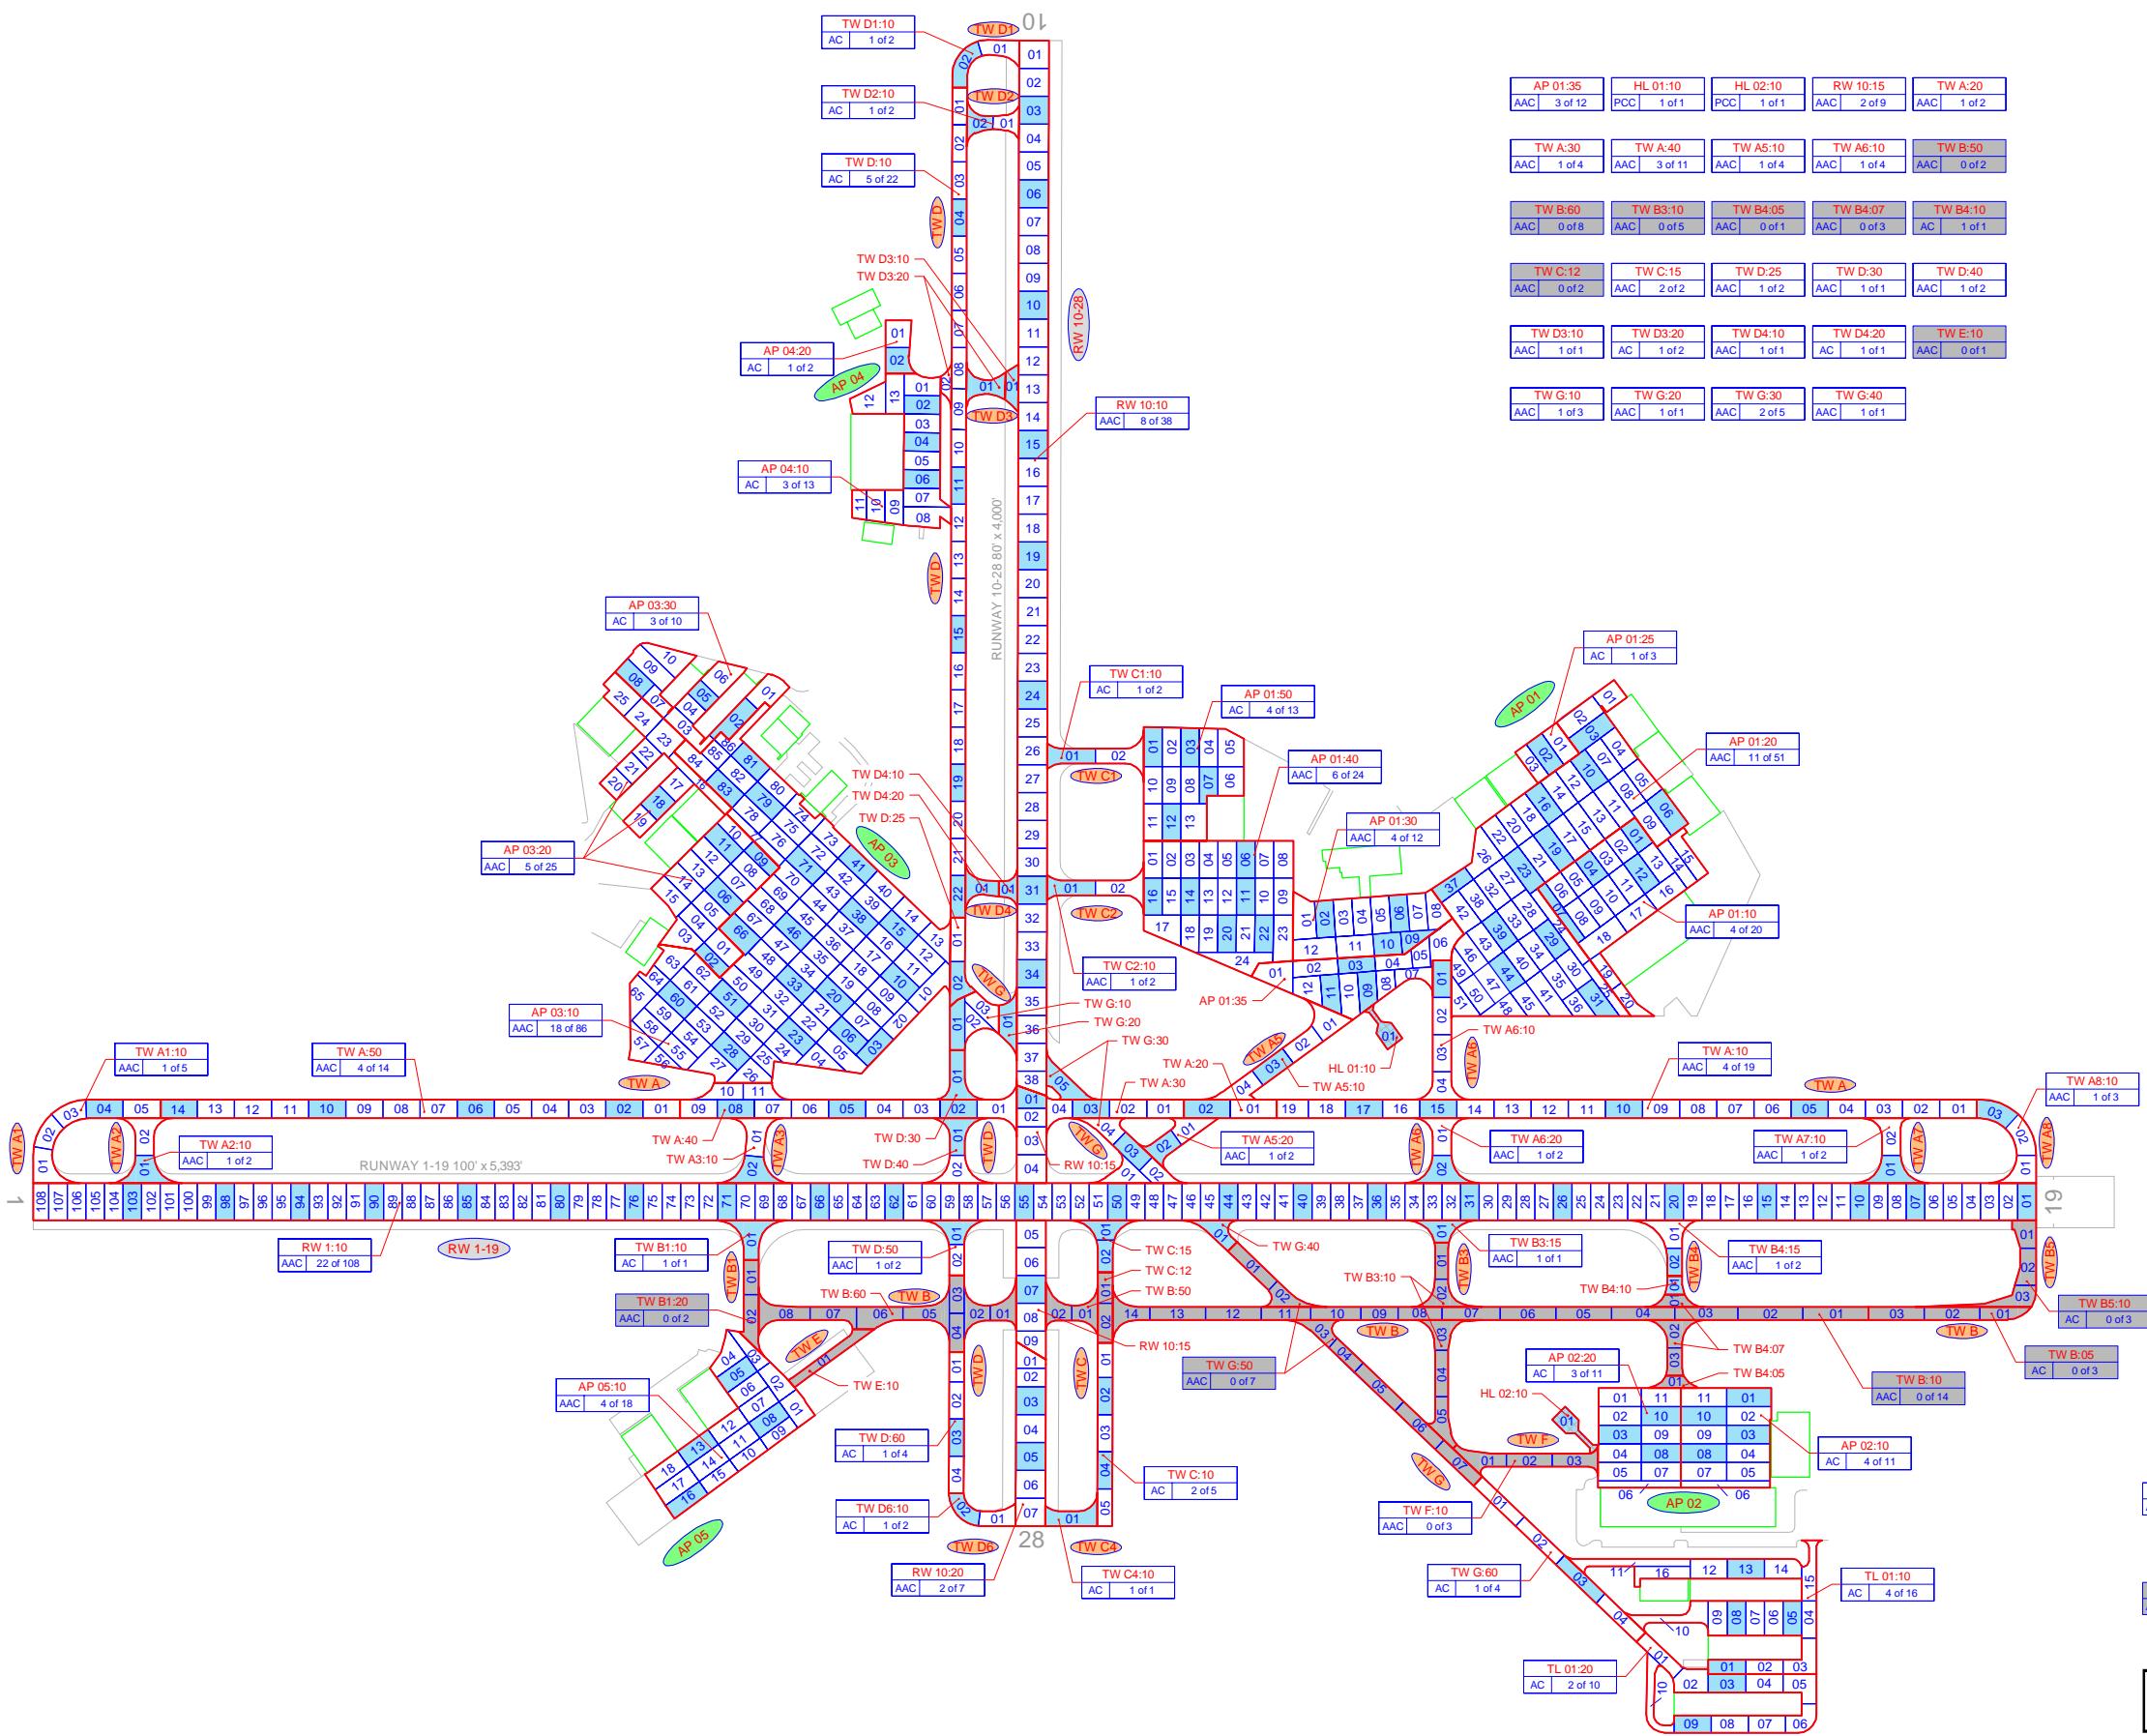
AIRFIELD PAVEMENT NETWORK DEFINITION EXHIBIT

TOTAL SAMPLES INSPECTED = 172
AC: 170 PCC: 2

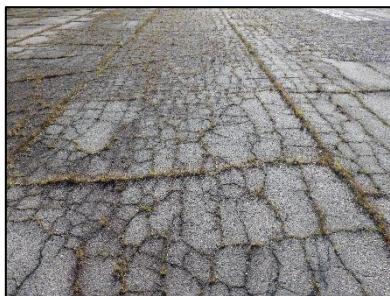
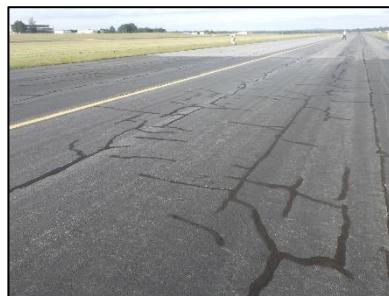
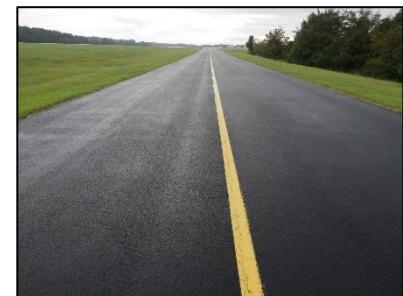
Figure 3 – Representation of Pavement Condition Index Values

Visual condition data collected during the PCI survey is analyzed and used to calculate the current PCI for each inspected sample unit and section. The PCI is a value ranging from 0 to 100, which indicates the apparent structural integrity and surface operational condition of the pavement, with **“100” indicating a pavement in new condition and “0” indicating a failed pavement section**. Pavement Condition Ratings are associated with PCI categories that range from Failed to Good. Representative photos of varying Pavement Condition Ratings are displayed in **Figure 3**.

Poor/Failed Pavement

Pavements that are Poor to Failed require significant and costly interventions such as reconstruction to restore the pavement to operational service.

Fair Pavement

Pavements with a Fair condition rating typically require rehabilitation, or maintenance activities if rehabilitation cannot be immediately performed.

Good/New Pavement

Pavements classified as Good require either no treatment or would benefit from the application of preventive maintenance activities such as crack sealing. .

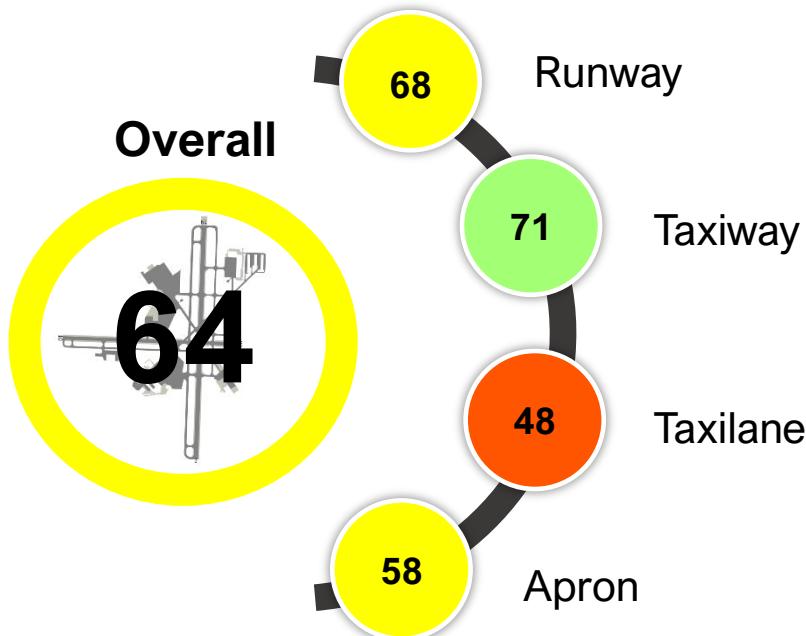
Figure 5 – Area Weighted Average Pavement Condition

The PCI survey for Greenville Downtown Airport (GMU) was performed in October 2021. **The overall area-weighted average PCI value of the network was 64**, representing a condition rating of **Fair**. Approximately 16% of inspected pavements are in Good or Satisfactory condition, 59% of inspected pavements are in Fair condition, and the remaining 25% are in Poor or worse condition as summarized in **Figure 4**.

The area-weighted average PCIs by branch use are summarized in the figure below. The current PCIs at a section-level are displayed graphically on the **2021 Airfield Pavement Condition Index (PCI) Exhibit** and are summarized in **Table 2**.

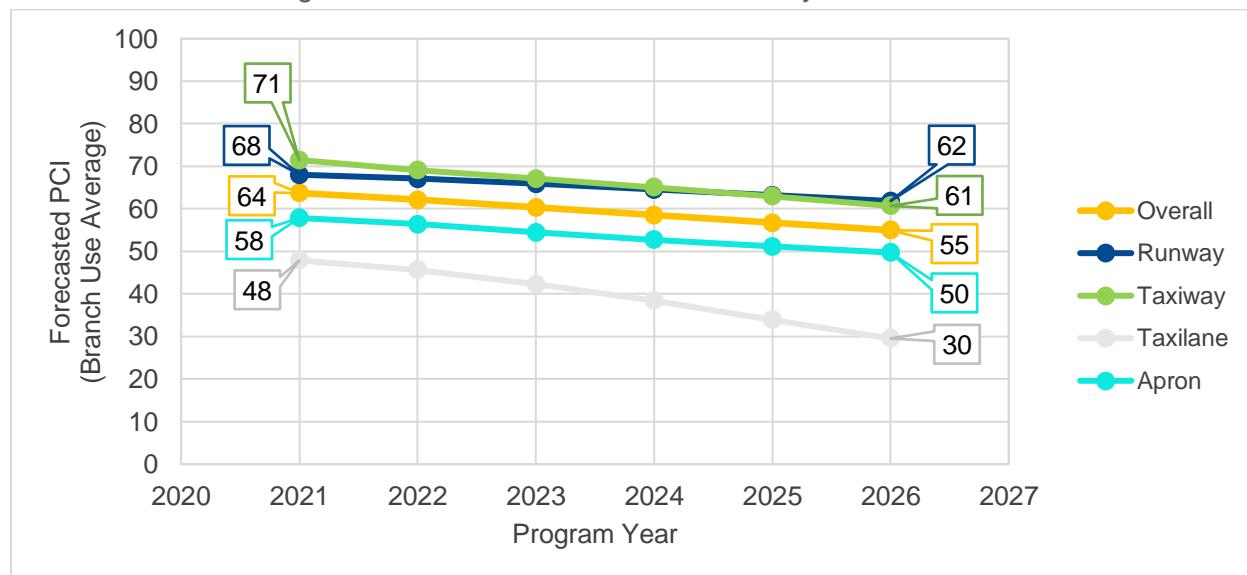
Figure 6 – Forecasted 5-Year PCI by Branch Use

A primary objective of this APMS is to estimate the future condition of each individual pavement section. PAVER™ was utilized to develop prediction curves and determine typical deterioration rates that are then used to forecast a future PCI value. This value will assist decision makers in determining at what point in time certain pavement sections will require rehabilitation. The figure below shows the current and 5-year area-weighted forecasted pavement condition distribution of each functional use (Runway, Taxiway, Taxilane, Apron) found at the Airport. The forecasted 5-year PCIs at a section-level are displayed graphically on the **2026 Forecasted Airfield Pavement Condition Index Exhibit** and are summarized in **Table 3**. All forecasts presented assume that no maintenance or rehabilitation is performed within the 5-year analysis period. **Figure 6** displays the forecasted pavement conditions at the branch-level for GMU.

All condition forecasts are based on historical observations and analysis of South Carolina airfield pavements. The forecasts are not a guarantee of future PCI:- rather, they are a planning tool to aid in the timing of maintenance and rehabilitation activities.

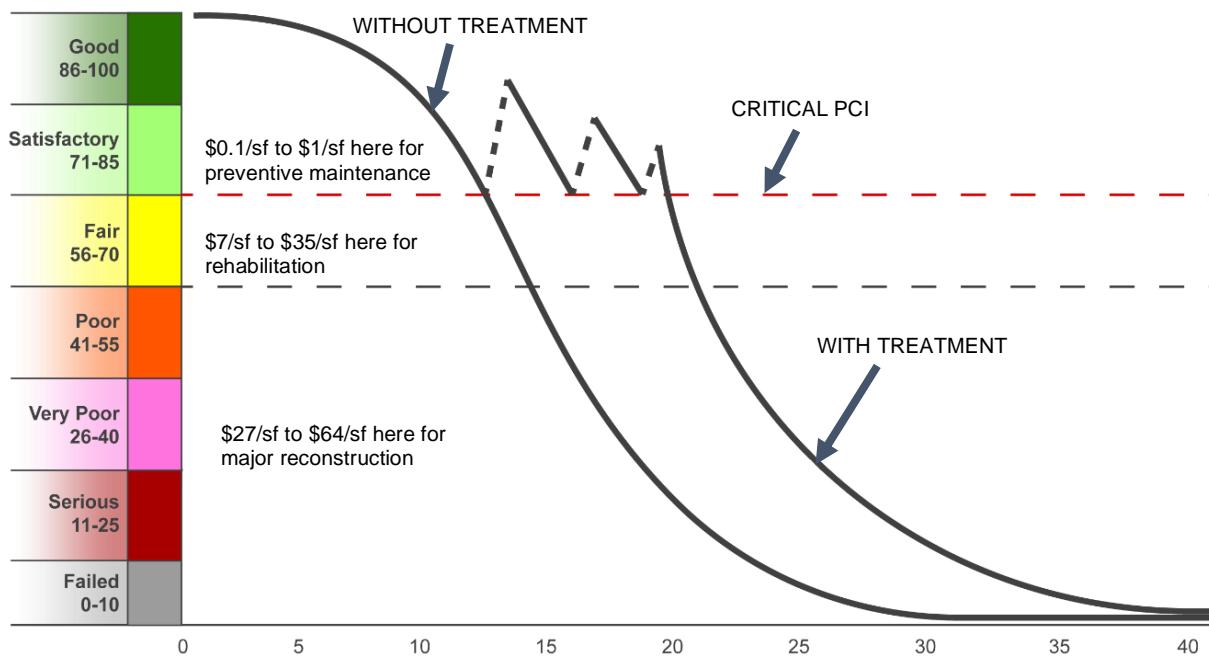
Figure 7 – Pavement Life and the Effect of Treatments

M&R planning considers various methods of repair to address the cause of the problem rather than just treating the symptom. As pavements deteriorate, repair costs can increase significantly. Once pavements have deteriorated below a certain condition threshold (the Critical PCI value), the pavement benefits more from substantial rehabilitation in lieu of maintenance activities. The figure below illustrates how the cost of pavement repairs can exponentially increase if M&R activities are delayed.

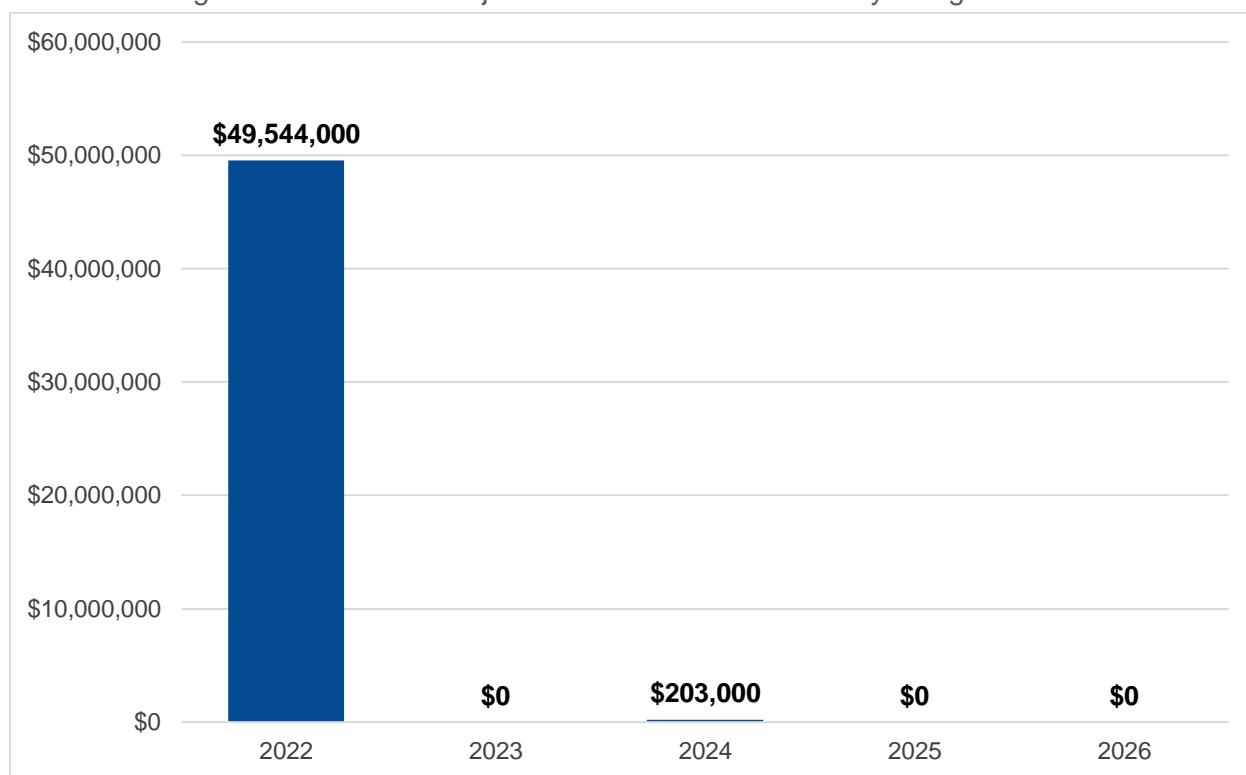
Figure 8 – 5-Year Major Rehabilitation Needs by Program Year

Major rehabilitation needs are identified by analyzing the Airport's pavement condition in relationship to Critical PCI values, density of load-related distresses, and major rehabilitation policies, assuming there are no budget constraints. The needs analysis is performed over a 5-year analysis period. Major rehabilitation resets the PCI value to 100 and is divided into two policy categories:

- **AC:** Milling of the upper surface course and replacing with new AC with isolated areas of full-depth reconstruction
- **PCC:** Combination of crack sealing, joint seal replacement, limited patching, and slab replacement

→ **Full-Depth Reconstruction (PCI 0 to 55) –** Removal and replacement of the existing pavement section down to the subgrade

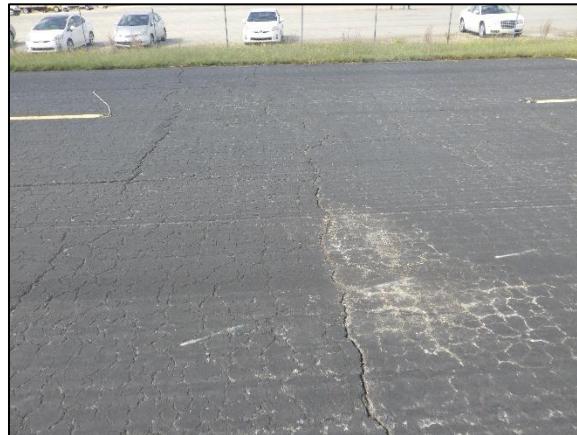
AP 01-50

| Section ID | Area (SF) | Surface | Est. Last Major Work Year | Est. Last Global Treatment Year | PCI | Condition Rating | PCI % Climate | PCI % Load | PCI % Other |
|---|---|---|---|---|---|---|---|---|---|
| 50 | 69,200 | AC | 1970 | 2009 | 37 | Very Poor | 81 | 19 | 0 |

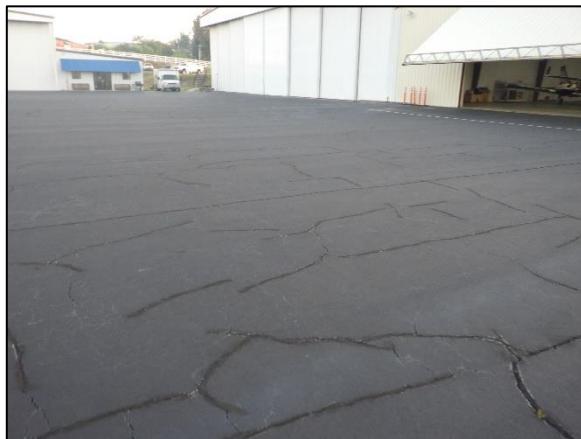
AP 02-10

| Section ID | Area (SF) | Surface | Est. Last Major Work Year | Est. Last Global Treatment Year | PCI | Condition Rating | PCI % Climate | PCI % Load | PCI % Other |
|---|---|---|---|---|---|---|---|---|---|
| 10 | 64,248 | AC | 1992 | 2008 | 40 | Very Poor | 100 | 0 | 0 |

| Network ID | Branch ID | Section ID | Description | Severity | Distress Qty | Distress Unit | Distress Density | Policy Type | Localized Work Type | Work Qty | Work Unit | Unit Cost | Work Cost |
|---|---|---|---|---|---|---|---|---|---|---|---|---|---|
| GMU | AP 02 | 10 | BLOCK CR | Medium | 17,112 | SF | 26.6% | Stopgap | AC Crack Sealing Narrow | 5,216 | LF | \$ 4.00 | \$ 20,870 |

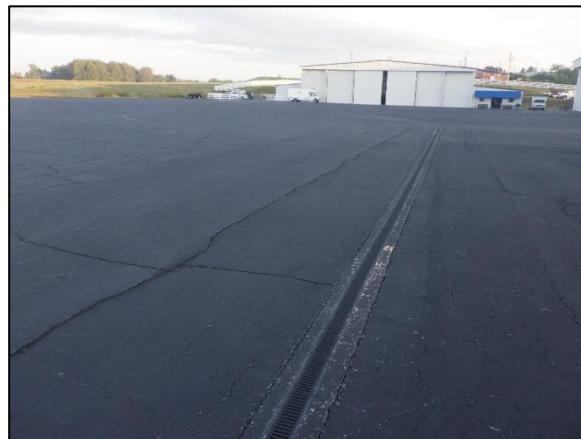
AP 02-20

| Section ID | Area (SF) | Surface | Est. Last Major Work Year | Est. Last Global Treatment Year | PCI | Condition Rating | PCI % Climate | PCI % Load | PCI % Other |
|---|---|---|---|---|---|---|---|---|---|
| 20 | 59,501 | AC | 1989 | 2008 | 53 | Poor | 100 | 0 | 0 |

| Network ID | Branch ID | Section ID | Description | Severity | Distress Qty | Distress Unit | Distress Density | Policy Type | Localized Work Type | Work Qty | Work Unit | Unit Cost | Work Cost |
|---|---|---|---|---|---|---|---|---|---|---|---|---|---|
| GMU | AP 02 | 20 | L & T CR | Medium | 2,094 | LF | 3.5% | Stopgap | AC Crack Sealing Narrow | 2,094 | LF | \$ 4.00 | \$ 8,380 |

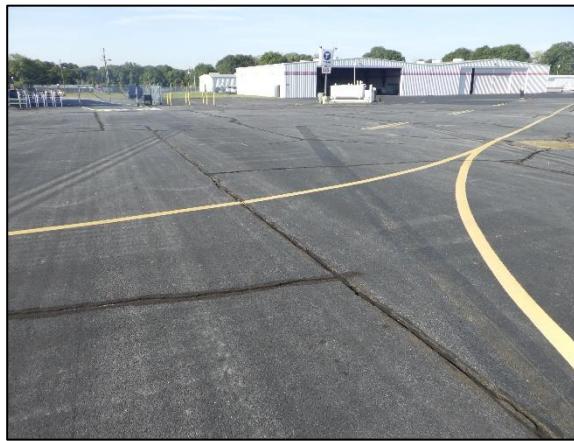
AP 03-20

| Section ID | Area (SF) | Surface | Est. Last Major Work Year | Est. Last Global Treatment Year | PCI | Condition Rating | PCI % Climate | PCI % Load | PCI % Other |
|---|---|---|---|---|---|---|---|---|---|
| 20 | 120,734 | AAC | 1999 | 2009 | 62 | Fair | 98 | 0 | 2 |

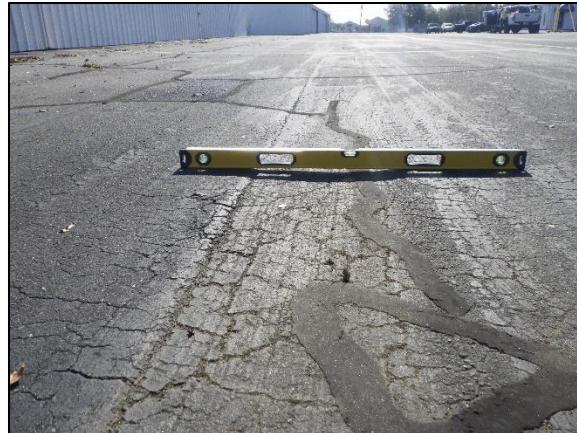
AP 03-30

| Section ID | Area (SF) | Surface | Est. Last Major Work Year | Est. Last Global Treatment Year | PCI | Condition Rating | PCI % Climate | PCI % Load | PCI % Other |
|---|---|---|---|---|---|---|---|---|---|
| 30 | 52,215 | AC | 1965 | 2009 | 35 | Very Poor | 73 | 25 | 2 |

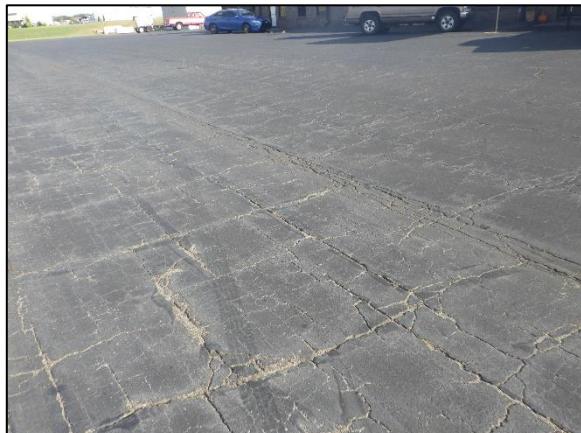
AP 04-10

| Section ID | Area (SF) | Surface | Est. Last Major Work Year | Est. Last Global Treatment Year | PCI | Condition Rating | PCI % Climate | PCI % Load | PCI % Other |
|---|---|---|---|---|---|---|---|---|---|
| 10 | 64,419 | AC | 1977 | 2008 | 29 | Very Poor | 68 | 32 | 0 |

| Network ID | Branch ID | Section ID | Description | Severity | Distress Qty | Distress Unit | Distress Density | Policy Type | Localized Work Type | Work Qty | Work Unit | Unit Cost | Work Cost |
|---|---|---|---|---|---|---|---|---|---|---|---|---|---|
| GMU | AP 04 | 10 | BLOCK CR | Medium | 63,104 | SF | 98.0% | Stopgap | AC Crack Sealing Narrow | 19,234 | LF | \$ 4.00 | \$ 76,940 |

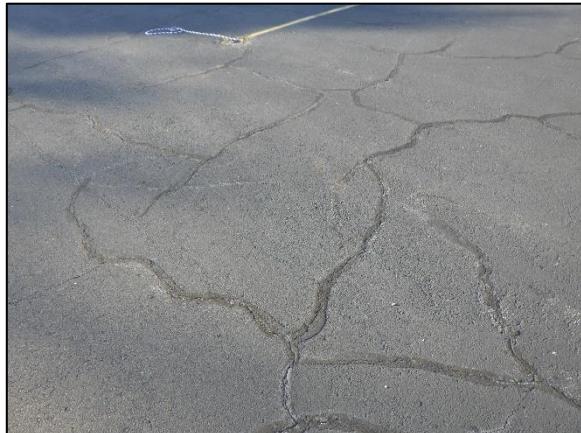
AP 05-10

| Section ID | Area (SF) | Surface | Est. Last Major Work Year | Est. Last Global Treatment Year | PCI | Condition Rating | PCI % Climate | PCI % Load | PCI % Other |
|---|---|---|---|---|---|---|---|---|---|
| 10 | 86,975 | AAC | 1997 | 2008 | 55 | Poor | 75 | 25 | 0 |

| Network ID | Branch ID | Section ID | Description | Severity | Distress Qty | Distress Unit | Distress Density | Policy Type | Localized Work Type | Work Qty | Work Unit | Unit Cost | Work Cost |
|---|---|---|---|---|---|---|---|---|---|---|---|---|---|
| GMU | AP 05 | 10 | L & T CR | Medium | 1,120 | LF | 1.3% | Stopgap | AC Crack Sealing Narrow | 1,120 | LF | \$ 4.00 | \$ 4,480 |

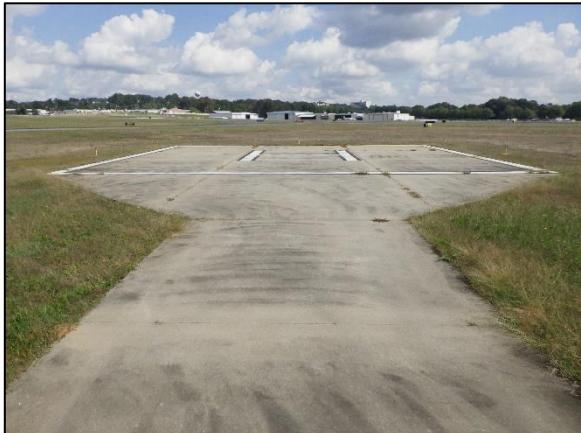
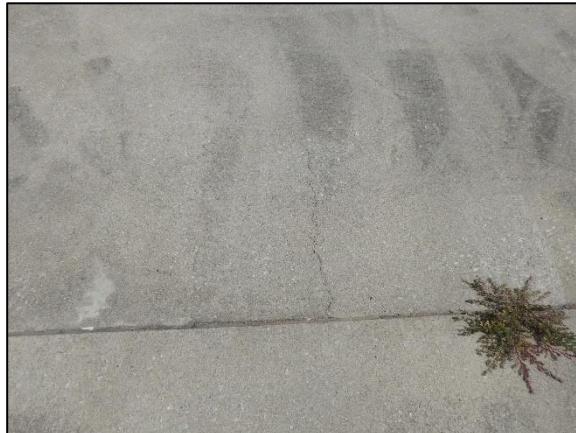
HL 01-10

| Section ID | Area (SF) | Surface | Est. Last Major Work Year | Est. Last Global Treatment Year | PCI | Condition Rating | PCI % Climate | PCI % Load | PCI % Other |
|---|---|---|---|---|---|---|---|---|---|
| 10 | 3,867 | PCC | 1990 | - | 86 | Good | 43 | 0 | 57 |

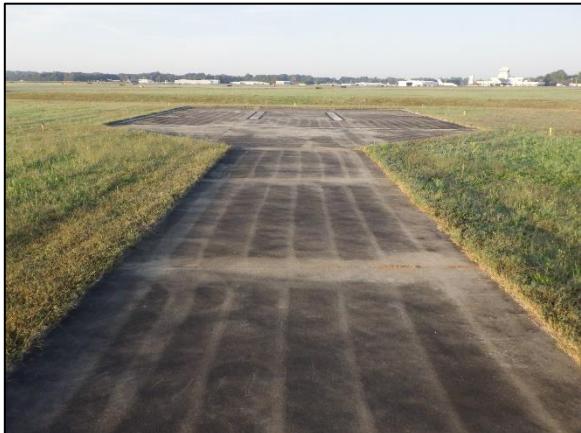
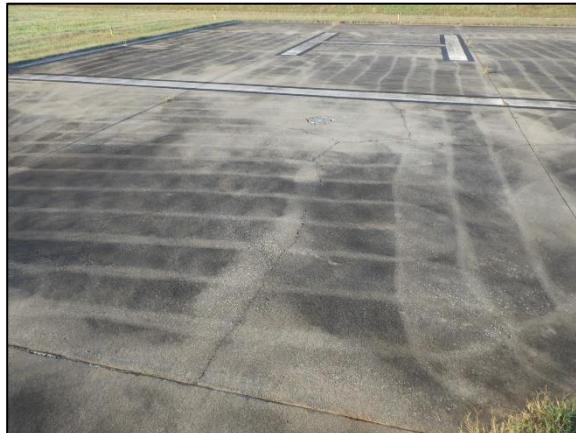
HL 02-10

| Section ID | Area (SF) | Surface | Est. Last Major Work Year | Est. Last Global Treatment Year | PCI | Condition Rating | PCI % Climate | PCI % Load | PCI % Other |
|---|---|---|---|---|---|---|---|---|---|
| 10 | 4,181 | PCC | 1990 | - | 72 | Satisfactory | 20 | 47 | 33 |

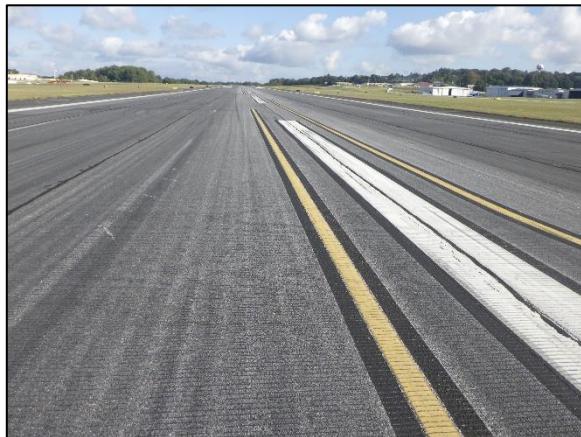
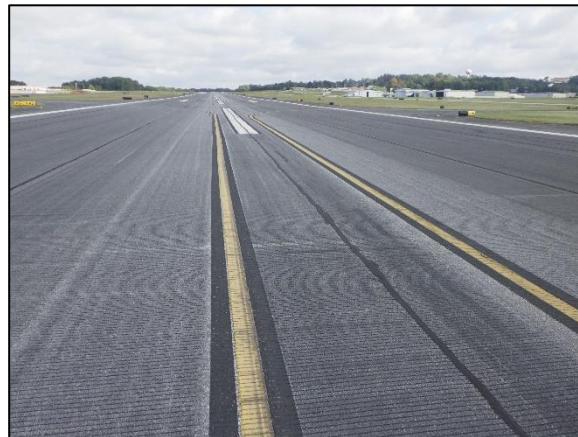
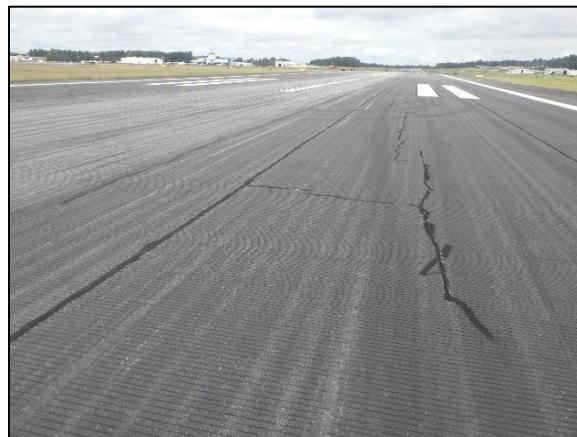
RW 1-10

| Section ID | Area (SF) | Surface | Est. Last Major Work Year | Est. Last Global Treatment Year | PCI | Condition Rating | PCI % Climate | PCI % Load | PCI % Other |
|---|---|---|---|---|---|---|---|---|---|
| 10 | 539,300 | AAC | 2002 | 2009 | 68 | Fair | 97 | 0 | 3 |

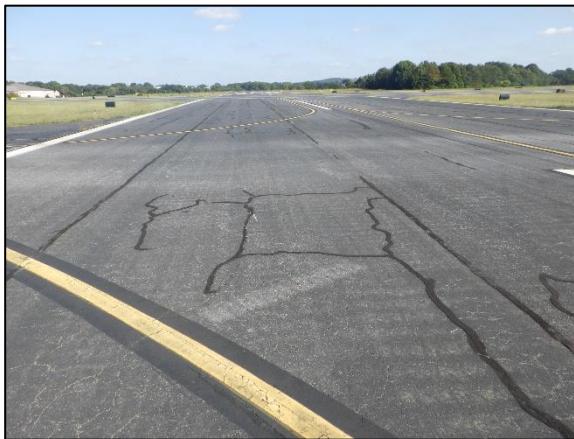
RW 10-15

| Section ID | Area (SF) | Surface | Est. Last Major Work Year | Est. Last Global Treatment Year | PCI | Condition Rating | PCI % Climate | PCI % Load | PCI % Other |
|---|---|---|---|---|---|---|---|---|---|
| 15 | 48,003 | AAC | 2002 | 2009 | 59 | Fair | 100 | 0 | 0 |

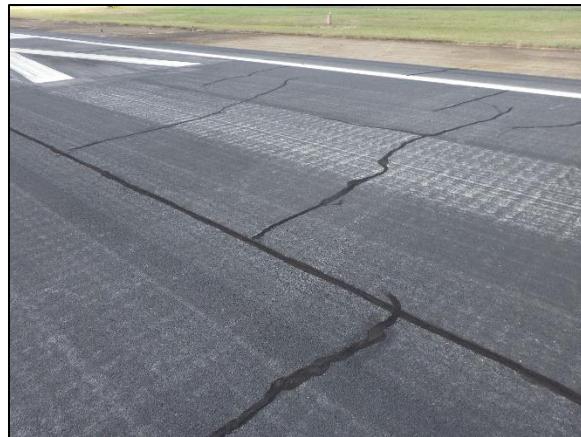
RW 10-20

| Section ID | Area (SF) | Surface | Est. Last Major Work Year | Est. Last Global Treatment Year | PCI | Condition Rating | PCI % Climate | PCI % Load | PCI % Other |
|---|---|---|---|---|---|---|---|---|---|
| 20 | 37,705 | AAC | 1999 | 2009 | 68 | Fair | 100 | 0 | 0 |

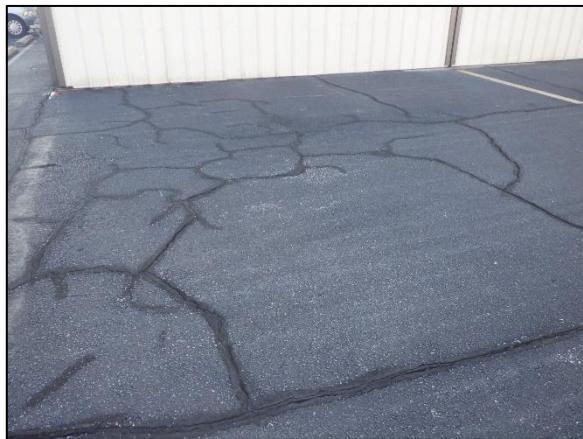
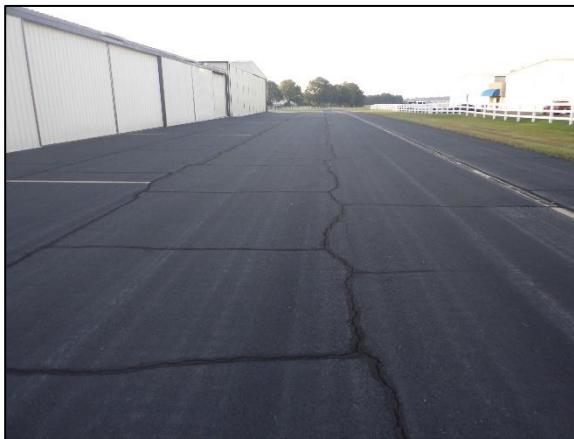
TL 01-10

| Section ID | Area (SF) | Surface | Est. Last Major Work Year | Est. Last Global Treatment Year | PCI | Condition Rating | PCI % Climate | PCI % Load | PCI % Other |
|---|---|---|---|---|---|---|---|---|---|
| 10 | 80,995 | AC | 1989 | 2009 | 54 | Poor | 68 | 30 | 2 |

| Network ID | Branch ID | Section ID | Description | Severity | Distress Qty | Distress Unit | Distress Density | Policy Type | Localized Work Type | Work Qty | Work Unit | Unit Cost | Work Cost |
|---|---|---|---|---|---|---|---|---|---|---|---|---|---|
| GMU | TL 01 | 10 | L & T CR | Medium | 815 | LF | 1.0% | Stopgap | AC Crack Sealing Narrow | 815 | LF | \$ 4.00 | \$ 3,270 |

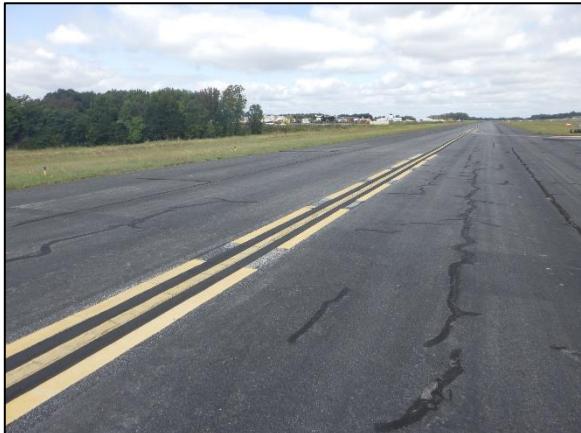
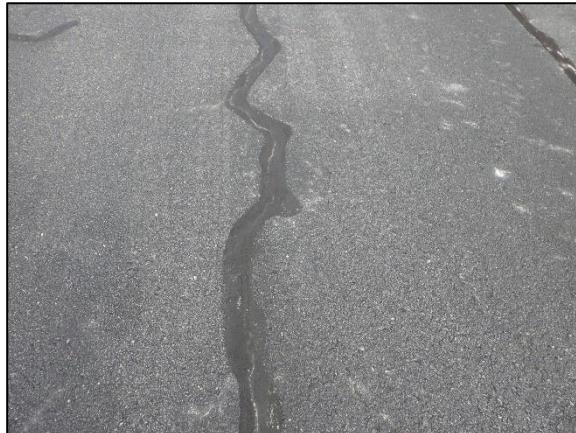
TW A1-10

| Section ID | Area (SF) | Surface | Est. Last Major Work Year | Est. Last Global Treatment Year | PCI | Condition Rating | PCI % Climate | PCI % Load | PCI % Other |
|---|---|---|---|---|---|---|---|---|---|
| 10 | 24,442 | AAC | 2002 | 2009 | 62 | Fair | 100 | 0 | 0 |

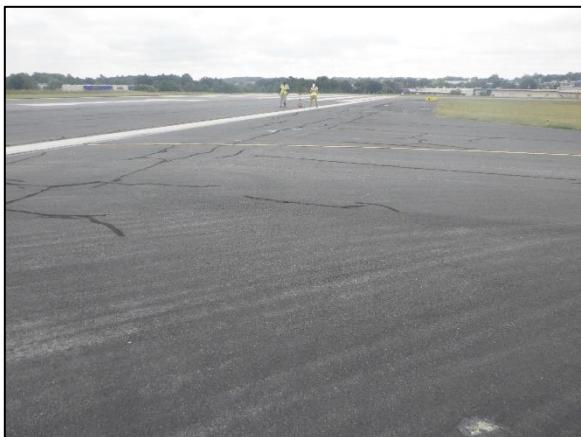
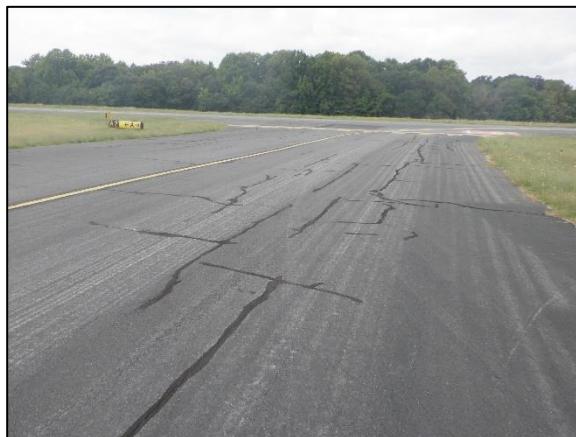
TW A2-10

| Section ID | Area (SF) | Surface | Est. Last Major Work Year | Est. Last Global Treatment Year | PCI | Condition Rating | PCI % Climate | PCI % Load | PCI % Other |
|---|---|---|---|---|---|---|---|---|---|
| 10 | 12,082 | AAC | 2002 | 2009 | 59 | Fair | 100 | 0 | 0 |

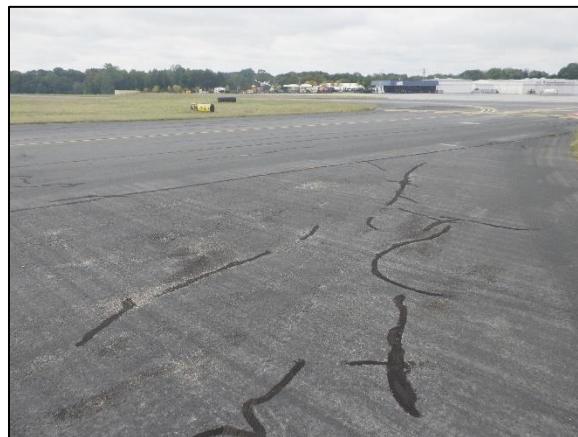
TW A3-10

| Section ID | Area (SF) | Surface | Est. Last Major Work Year | Est. Last Global Treatment Year | PCI | Condition Rating | PCI % Climate | PCI % Load | PCI % Other |
|---|---|---|---|---|---|---|---|---|---|
| 10 | 12,187 | AAC | 2003 | 2009 | 64 | Fair | 100 | 0 | 0 |

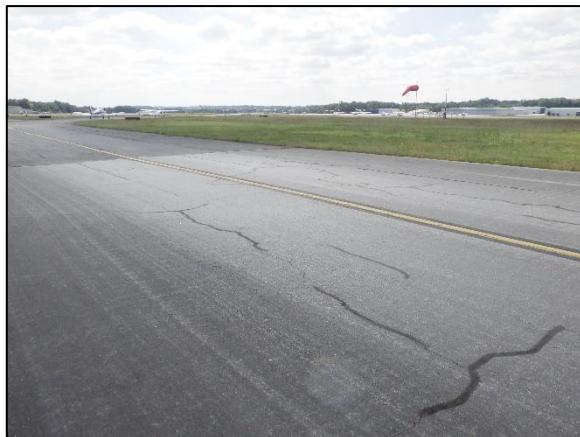
TW A5-10

| Section ID | Area (SF) | Surface | Est. Last Major Work Year | Est. Last Global Treatment Year | PCI | Condition Rating | PCI % Climate | PCI % Load | PCI % Other |
|---|---|---|---|---|---|---|---|---|---|
| 10 | 21,277 | AAC | 2006 | 2009 | 73 | Satisfactory | 100 | 0 | 0 |

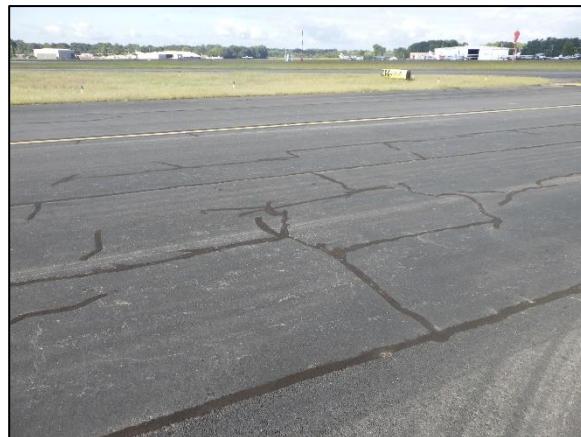
TW A5-20

| Section ID | Area (SF) | Surface | Est. Last Major Work Year | Est. Last Global Treatment Year | PCI | Condition Rating | PCI % Climate | PCI % Load | PCI % Other |
|---|---|---|---|---|---|---|---|---|---|
| 20 | 9,310 | AAC | 2003 | 2009 | 65 | Fair | 100 | 0 | 0 |

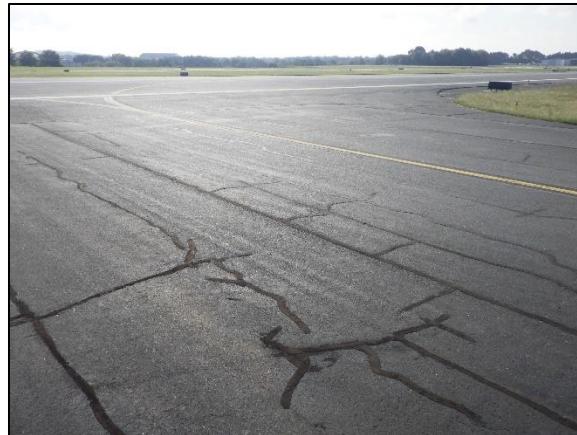
TW A6-20

| Section ID | Area (SF) | Surface | Est. Last Major Work Year | Est. Last Global Treatment Year | PCI | Condition Rating | PCI % Climate | PCI % Load | PCI % Other |
|---|---|---|---|---|---|---|---|---|---|
| 20 | 12,135 | AAC | 2003 | 2009 | 66 | Fair | 100 | 0 | 0 |

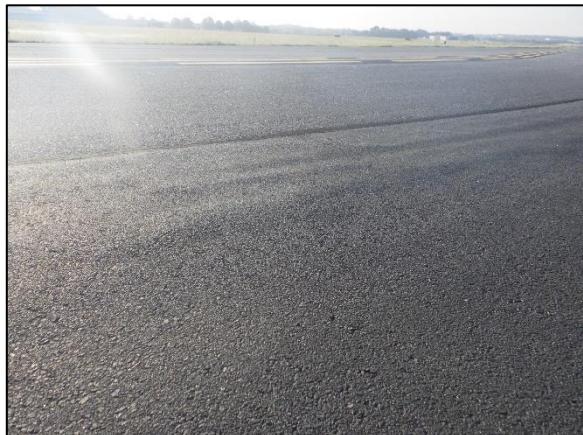
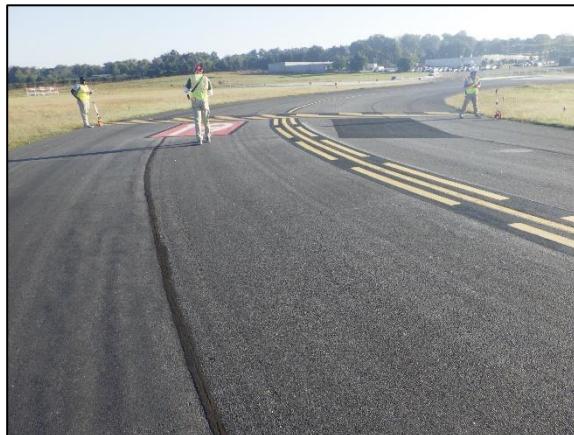
TW A8-10

| Section ID | Area (SF) | Surface | Est. Last Major Work Year | Est. Last Global Treatment Year | PCI | Condition Rating | PCI % Climate | PCI % Load | PCI % Other |
|---|---|---|---|---|---|---|---|---|---|
| 10 | 15,632 | AAC | 2003 | 2009 | 64 | Fair | 76 | 0 | 24 |

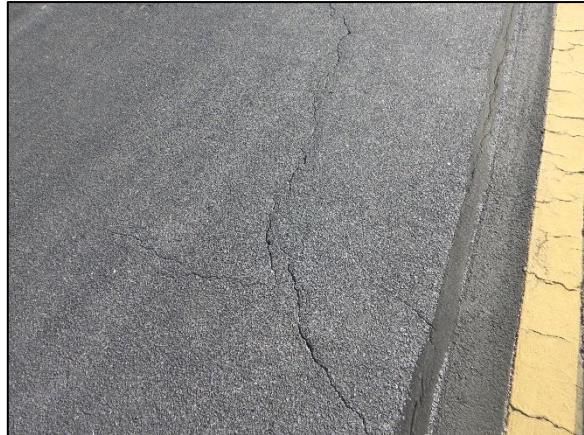
TW B3-10

| Section ID | Area (SF) | Surface | Est. Last Major Work Year | Est. Last Global Treatment Year | PCI | Condition Rating | PCI % Climate | PCI % Load | PCI % Other |
|---|---|---|---|---|---|---|---|---|---|
| 10 | 22,093 | AAC | 2021 | - | 100 | Good | 0 | 0 | 0 |

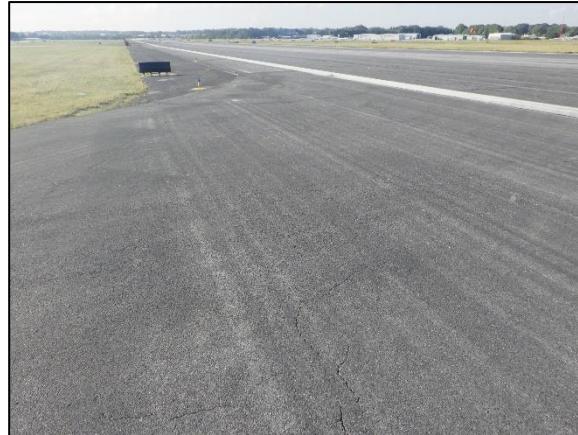
TW B3-15

| Section ID | Area (SF) | Surface | Est. Last Major Work Year | Est. Last Global Treatment Year | PCI | Condition Rating | PCI % Climate | PCI % Load | PCI % Other |
|---|---|---|---|---|---|---|---|---|---|
| 15 | 4,499 | AAC | 2002 | 2009 | 64 | Fair | 100 | 0 | 0 |

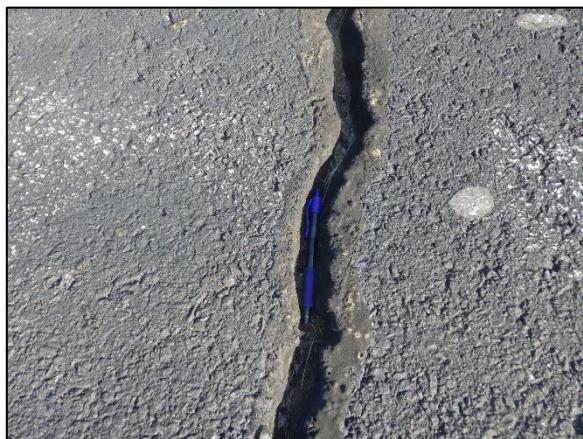
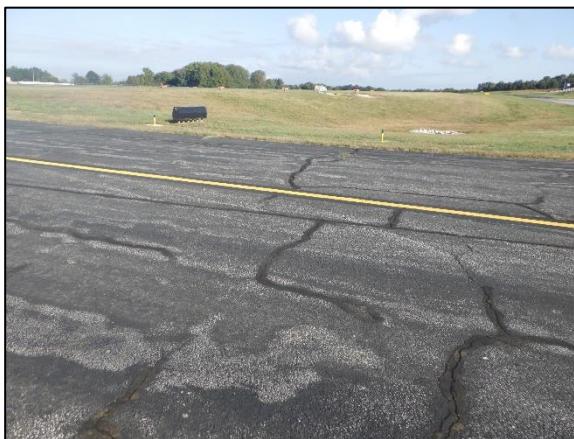
TW B4-10

| Section ID | Area (SF) | Surface | Est. Last Major Work Year | Est. Last Global Treatment Year | PCI | Condition Rating | PCI % Climate | PCI % Load | PCI % Other |
|---|---|---|---|---|---|---|---|---|---|
| 10 | 2,113 | AC | 1992 | 2009 | 47 | Poor | 100 | 0 | 0 |

| Network ID | Branch ID | Section ID | Description | Severity | Distress Qty | Distress Unit | Distress Density | Policy Type | Localized Work Type | Work Qty | Work Unit | Unit Cost | Work Cost |
|---|---|---|---|---|---|---|---|---|---|---|---|---|---|
| GMU | TW B4 | 10 | L & T CR | Medium | 77 | LF | 3.6% | Stopgap | AC Crack Sealing Narrow | 77 | LF | \$ 4.00 | \$ 310 |

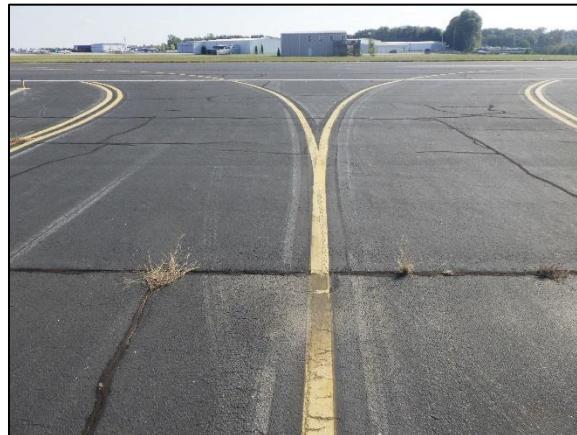
TW C1-10

| Section ID | Area (SF) | Surface | Est. Last Major Work Year | Est. Last Global Treatment Year | PCI | Condition Rating | PCI % Climate | PCI % Load | PCI % Other |
|---|---|---|---|---|---|---|---|---|---|
| 10 | 11,836 | AC | 1970 | 2009 | 63 | Fair | 100 | 0 | 0 |

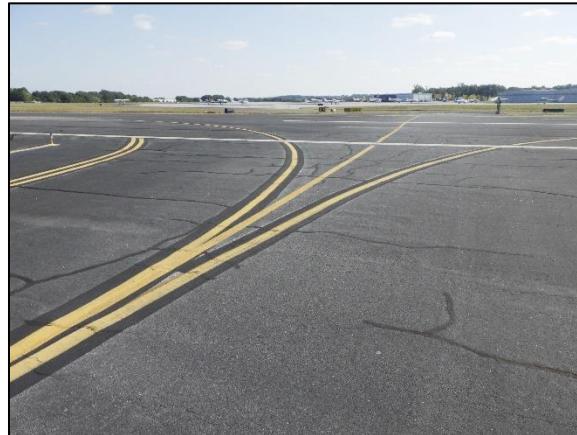
TW C2-10

| Section ID | Area (SF) | Surface | Est. Last Major Work Year | Est. Last Global Treatment Year | PCI | Condition Rating | PCI % Climate | PCI % Load | PCI % Other |
|---|---|---|---|---|---|---|---|---|---|
| 10 | 11,805 | AAC | 1975 | 2009 | 65 | Fair | 96 | 0 | 4 |

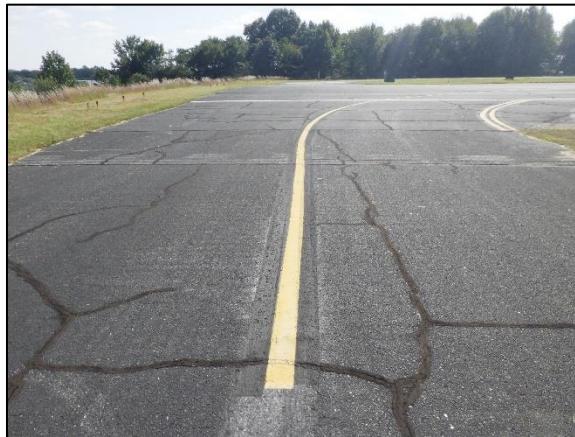
TW C4-10

| Section ID | Area (SF) | Surface | Est. Last Major Work Year | Est. Last Global Treatment Year | PCI | Condition Rating | PCI % Climate | PCI % Load | PCI % Other |
|---|---|---|---|---|---|---|---|---|---|
| 10 | 6,318 | AC | 1977 | 2009 | 64 | Fair | 100 | 0 | 0 |

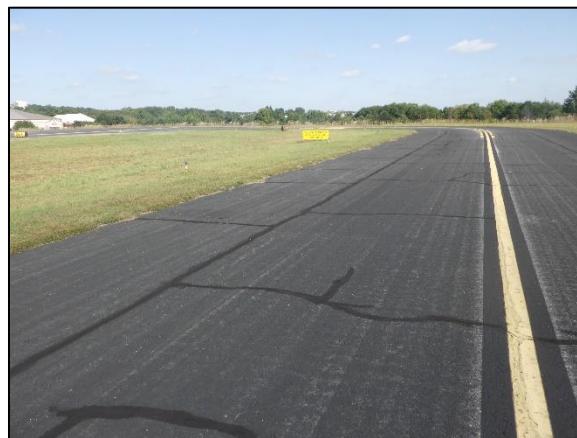
TW D-60

| Section ID | Area (SF) | Surface | Est. Last Major Work Year | Est. Last Global Treatment Year | PCI | Condition Rating | PCI % Climate | PCI % Load | PCI % Other |
|---|---|---|---|---|---|---|---|---|---|
| 60 | 15,216 | AC | 1977 | 2009 | 54 | Poor | 100 | 0 | 0 |

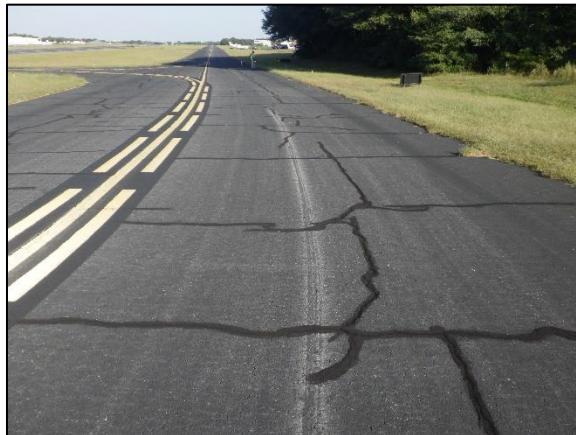
TW D1-10

| Section ID | Area (SF) | Surface | Est. Last Major Work Year | Est. Last Global Treatment Year | PCI | Condition Rating | PCI % Climate | PCI % Load | PCI % Other |
|---|---|---|---|---|---|---|---|---|---|
| 10 | 10,048 | AC | 1977 | 2009 | 56 | Fair | 100 | 0 | 0 |

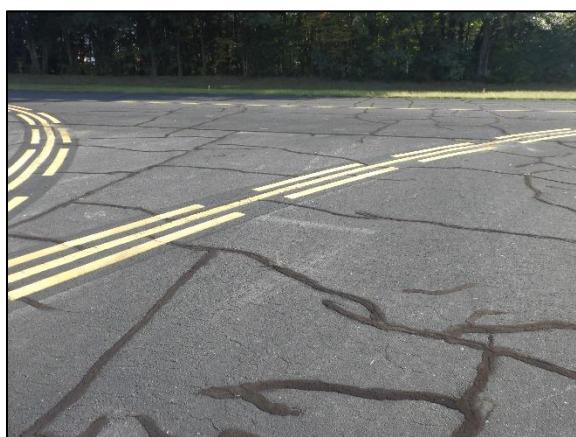
TW D2-10

| Section ID | Area (SF) | Surface | Est. Last Major Work Year | Est. Last Global Treatment Year | PCI | Condition Rating | PCI % Climate | PCI % Load | PCI % Other |
|---|---|---|---|---|---|---|---|---|---|
| 10 | 6,934 | AC | 1977 | 2009 | 54 | Poor | 100 | 0 | 0 |

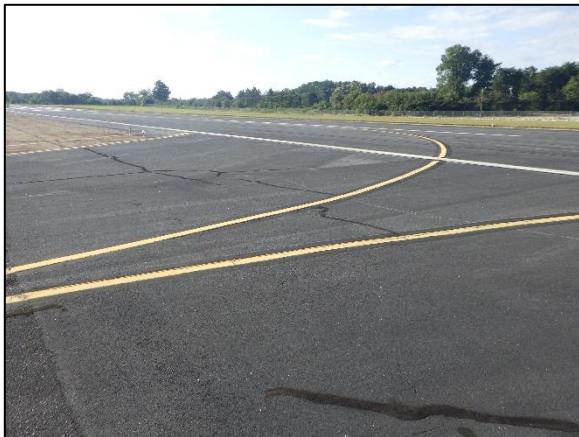
TW D3-10

| Section ID | Area (SF) | Surface | Est. Last Major Work Year | Est. Last Global Treatment Year | PCI | Condition Rating | PCI % Climate | PCI % Load | PCI % Other |
|---|---|---|---|---|---|---|---|---|---|
| 10 | 3,492 | AAC | 1999 | 2009 | 68 | Fair | 100 | 0 | 0 |
