SOUTH CAROLINA AERONAUTICS COMMISSION

STATEWIDE AIRFIELD PAVEMENT MANAGEMENT SYSTEM UPDATE

GMU - Greenville Downtown Airport

2022

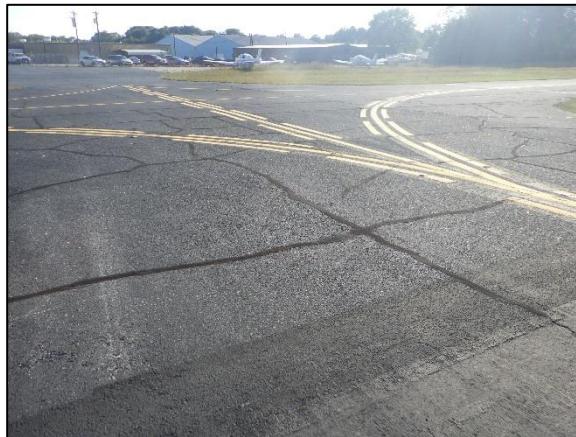
TW D3-20

| Section ID | Area (SF) | Surface | Est. Last Major Work Year | Est. Last Global Treatment Year | PCI | Condition Rating | PCI % Climate | PCI % Load | PCI % Other |
|---|---|---|---|---|---|---|---|---|---|
| 20 | 7,419 | AC | 1977 | 2009 | 58 | Fair | 100 | 0 | 0 |

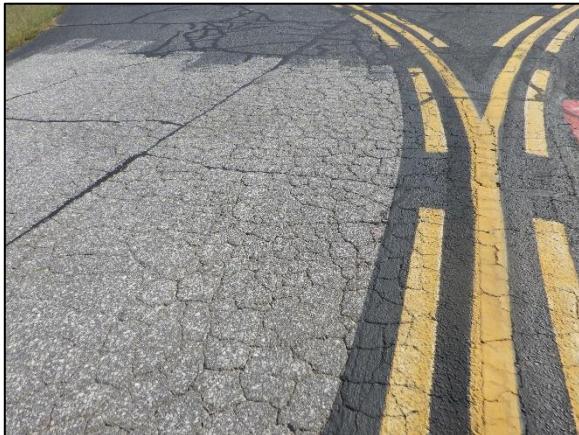
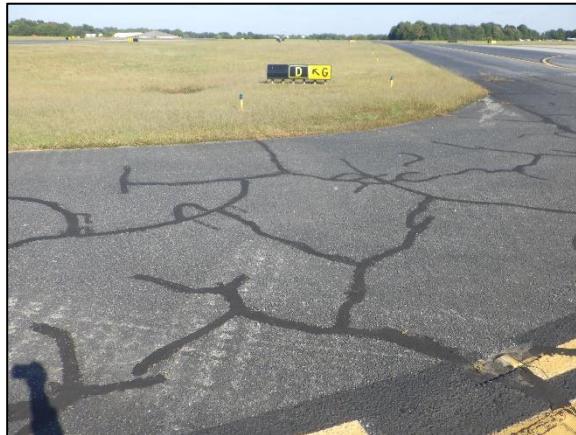
TW D4-20

| Section ID | Area (SF) | Surface | Est. Last Major Work Year | Est. Last Global Treatment Year | PCI | Condition Rating | PCI % Climate | PCI % Load | PCI % Other |
|---|---|---|---|---|---|---|---|---|---|
| 20 | 4,509 | AC | 1977 | 2009 | 12 | Serious | 60 | 38 | 2 |

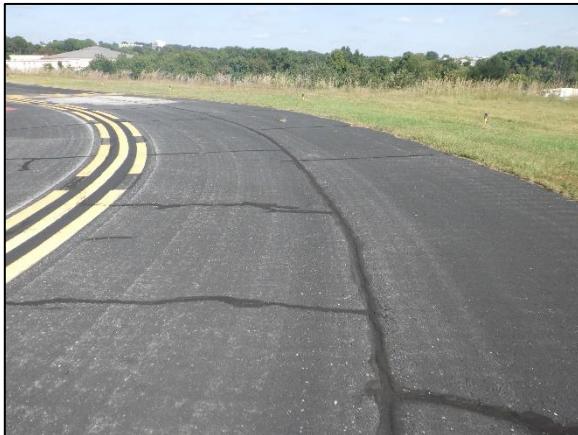
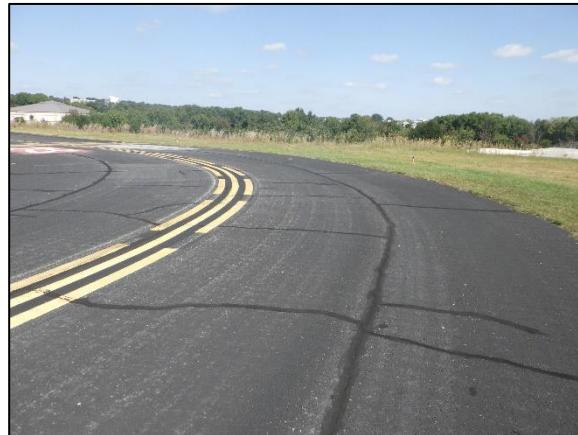
TW D6-10

| Section ID | Area (SF) | Surface | Est. Last Major Work Year | Est. Last Global Treatment Year | PCI | Condition Rating | PCI % Climate | PCI % Load | PCI % Other |
|---|---|---|---|---|---|---|---|---|---|
| 10 | 8,278 | AC | 1977 | 2009 | 54 | Poor | 100 | 0 | 0 |

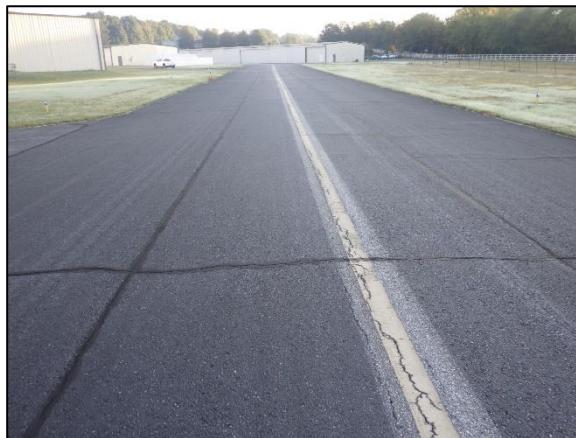
TW G-60

| Section ID | Area (SF) | Surface | Est. Last Major Work Year | Est. Last Global Treatment Year | PCI | Condition Rating | PCI % Climate | PCI % Load | PCI % Other |
|---|---|---|---|---|---|---|---|---|---|
| 60 | 21,259 | AC | 1989 | 2009 | 56 | Fair | 80 | 0 | 20 |
