SOUTH CAROLINA AERONAUTICS COMMISSION

STATEWIDE AIRFIELD PAVEMENT MANAGEMENT SYSTEM UPDATE

GRD - Greenwood County Airport

2022

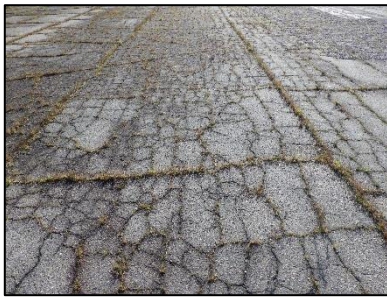
Figure 3 – Representation of Pavement Condition Index Values

Poor/Failed Pavement

Pavements that are Poor to Failed require significant and costly interventions such as reconstruction to restore the pavement to operational service.

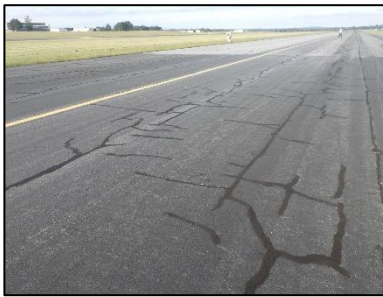
Fair Pavement

Pavements with a Fair condition rating typically require rehabilitation, or maintenance activities if rehabilitation cannot be immediately performed.

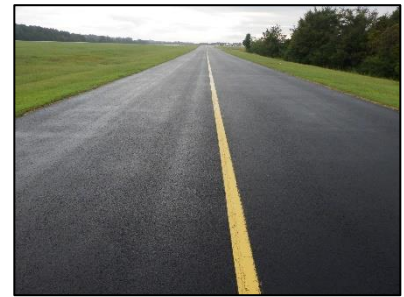
Good/New Pavement

Pavements classified as Good require either no treatment or would benefit from the application of preventive maintenance activities such as crack sealing.

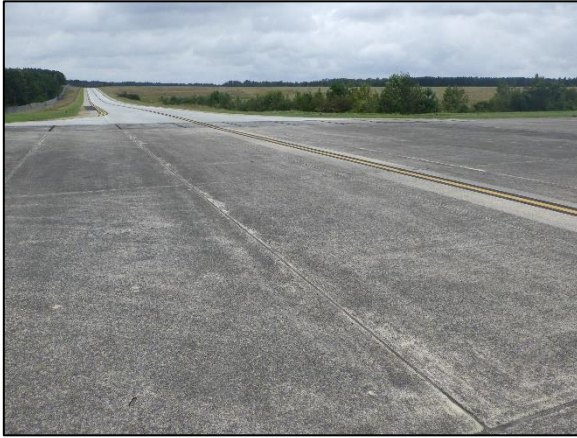
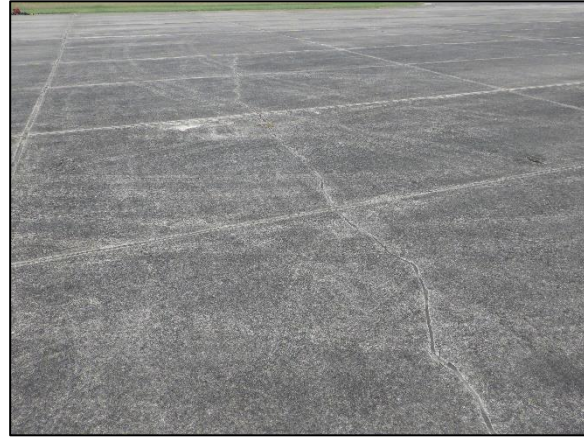
AP 01-10

Section ID	Area (SF)	Surface	Est. Last Major Work Year	Est. Last Global Treatment Year	PCI	Condition Rating	PCI % Climate	PCI % Load	PCI % Other
10	231,749	PCC	1943	-	85	Satisfactory	9	50	41

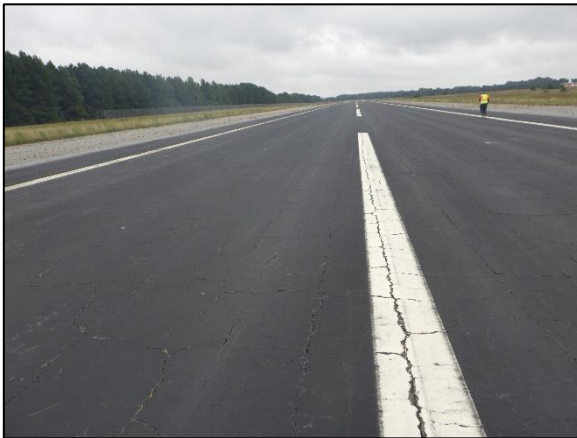
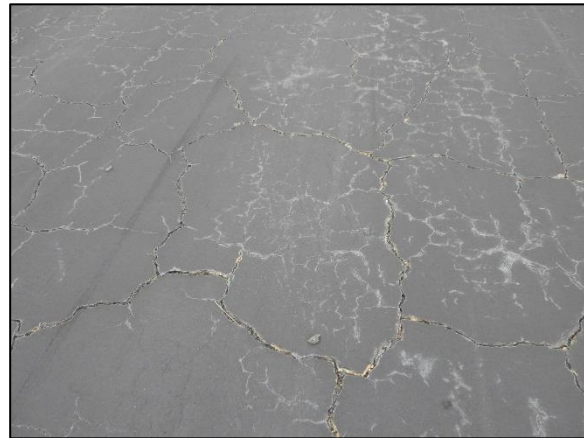
RW 5-10

Section ID	Area (SF)	Surface	Est. Last Major Work Year	Est. Last Global Treatment Year	PCI	Condition Rating	PCI % Climate	PCI % Load	PCI % Other
10	235,664	AC	1951	2011	46	Poor	69	31	0
20	9,758	AAC	2016	-	94	Good	100	0	0

GRD	RW 5	10	BLOCK CR	Medium	74,622	SF	31.7%	Stopgap	AC Crack Sealing Narrow	22,745	LF	\$ 4.00	\$ 90,980
GRD	RW 5	10	RAVELING	Medium	4,142	SF	1.8%	Stopgap	Surface Seal	4,142	SF	\$ 0.90	\$ 3,730
GRD	RW 5	10	RUTTING	Medium	133	SF	0.1%	Stopgap	AC Full-Depth Patching	134	SF	\$ 21.75	\$ 2,900
GRD	TL 01	40	BLOCK CR	Medium	6,536	SF	12.9%	Stopgap	AC Crack Sealing Narrow	1,992	LF	\$ 4.00	\$ 7,970
GRD	TL 01	40	L & T CR	Medium	287	LF	0.6%	Stopgap	AC Crack Sealing Narrow	287	LF	\$ 4.00	\$ 1,150
GRD	TL 01	40	RAVELING	High	19	SF	0.0%	Stopgap	AC Partial-Depth Patching	19	SF	\$ 10.00	\$ 200
GRD	TW D	20	L & T CR	Medium	953	LF	0.7%	Stopgap	AC Crack Sealing Narrow	953	LF	\$ 4.00	\$ 3,820
GRD	TW D	20	RAVELING	Medium	8,598	SF	6.3%	Stopgap	Surface Seal	8,598	SF	\$ 0.90	\$ 7,740
GRD	TW D	30	BLOCK CR	Medium	100,820	SF	93.3%	Stopgap	AC Crack Sealing Narrow	30,730	LF	\$ 4.00	\$ 122,920

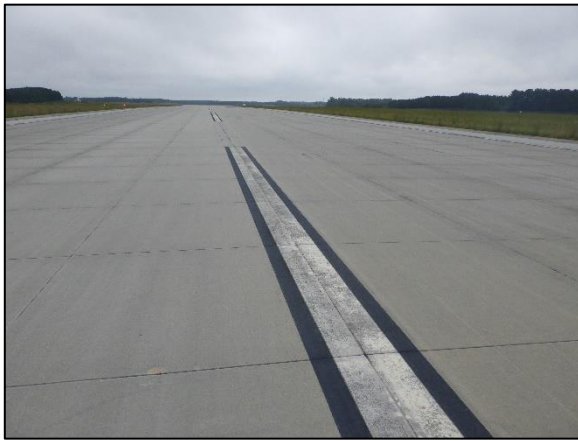
RW 9-10

Section ID	Area (SF)	Surface	Est. Last Major Work Year	Est. Last Global Treatment Year	PCI	Condition Rating	PCI % Climate	PCI % Load	PCI % Other
10	249,900	PCC	2016	-	99	Good	65	0	35
20	125,050	PCC	2016	-	100	Good	89	0	11
30	125,050	PCC	2016	-	100	Good	89	0	11

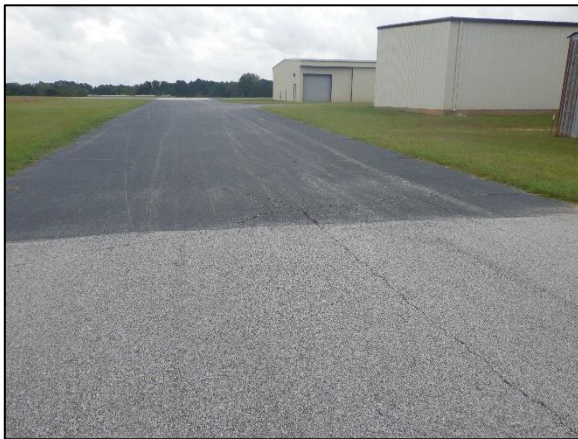
TL 01-10

Section ID	Area (SF)	Surface	Est. Last Major Work Year	Est. Last Global Treatment Year	PCI	Condition Rating	PCI % Climate	PCI % Load	PCI % Other
10	13,288	AC	1999	2011	55	Poor	98	0	2
20	24,525	AAC	2006	2011	67	Fair	96	0	4
30	10,486	AAC	2006	-	67	Fair	88	0	12
40	50,695	AAC	2006	2011	42	Poor	100	0	0

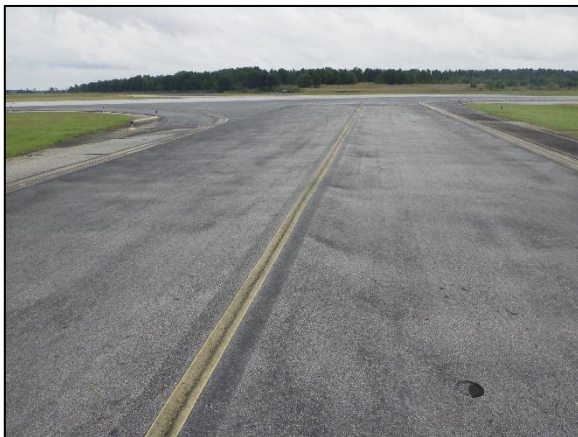
TW C-10

Section ID	Area (SF)	Surface	Est. Last Major Work Year	Est. Last Global Treatment Year	PCI	Condition Rating	PCI % Climate	PCI % Load	PCI % Other
10	14,593	AAC	2016	-	87	Good	99	0	1
20	15,021	AAC	2016	-	83	Satisfactory	100	0	0

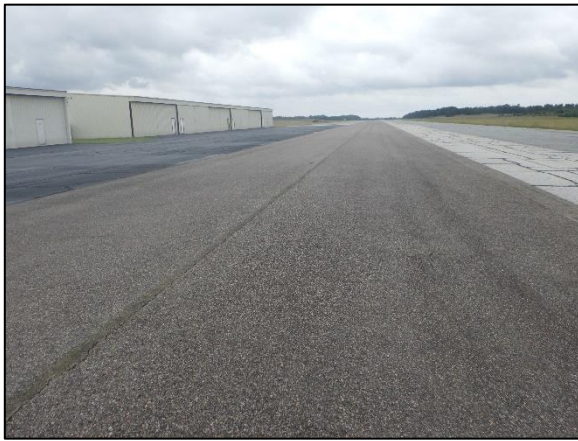
TW D-20

Section ID	Area (SF)	Surface	Est. Last Major Work Year	Est. Last Global Treatment Year	PCI	Condition Rating	PCI % Climate	PCI % Load	PCI % Other
10	7,350	AAC	2016	-	89	Good	100	0	0
20	137,593	AAC	2006	-	63	Fair	100	0	0
30	108,021	AAC	1978	2014	43	Poor	100	0	0
