SOUTH CAROLINA AERONAUTICS COMMISSION

# STATEWIDE AIRFIELD PAVEMENT MANAGEMENT SYSTEM UPDATE

HVS - Hartsville Regional Airport

2023

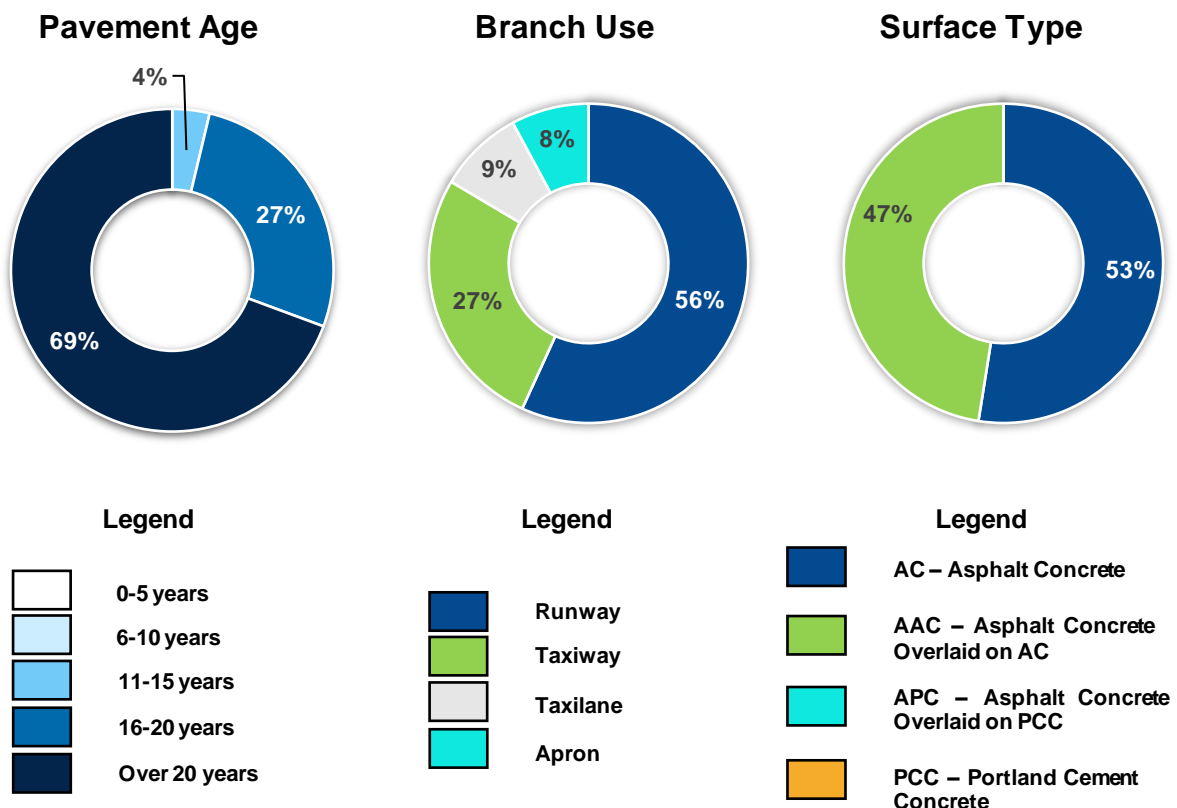
Figure 2 – System Inventory Summary

The following figure summarizes the inventory items at Hartsville Regional Airport (HVS). The **Estimated Age Exhibit** provides the last major work date for each pavement section based on the collected documentation.

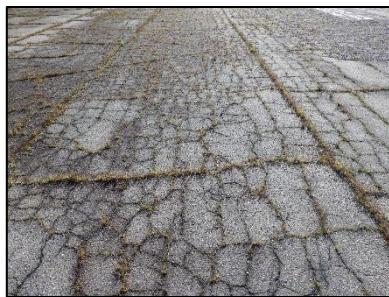
### Poor/Failed Pavement

Pavements that are Poor to Failed require significant and costly interventions such as reconstruction to restore the pavement to operational service.

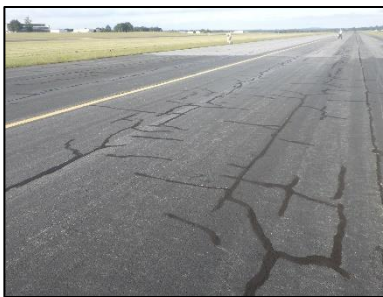
### Fair Pavement

Pavements with a Fair condition rating typically require rehabilitation, or maintenance activities if rehabilitation cannot be immediately performed.

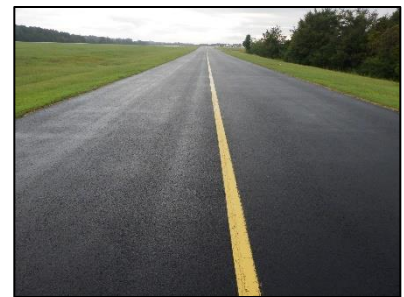
### Good/New Pavement

Pavements classified as Good require either no treatment or would benefit from the application of preventive maintenance activities such as crack sealing.

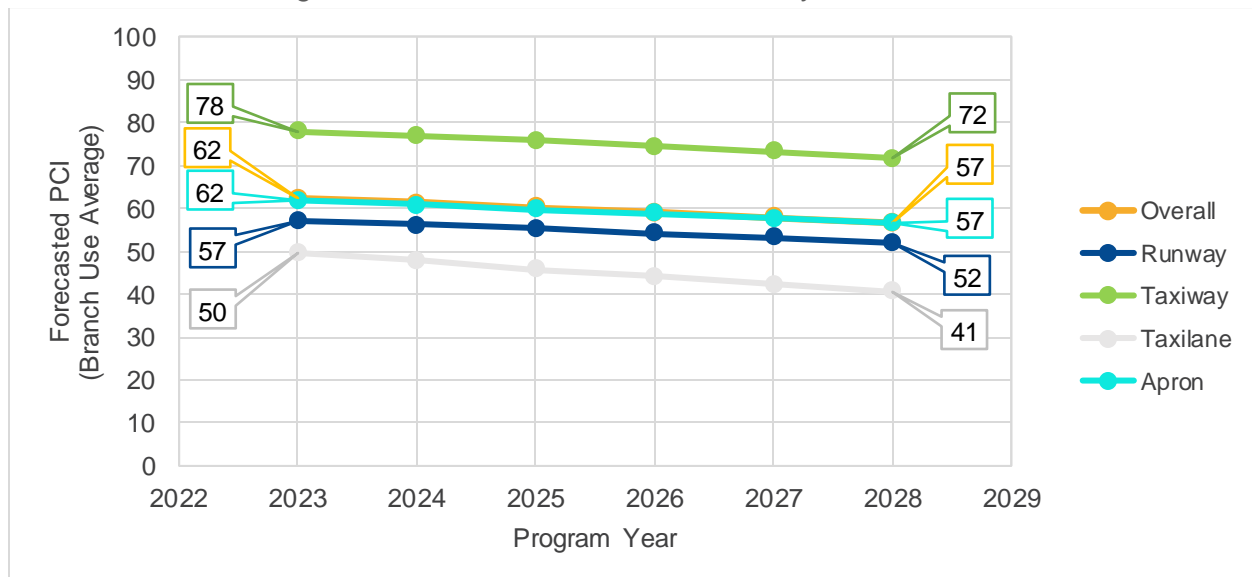
Figure 6 – Forecasted 5-Year PCI by Branch Use

A primary objective of this APMS is to estimate the future condition of each individual pavement section. PAVER™ was utilized to develop prediction curves and determine typical deterioration rates that are then used to forecast a future PCI value. This value will assist decision makers in determining at what point in time certain pavement sections will require rehabilitation. The figure below shows the current and 5-year area-weighted forecasted pavement condition distribution of each functional use (Runway, Taxiway, Taxilane, Apron) found at the Airport. The forecasted 5-year PCIs at a section-level are displayed graphically on the **2028 Forecasted Airfield Pavement Condition Index Exhibit** and are summarized in **Table 3**. All forecasts presented assume that no maintenance or rehabilitation is performed within the 5-year analysis period. **Figure 6** displays the forecasted pavement conditions at the branch-level for HVS.

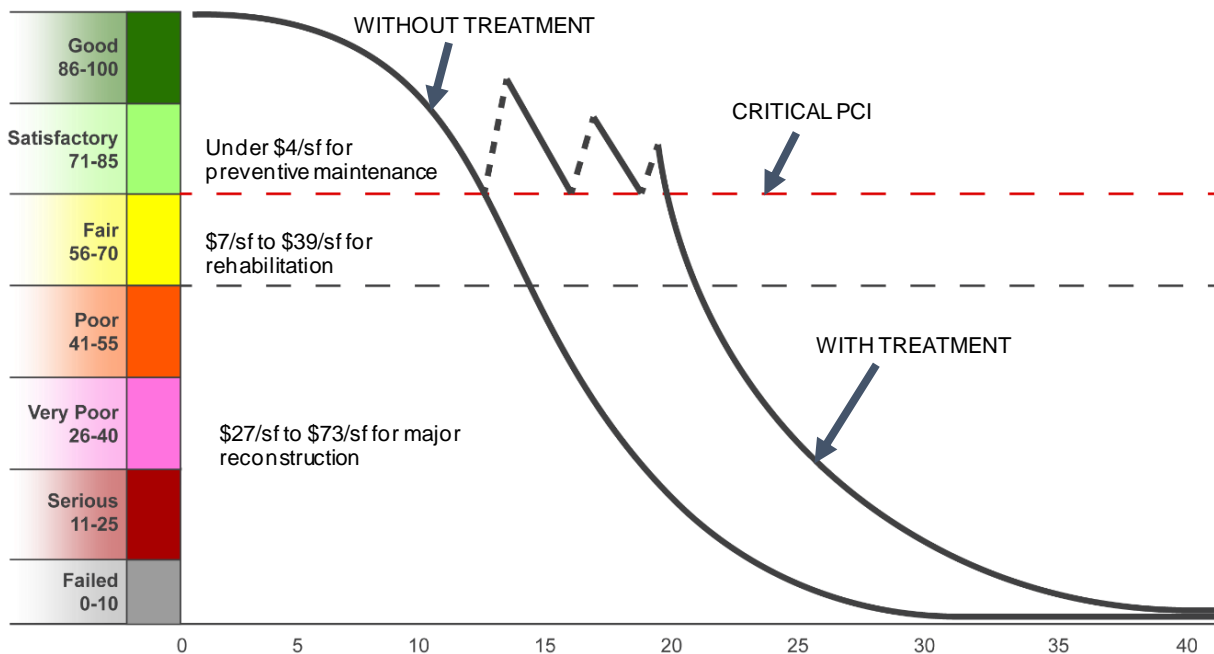
Figure 7 – Pavement Life and the Effect of Treatments

M&R planning considers various methods of repair to address the cause of the problem rather than just treating the symptom. As pavements deteriorate, repair costs can increase significantly. Once pavements have deteriorated below a certain condition threshold (the Critical PCI value), the pavement benefits more from substantial rehabilitation in lieu of maintenance activities. The figure below illustrates how the cost of pavement repairs can exponentially increase if M&R activities are delayed.

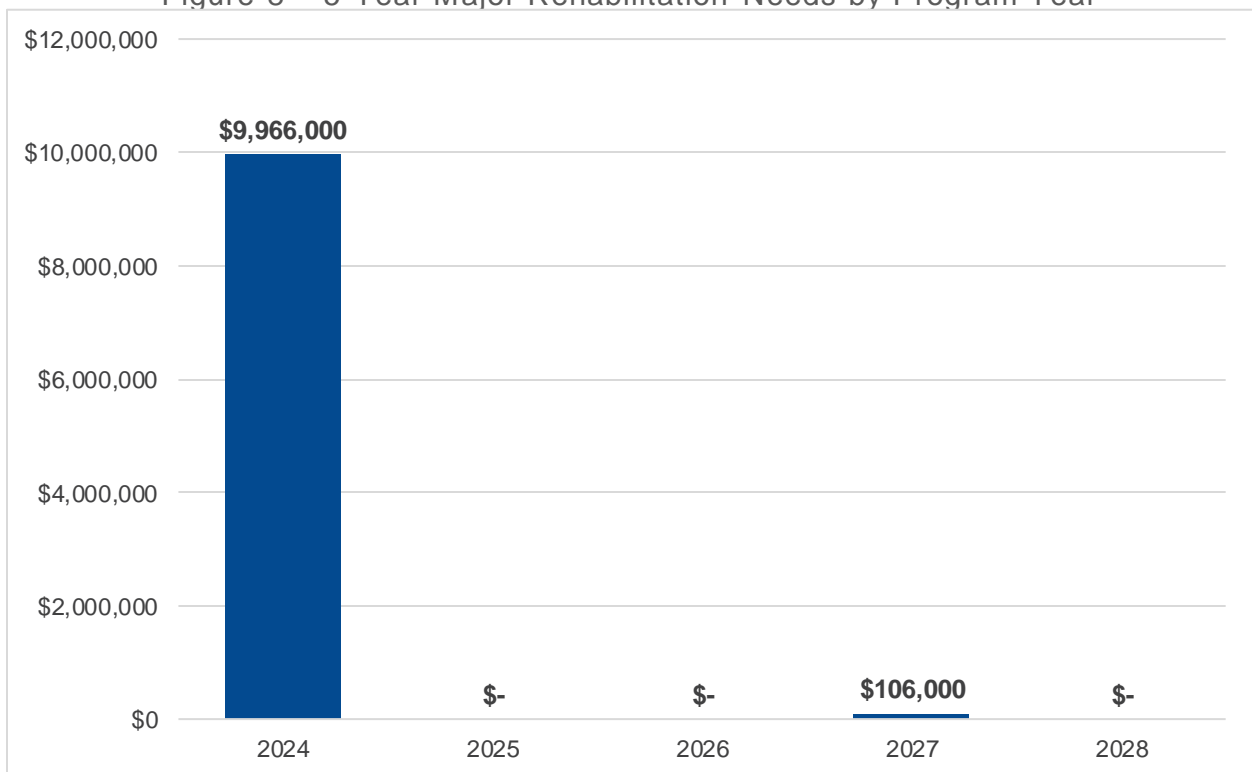
Figure 8 – 5-Year Major Rehabilitation Needs by Program Year

The 5-year major rehabilitation needs analysis at HVS results in a total 5-year cost of \$10.07M. The **5-Year Major Rehabilitation Needs Exhibit** graphically depicts the major rehabilitation needs at a section-level which are also summarized in **Table 5** with rounded costs. Annual needs are displayed graphically in **Figure 8**.

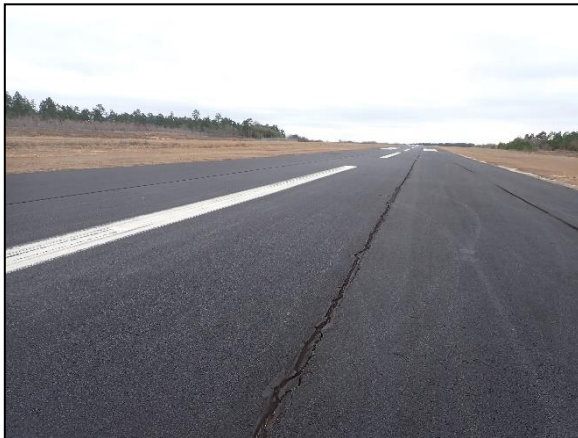
RW 3-10

Section ID	Area (SF)	Surface	Est. Last Major Work Year	Est. Last Global Treatment Year	PCI	Condition Rating	PCI % Climate	PCI % Load	PCI % Other
10	127,500	AC	1996	2018	61	Fair	98	0	2
20	247,500	AAC	1985	2018	55	Poor	100	0	0

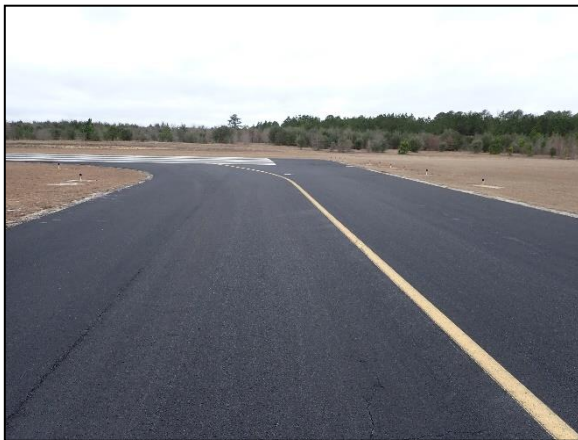
TWA A-10

Section ID	Area (SF)	Surface	Est. Last Major Work Year	Est. Last Global Treatment Year	PCI	Condition Rating	PCI % Climate	PCI % Load	PCI % Other
10	11,674	AAC	2003	2018	75	Satisfactory	100	0	0
15	125,176	AC	2003	2018	81	Satisfactory	100	0	0

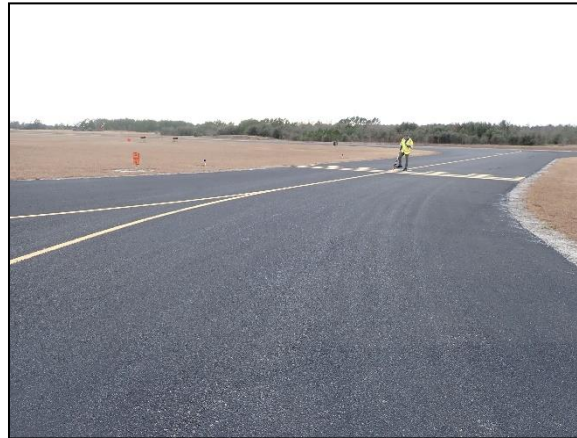
TW B-10

Section ID	Area (SF)	Surface	Est. Last Major Work Year	Est. Last Global Treatment Year	PCI	Condition Rating	PCI % Climate	PCI % Load	PCI % Other
10	13,439	AAC	1985	2018	81	Satisfactory	100	0	0

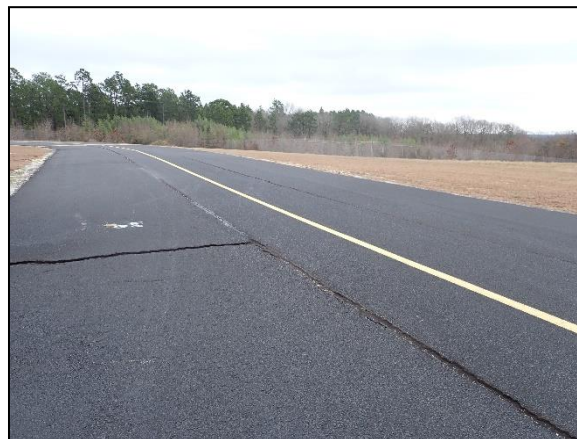
TW TA-3

Section ID	Area (SF)	Surface	Est. Last Major Work Year	Est. Last Global Treatment Year	PCI	Condition Rating	PCI % Climate	PCI % Load	PCI % Other
10	26,027	AC	1996	2018	62	Fair	100	0	0

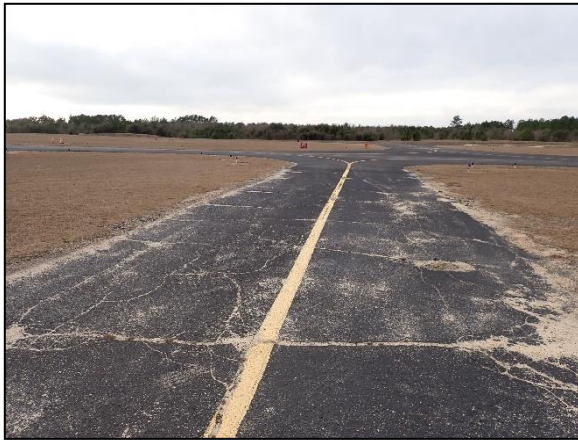
TL 01-10

Section ID	Area (SF)	Surface	Est. Last Major Work Year	Est. Last Global Treatment Year	PCI	Condition Rating	PCI % Climate	PCI % Load	PCI % Other
10	4,594	AC	1975	2020	12	Serious	76	24	0
20	8,299	AC	1975	-	0	Failed	56	44	0

HVS	TL 01	10	BLOCKCR	Medium	4,494	SF	97.8%	Stopgap	AC Crack Sealing Narrow	1,370	LF	\$ 3.50	\$ 4,800
HVS	TL 01	10	RAVELING	Medium	4,584	SF	99.8%	Stopgap	Surface Seal	4,584	SF	\$ 1.65	\$ 7,570
HVS	TL 01	10	RAVELING	High	10	SF	0.2%	Stopgap	AC Partial-Depth Patching	10	SF	\$ 6.00	\$ 60
HVS	TL 01	20	ALLIGATOR CR	Medium	864	SF	10.4%	Stopgap	AC Full-Depth Patching	987	SF	\$ 17.75	\$ 17,520
HVS	TL 01	20	ALLIGATOR CR	High	533	SF	6.4%	Stopgap	AC Full-Depth Patching	630	SF	\$ 17.75	\$ 11,180
HVS	TL 01	20	BLOCKCR	Medium	4,364	SF	52.6%	Stopgap	AC Crack Sealing Narrow	1,330	LF	\$ 3.50	\$ 4,660

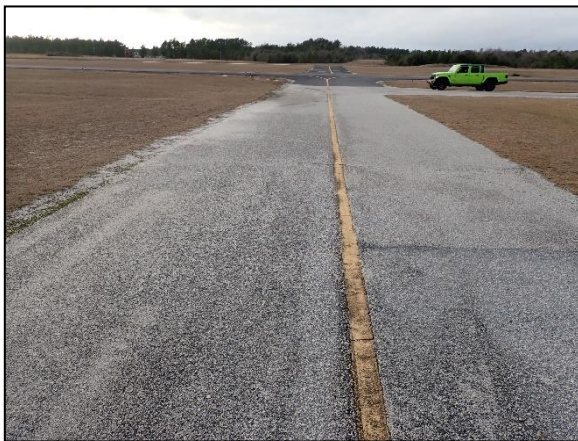
TL 02-10

Section ID	Area (SF)	Surface	Est. Last Major Work Year	Est. Last Global Treatment Year	PCI	Condition Rating	PCI % Climate	PCI % Load	PCI % Other
10	14,584	AC	1998	-	29	Very Poor	70	30	0
20	24,648	AC	2010	-	85	Satisfactory	100	0	0
30	4,715	AC	1998	2018	52	Poor	80	20	0

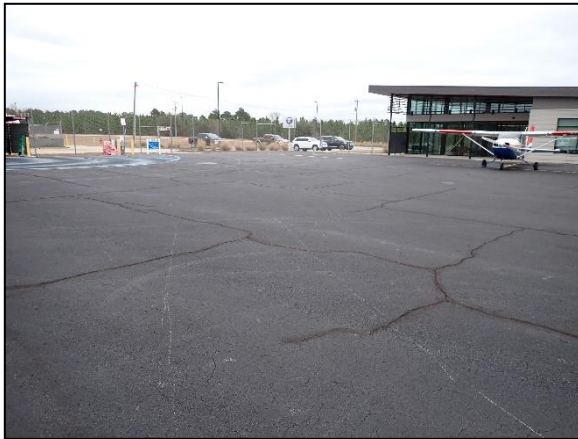
AP 01-10

Section ID	Area (SF)	Surface	Est. Last Major Work Year	Est. Last Global Treatment Year	PCI	Condition Rating	PCI % Climate	PCI % Load	PCI % Other
10	40,850	AAC	2003	2018	68	Fair	100	0	0
20	11,018	AC	1975	-	39	Very Poor	100	0	0
