SOUTH CAROLINA AERONAUTICS COMMISSION

STATEWIDE AIRFIELD PAVEMENT MANAGEMENT SYSTEM UPDATE

LKR - Lancaster County Airport - McWhirter Field

2022

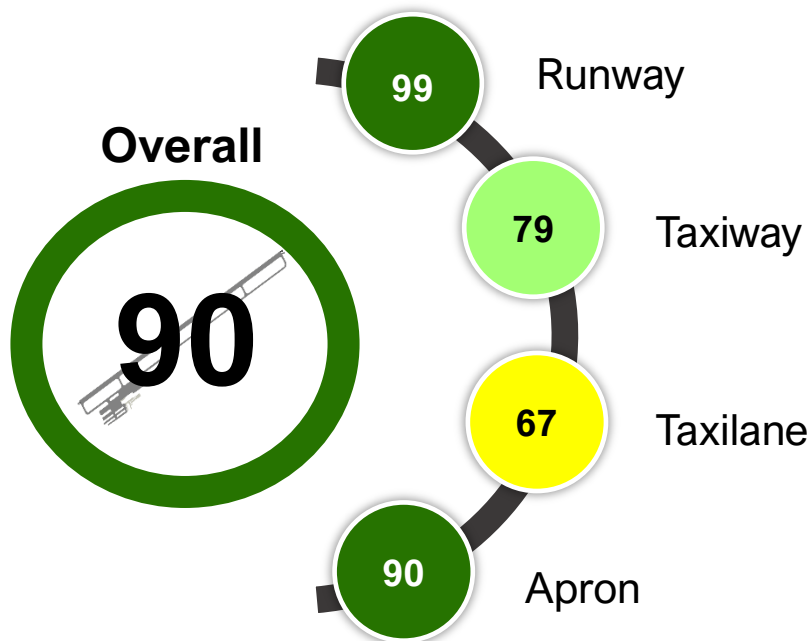
Figure 5 – Area Weighted Average Pavement Condition

The area-weighted average PCIs by branch use are summarized in the figure below. The current PCIs at a section-level are displayed graphically on the **2021 Airfield Pavement Condition Index (PCI) Exhibit** and are summarized in **Table 2**.

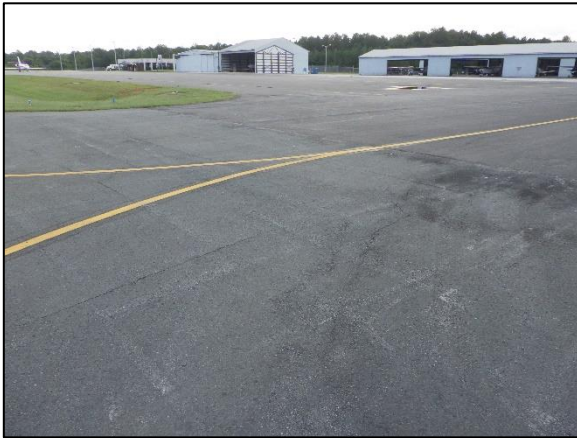
AP 01-05

Section ID	Area (SF)	Surface	Est. Last Major Work Year	Est. Last Global Treatment Year	PCI	Condition Rating	PCI % Climate	PCI % Load	PCI % Other
05	2,535	AAC	2015	2015	74	Satisfactory	100	0	0
10	48,604	AAC	2020	2020	100	Good	0	0	0
20	51,020	AAC	2020	2020	100	Good	0	0	0
30	39,271	AC	2009	-	62	Fair	100	0	0
40	1,200	AC	2020	-	100	Good	0	0	0
50	5,975	AAC	2020	-	100	Good	0	0	0
60	95,022	AC	2018	-	91	Good	100	0	0

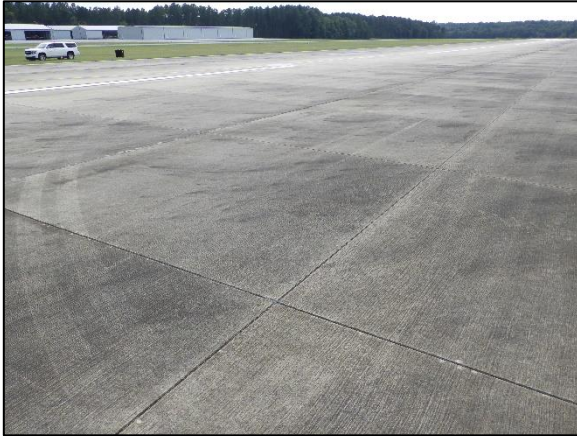
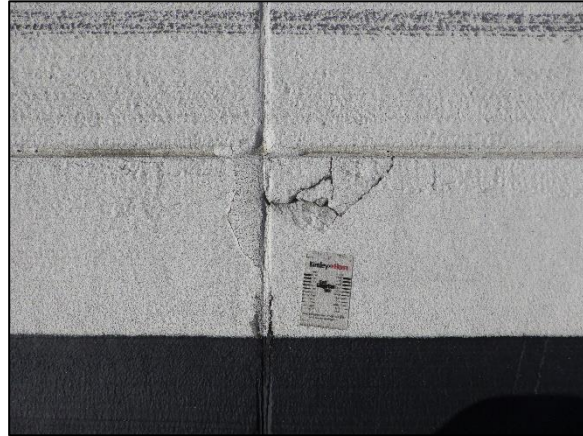
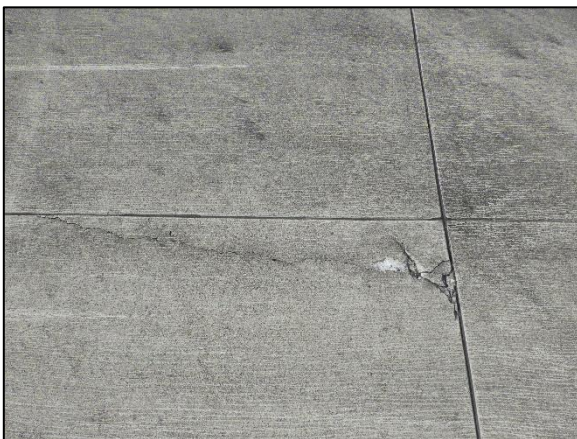
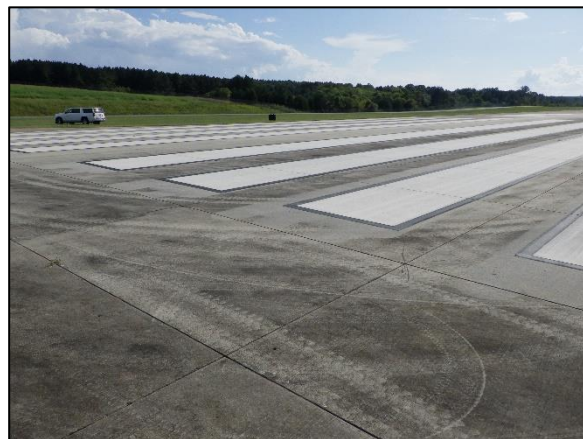
RW 6-10

Section ID	Area (SF)	Surface	Est. Last Major Work Year	Est. Last Global Treatment Year	PCI	Condition Rating	PCI % Climate	PCI % Load	PCI % Other
10	600,400	PCC	2010	-	99	Good	52	0	48

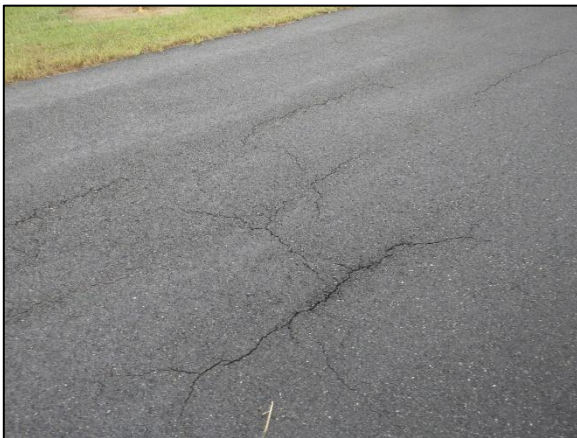
TW A-05

Section ID	Area (SF)	Surface	Est. Last Major Work Year	Est. Last Global Treatment Year	PCI	Condition Rating	PCI % Climate	PCI % Load	PCI % Other
05	5,980	AAC	2015	2015	70	Fair	100	0	0
10	36,354	AAC	2015	2015	74	Satisfactory	100	0	0
20	43,143	AAC	2015	2015	75	Satisfactory	100	0	0
30	129,646	AAC	2015	2015	80	Satisfactory	96	0	4
40	20,961	AAC	2020	-	100	Good	0	0	0
50	2,567	AAC	2010	-	74	Satisfactory	100	0	0

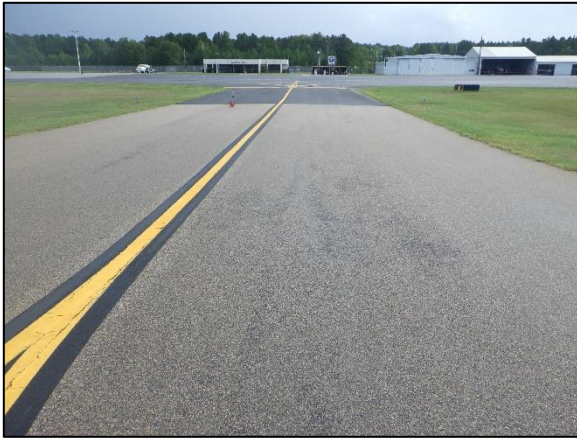
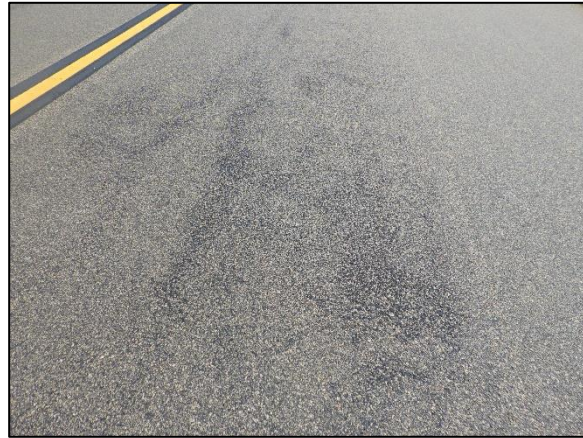
TW B-20

Section ID	Area (SF)	Surface	Est. Last Major Work Year	Est. Last Global Treatment Year	PCI	Condition Rating	PCI % Climate	PCI % Load	PCI % Other
10	6,159	AAC	2020	-	100	Good	0	0	0
20	5,473	AAC	2010	-	70	Fair	65	0	35

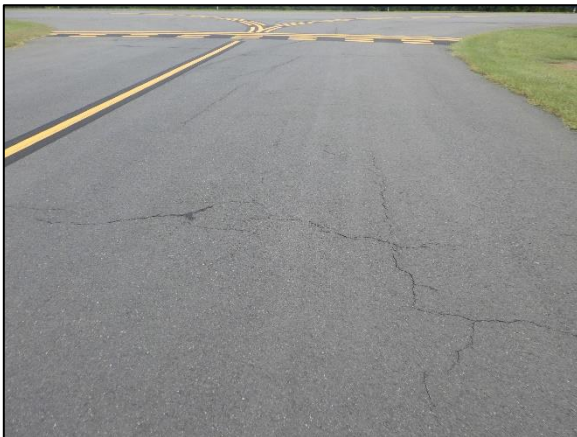
TW C-10

Section ID	Area (SF)	Surface	Est. Last Major Work Year	Est. Last Global Treatment Year	PCI	Condition Rating	PCI % Climate	PCI % Load	PCI % Other
10	5,406	AAC	2015	2015	69	Fair	100	0	0
20	6,113	AAC	2015	2015	67	Fair	100	0	0

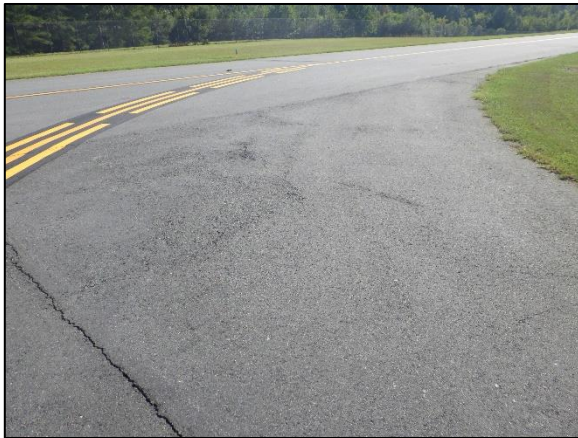
TW D-10

Section ID	Area (SF)	Surface	Est. Last Major Work Year	Est. Last Global Treatment Year	PCI	Condition Rating	PCI % Climate	PCI % Load	PCI % Other
10	5,705	AAC	2015	2015	66	Fair	100	0	0
20	6,113	AAC	2015	2015	73	Satisfactory	100	0	0

LKR	TW C	20	RAVELING	Medium	4	SF	0.1%	Stopgap	Surface Seal	4	SF	\$ 0.90	\$ 10
LKR	TW D	10	L & T CR	Medium	34	LF	0.6%	Stopgap	AC Crack Sealing Narrow	34	LF	\$ 4.00	\$ 140

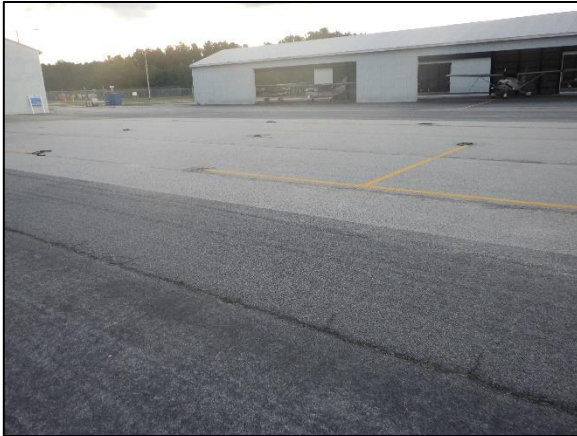
TL 01-10

Section ID	Area (SF)	Surface	Est. Last Major Work Year	Est. Last Global Treatment Year	PCI	Condition Rating	PCI % Climate	PCI % Load	PCI % Other
10	51,680	AC	2006	2013	71	Satisfactory	99	0	1
20	55,468	AC	2011	2015	63	Fair	100	0	0
