SOUTH CAROLINA AERONAUTICS COMMISSION

STATEWIDE AIRFIELD PAVEMENT MANAGEMENT SYSTEM UPDATE

LQK - Pickens County Airport

2022

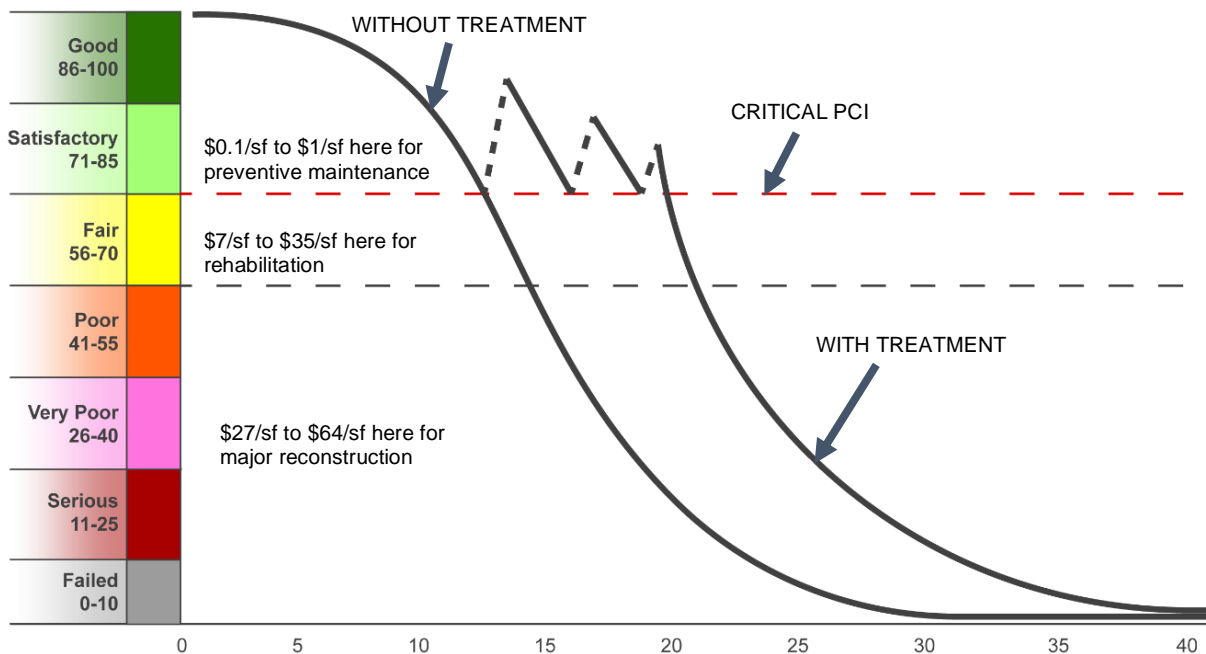
Figure 7 – Pavement Life and the Effect of Treatments

M&R planning considers various methods of repair to address the cause of the problem rather than just treating the symptom. As pavements deteriorate, repair costs can increase significantly. Once pavements have deteriorated below a certain condition threshold (the Critical PCI value), the pavement benefits more from substantial rehabilitation in lieu of maintenance activities. The figure below illustrates how the cost of pavement repairs can exponentially increase if M&R activities are delayed.

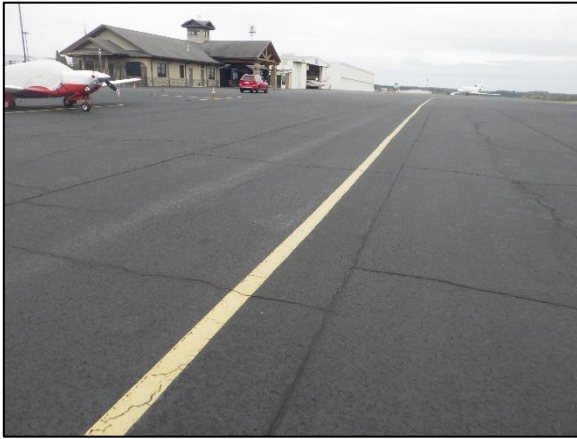
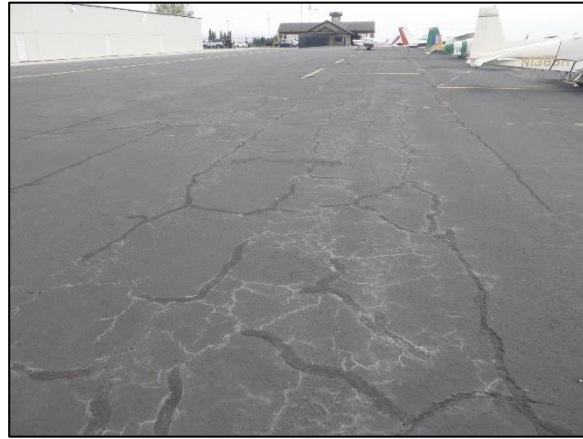
AP 01-10

Section ID	Area (SF)	Surface	Est. Last Major Work Year	Est. Last Global Treatment Year	PCI	Condition Rating	PCI % Climate	PCI % Load	PCI % Other
10	80,158	AC	1993	2017	57	Fair	100	0	0
20	87,709	AAC	2006	2017	71	Satisfactory	100	0	0
25	11,094	AAC	1974	2017	62	Fair	100	0	0

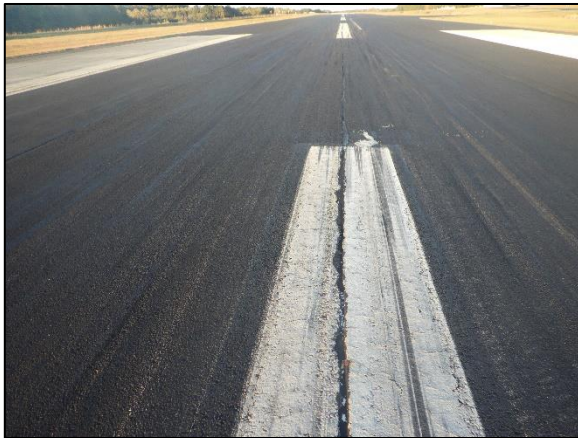
RW 5-10

Section ID	Area (SF)	Surface	Est. Last Major Work Year	Est. Last Global Treatment Year	PCI	Condition Rating	PCI % Climate	PCI % Load	PCI % Other
10	160,000	AAC	2005	2017	73	Satisfactory	96	0	4
20	341,700	AAC	2005	2017	74	Satisfactory	96	0	4

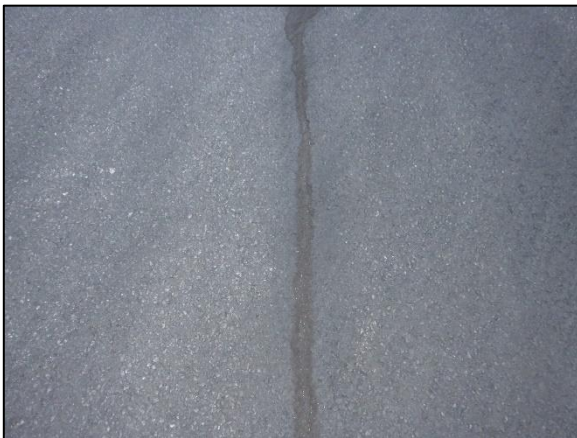
TW A-10

Section ID	Area (SF)	Surface	Est. Last Major Work Year	Est. Last Global Treatment Year	PCI	Condition Rating	PCI % Climate	PCI % Load	PCI % Other
10	7,322	AAC	2005	2017	82	Satisfactory	100	0	0
20	83,357	AC	1999	2017	68	Fair	100	0	0
45	9,689	AAC	2005	2017	83	Satisfactory	100	0	0
50	81,623	AC	1996	2017	77	Satisfactory	100	0	0
60	4,456	AC	1991	2017	69	Fair	100	0	0
65	10,809	AAC	2005	2017	92	Good	100	0	0

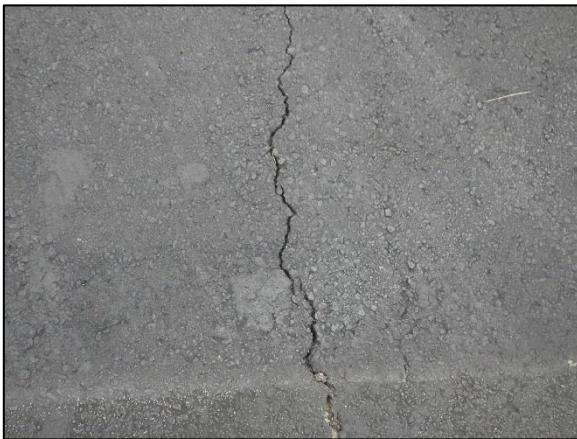
TW A1-10

Section ID	Area (SF)	Surface	Est. Last Major Work Year	Est. Last Global Treatment Year	PCI	Condition Rating	PCI % Climate	PCI % Load	PCI % Other
10	3,827	AAC	1999	2017	69	Fair	100	0	0
15	6,123	AAC	2005	2017	81	Satisfactory	100	0	0

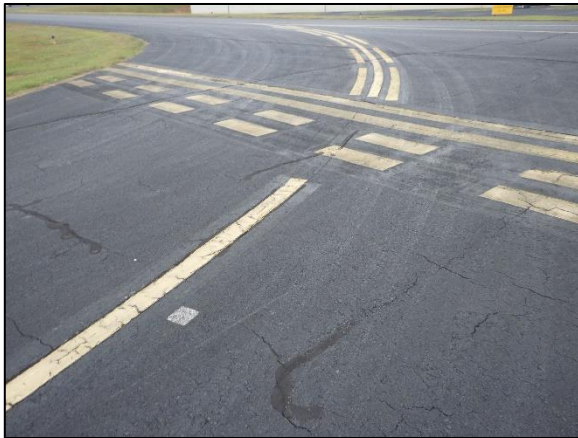
TW A2-10

Section ID	Area (SF)	Surface	Est. Last Major Work Year	Est. Last Global Treatment Year	PCI	Condition Rating	PCI % Climate	PCI % Load	PCI % Other
10	3,948	AAC	1999	2017	69	Fair	100	0	0
15	11,858	AAC	2005	2017	83	Satisfactory	100	0	0

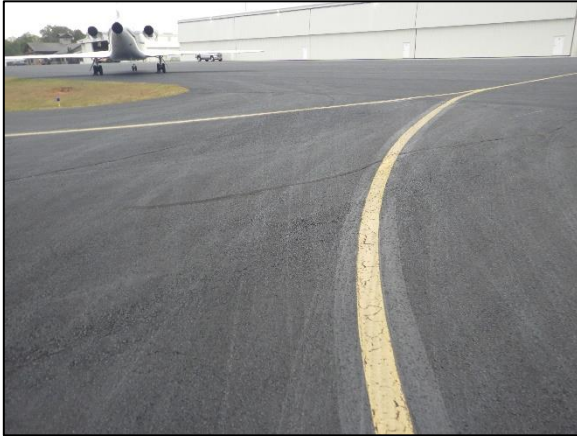
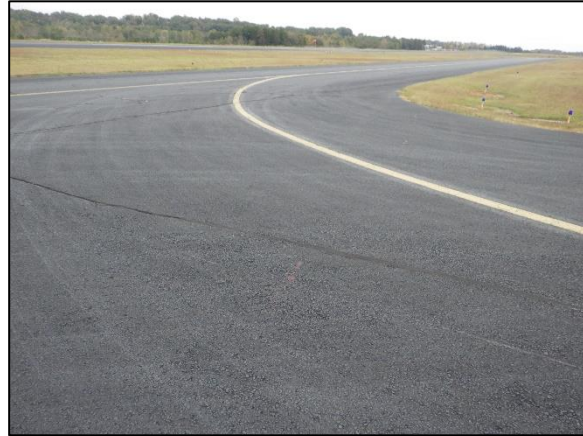
TW A3-10

Section ID	Area (SF)	Surface	Est. Last Major Work Year	Est. Last Global Treatment Year	PCI	Condition Rating	PCI % Climate	PCI % Load	PCI % Other
10	3,603	AAC	1999	2017	74	Satisfactory	100	0	0

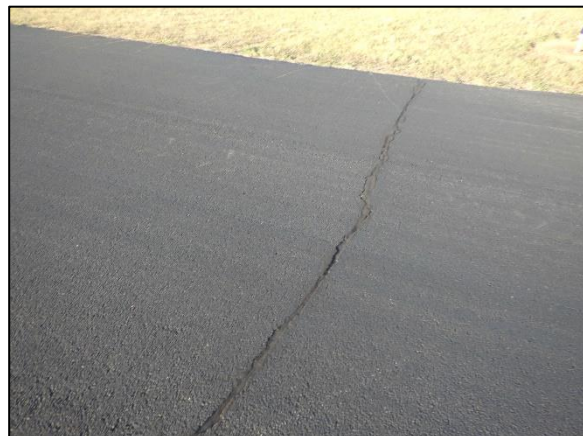
TW A4-10

Section ID	Area (SF)	Surface	Est. Last Major Work Year	Est. Last Global Treatment Year	PCI	Condition Rating	PCI % Climate	PCI % Load	PCI % Other
10	11,036	AAC	2005	2017	77	Satisfactory	100	0	0

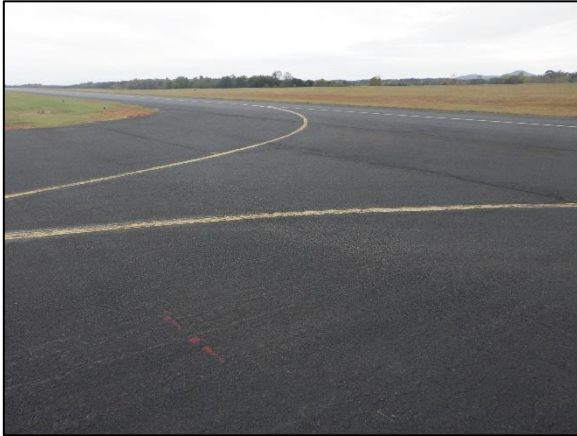
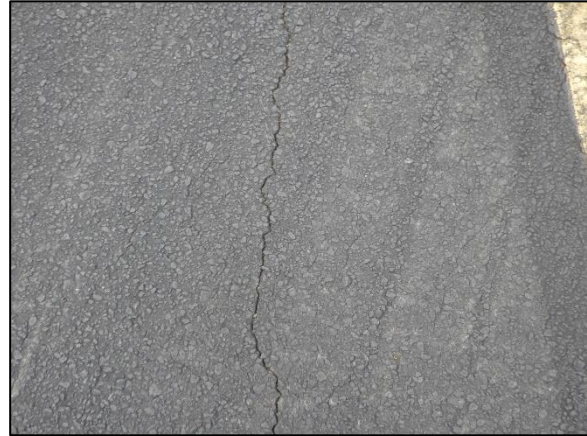
TW A5-10

Section ID	Area (SF)	Surface	Est. Last Major Work Year	Est. Last Global Treatment Year	PCI	Condition Rating	PCI % Climate	PCI % Load	PCI % Other
10	4,049	AC	1996	2017	66	Fair	100	0	0

LQK	TL 01	10	ALLIGATOR CR	Medium	664	SF	2.6%	Stopgap	AC Full-Depth Patching	772	SF	\$ 21.75	\$ 16,800
LQK	TL 01	15	ALLIGATOR CR	Medium	321	SF	1.9%	Stopgap	AC Full-Depth Patching	397	SF	\$ 21.75	\$ 8,650
LQK	TL 01	35	L & T CR	Medium	42	LF	0.3%	Stopgap	AC Crack Sealing Narrow	42	LF	\$ 4.00	\$ 170
LQK	TW A	60	L & T CR	Medium	6	LF	0.1%	Stopgap	AC Crack Sealing Narrow	6	LF	\$ 4.00	\$ 30

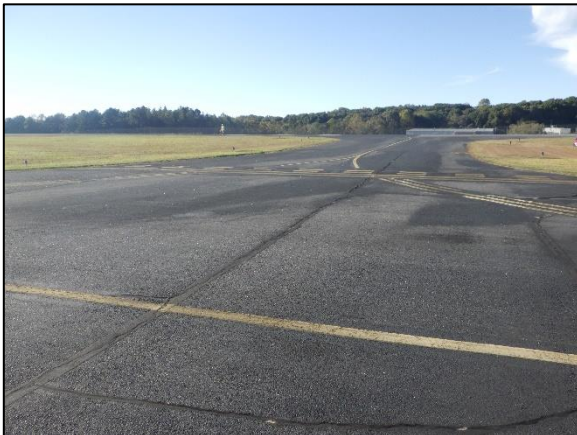
TW A6-10

Section ID	Area (SF)	Surface	Est. Last Major Work Year	Est. Last Global Treatment Year	PCI	Condition Rating	PCI % Climate	PCI % Load	PCI % Other
10	3,855	AC	1991	2017	68	Fair	100	0	0
15	4,373	AAC	2005	2017	78	Satisfactory	100	0	0

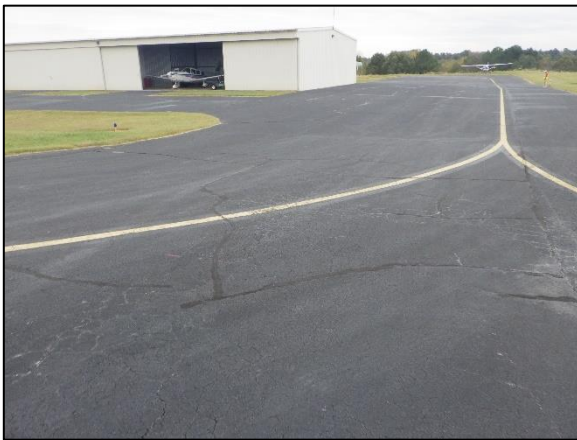
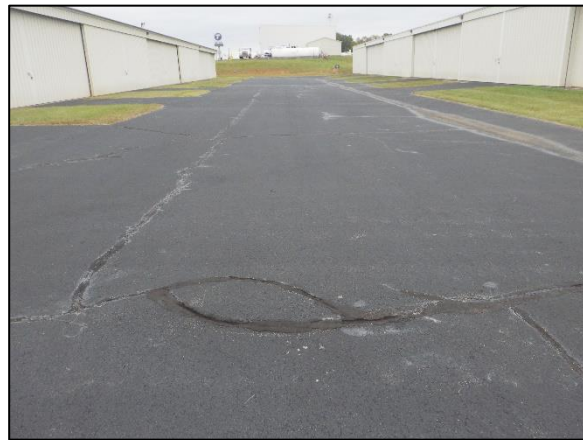
TL 01-10

Section ID	Area (SF)	Surface	Est. Last Major Work Year	Est. Last Global Treatment Year	PCI	Condition Rating	PCI % Climate	PCI % Load	PCI % Other
10	25,396	AC	2003	2017	44	Poor	56	41	3
15	16,533	AC	2005	2017	56	Fair	42	58	0
20	10,375	AC	2005	2017	79	Satisfactory	100	0	0
25	9,598	AC	2006	2017	73	Satisfactory	100	0	0
30	6,936	AC	2012	2017	71	Satisfactory	100	0	0
35	14,099	AC	2012	2017	66	Fair	100	0	0
