STATEWIDE AIRFIELD PAVEMENT MANAGEMENT SYSTEM UPDATE

6J2 - Saint George Airport

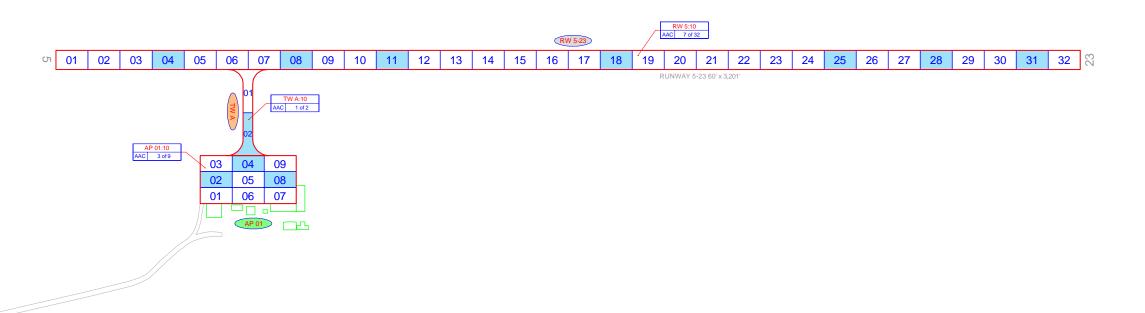
The pavements at Saint George Airport (6J2) include approximately 0.2 million square feet of airfield pavements consisting of runways, taxiways, and aprons. Per the guidance in the ASTM D5340-23, all pavements were divided and subdivided into pavement management units (Network, Branch, Section, Sample). The divisions are documented in the **Network Definition Exhibit** providing the name and location of each branch, section, and sample.

TOTAL SAMPLES INSPECTED = 11
AC: 11 PCC: 0

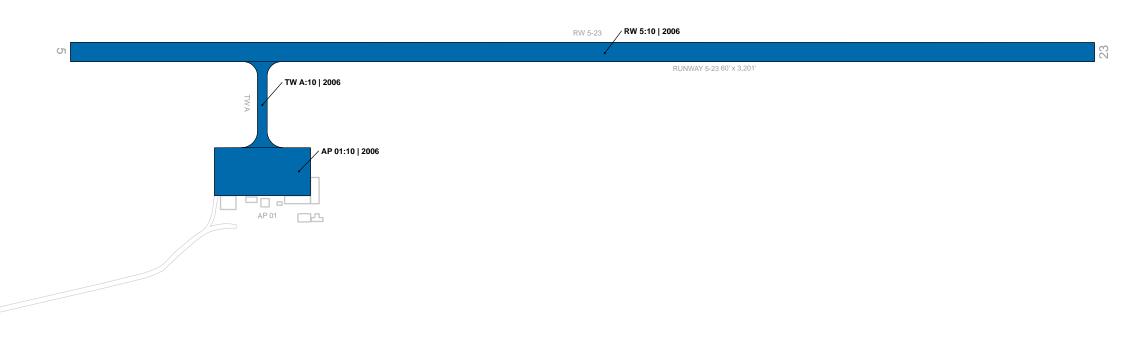
Estimated Age at Inspection

The following figure summarizes the inventory items at Saint George Airport (6J2). The **Estimated Age Exhibit** provides the last major work date for each pavement section based on the collected documentation.

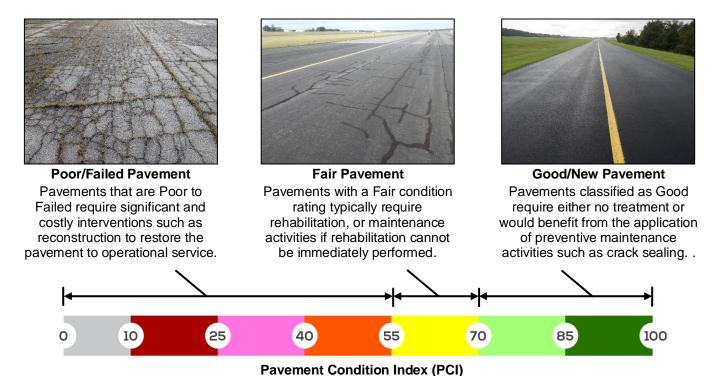
Figure 3 – Representation of Pavement Condition Index Values

Visual condition data collected during the PCI survey is analyzed and used to calculate the current PCI for each inspected sample unit and section. The PCI is a value ranging from 0 to 100, which indicates the apparent structural integrity and surface operational condition of the pavement, with "100" indicating a pavement in new condition and "0" indicating a failed pavement section. Pavement Condition Ratings are associated with PCI categories that range from "Failed" to "Good". Representative photos of varying Pavement Condition Ratings are displayed in Figure 3.

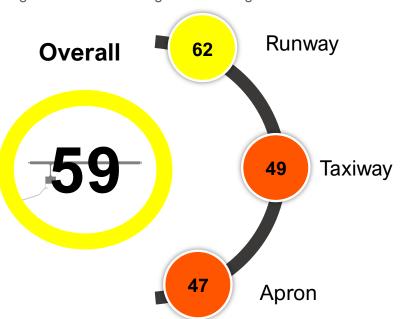
Figure 5 – Area Weighted Average Pavement Condition

The PCI survey for Saint George Airport (6J2) was performed in October 2023. **The overall area-weighted average PCI value of the network was 59**, representing a condition rating of **Fair**. None of inspected pavements are in Good or Satisfactory condition, 78% of inspected pavements are in Fair condition, and the remaining 22% are in Poor or worse condition as summarized in **Figure 4**.

The area-weighted average PCIs by branch use are summarized in the figure below. The current PCIs at a section-level are displayed graphically on the **2023 Airfield Pavement Condition Index Exhibit** and are summarized in **Table 2**.

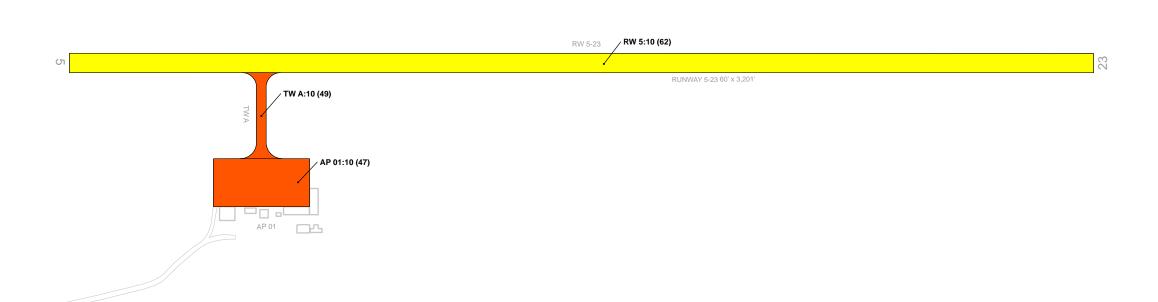
2023 Pavement Condition Index

Network ID	Branch ID	Branch Use	Section ID	Area (SF)	Surface	PCI	Condition Rating	PCI % Climate	PCI % Load	PCI % Other
6J2	AP 01	Apron	10	45,000	AAC	47	Poor	92	0	8
6J2	RW 5	Runway	10	192,000	AAC	62	Fair	74	0	26
6J2	TW A	Taxiway	10	10,056	AAC	49	Poor	75	0	25

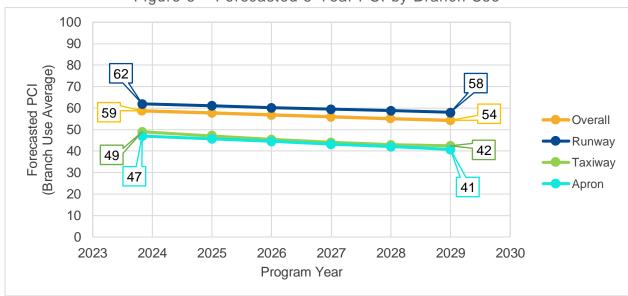
Figure 6 - Forecasted 5-Year PCI by Branch Use

A primary objective of this APMS is to estimate the future condition of each individual pavement section. PAVERTM was utilized to develop prediction curves and determine typical deterioration rates that are then used to forecast a future PCI value. This value will assist decision makers in determining at what point in time certain pavement sections will require rehabilitation. The figure below shows the current and 5-year area-weighted forecasted pavement condition distribution of each functional use (Runway, Taxiway, Apron) found at the Airport. The forecasted 5-year PCIs at a section-level are displayed graphically on the **2029 Forecasted Airfield Pavement Condition Index Exhibit** and are summarized in **Table 3**. All forecasts presented assume that no maintenance or rehabilitation is performed within the 5-year analysis period. **Figure 6** displays the forecasted pavement conditions at the branch-level for 6J2.

Network ID	Branch ID	Section ID	Current PCI	Forecasted PCI					
Network				2025	2026	2027	2028	2029	
6J2	AP 01	10	47	46	45	43	42	41	
6J2	RW 5	10	62	61	60	59	59	58	
6J2	TW A	10	49	47	46	44	43	42

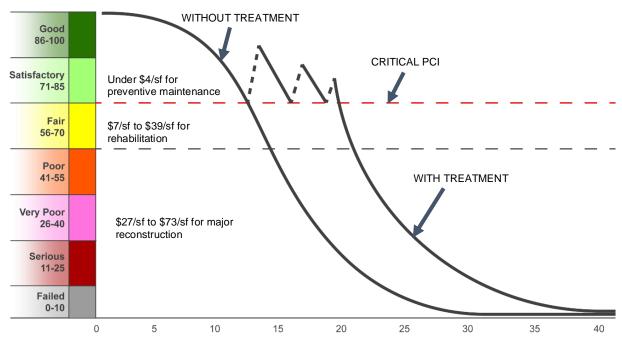
Figure 7 – Pavement Life and the Effect of Treatments

M&R planning considers various methods of repair to address the cause of the problem rather than just treating the symptom. As pavements deteriorate, repair costs can increase significantly. Once pavements have deteriorated below a certain condition threshold (the Critical PCI value), the pavement benefits more from substantial rehabilitation in lieu of maintenance activities. The figure below illustrates how the cost of pavement repairs can exponentially increase if M&R activities are delayed.

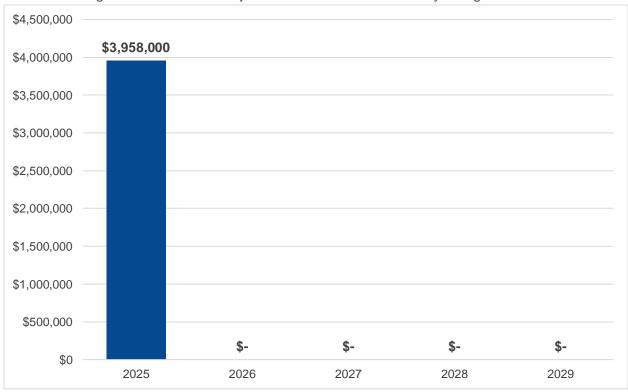
Figure 8 – 5-Year Major Rehabilitation Needs by Program Year

The 5-year major rehabilitation needs analysis at 6J2 results in a total 5-year cost of \$3.96M. The **5-Year Major Rehabilitation Needs Exhibit** graphically depicts the major rehabilitation needs at a section-level which are also summarized in **Table 5** with rounded costs. Annual needs are displayed graphically in **Figure 8**.

Program Year	Network ID	Branch ID	Section ID	Surface	Area (SF)	PCI Before	Rehabilitation Type		anning Cost Estimate	
2025	6J2	AP 01	10	AAC	45,000	46	AC Reconstruction	\$	1,587,000	
2025	6J2	RW 5	10	AAC	192,000	61	AC Rehabilitation	\$	2,016,000	
2025	6J2	TW A	10	AAC	10,056	47	AC Reconstruction	\$	355,000	
	Total 5-Year Major Rehabilitation Needs =
