SOUTH CAROLINA AERONAUTICS COMMISSION

STATEWIDE AIRFIELD PAVEMENT MANAGEMENT SYSTEM UPDATE

MNI - Santee Cooper Regional Airport

2024

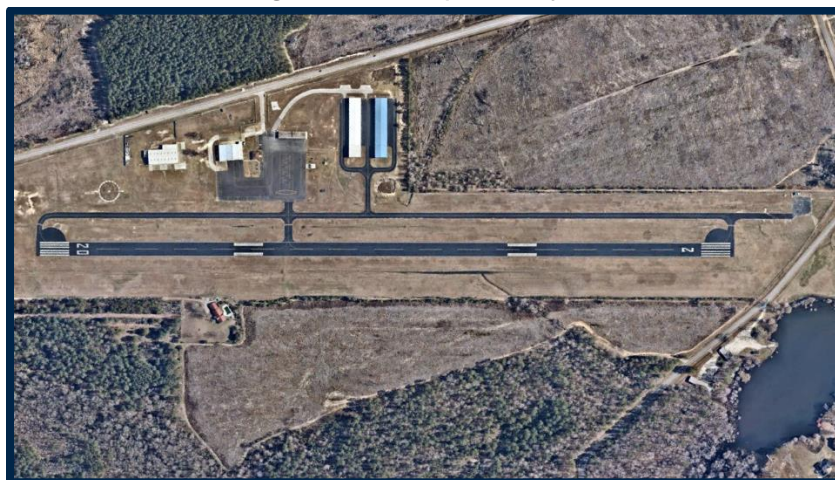
Figure 1 – Airport Layout

The pavements at Santee Cooper Regional Airport (MNI) include approximately 0.6 million square feet of airfield pavements consisting of runways, taxiways, taxilane, and aprons. Per the guidance in the ASTM D5340-23, all pavements were divided and subdivided into pavement management units (Network, Branch, Section, Sample). The divisions are documented in the **Network Definition Exhibit** providing the name and location of each branch, section, and sample.

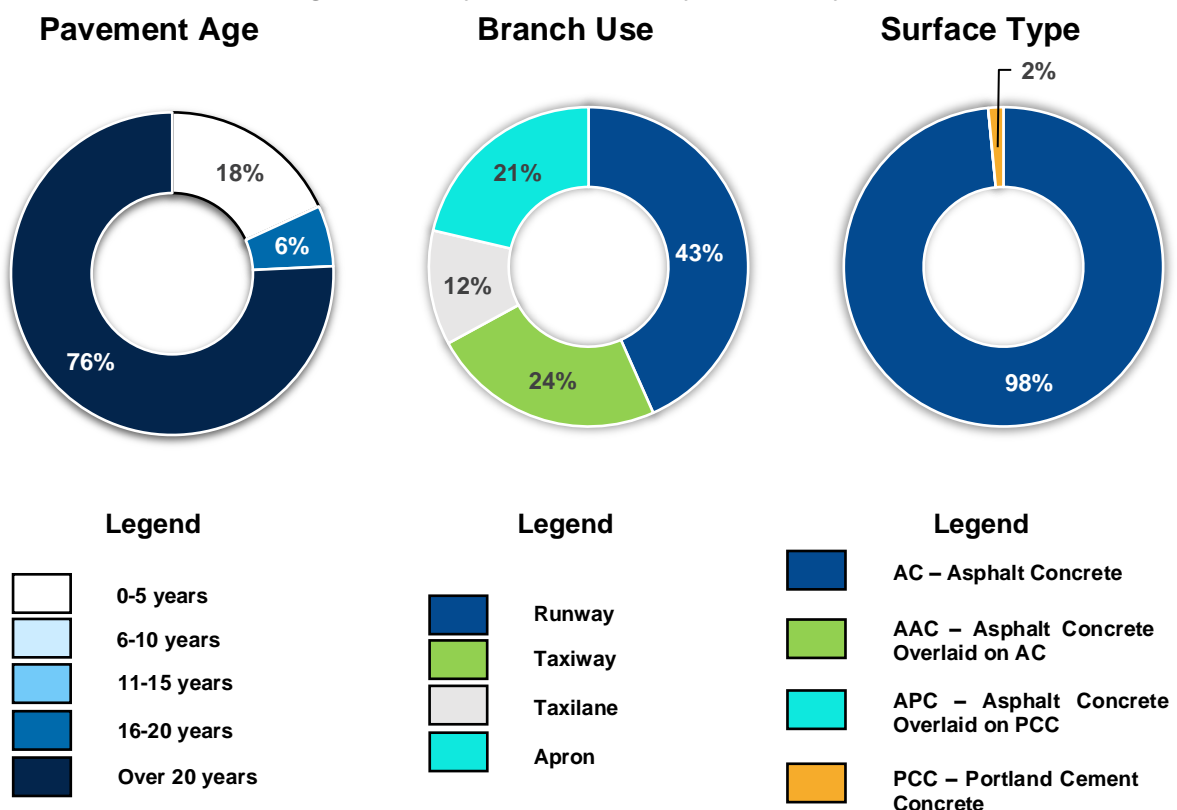
Figure 2 – System Inventory Summary

The following figure summarizes the inventory items at Santee Cooper Regional Airport (MNI) The **Estimated Age Exhibit** provides the last major work date for each pavement section based on the collected documentation.

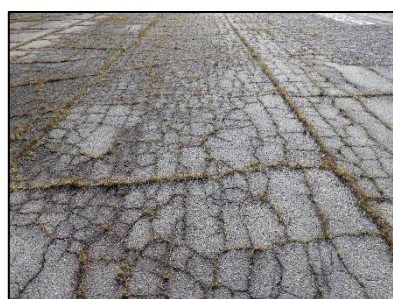
Figure 3 – Representation of Pavement Condition Index Values

Poor/Failed Pavement

Pavements that are Poor to Failed require significant and costly interventions such as reconstruction to restore the pavement to operational service.

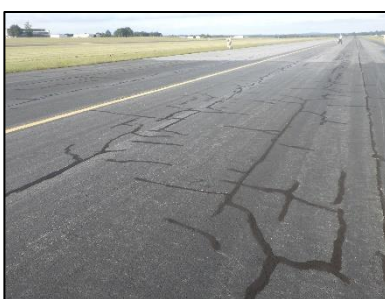
Fair Pavement

Pavements with a Fair condition rating typically require rehabilitation, or maintenance activities if rehabilitation cannot be immediately performed.

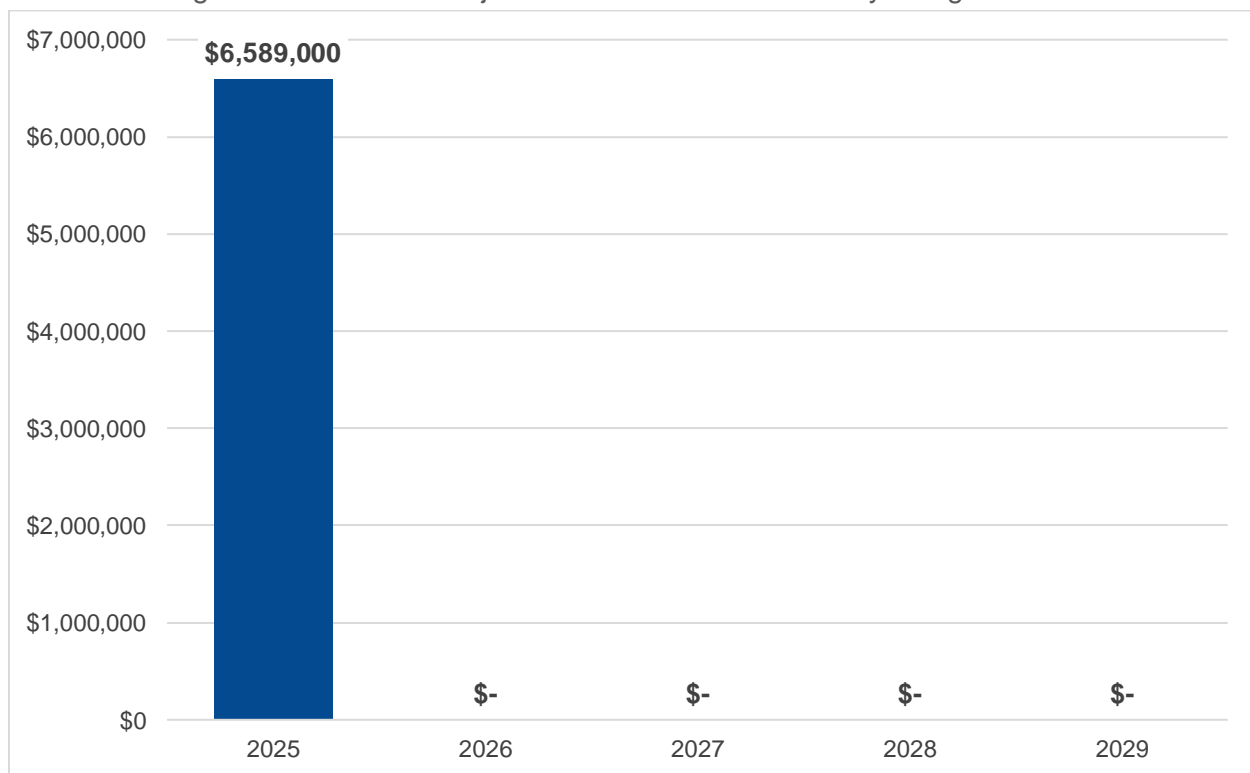
Figure 8 – 5-Year Major Rehabilitation Needs by Program Year

The 5-year major rehabilitation needs analysis at MNI results in a total 5-year cost of \$6.59M. The **5-Year Major Rehabilitation Needs Exhibit** graphically depicts the major rehabilitation needs at a section-level which are also summarized in **Table 5** with rounded costs. Annual needs are displayed graphically in **Figure 8**.

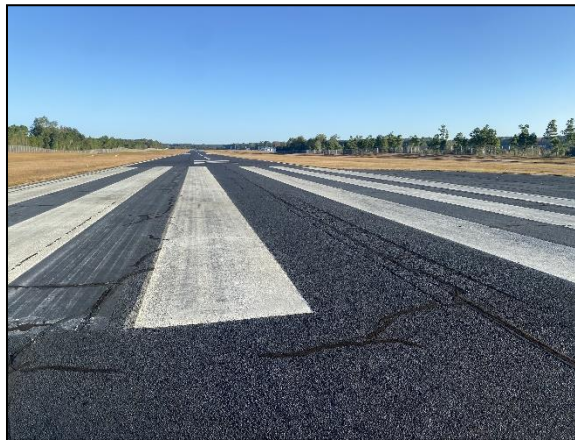
RW 2-10

Branch ID	Branch Use	Number of Sections	Branch Area (SF)	Branch Area-Weighted Avg PCI	Branch Condition Rating
RW 2	RUNWAY	1	270,150	63	Fair

Section ID	Area (SF)	Surface	Est. Last Major Work Year	Est. Last Global Treatment Year	PCI	Condition Rating	PCI % Climate	PCI % Load	PCI % Other
10	270,150	AC	1965	2017	63	Fair	100	0	0

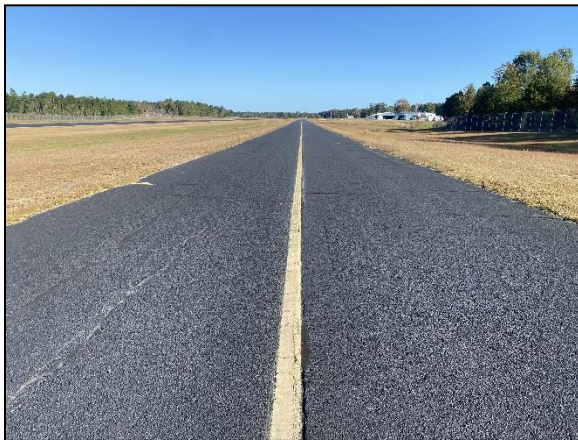
TW A-10

Branch ID	Branch Use	Number of Sections	Branch Area (SF)	Branch Area-Weighted Avg PCI	Branch Condition Rating
TW A	TAXIWAY	3	121,025	61	Fair

Section ID	Area (SF)	Surface	Est. Last Major Work Year	Est. Last Global Treatment Year	PCI	Condition Rating	PCI % Climate	PCI % Load	PCI % Other
10	77,605	AC	1981	2017	66	Fair	78	22	0
15	3,205	AC	1981	2017	48	Poor	95	0	5
20	40,215	AC	1981	2017	53	Poor	100	0	0

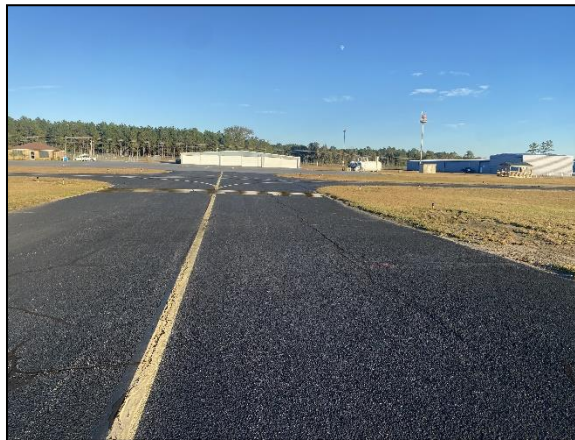
TW B-10

Branch ID	Branch Use	Number of Sections	Branch Area (SF)	Branch Area-Weighted Avg PCI	Branch Condition Rating
TW B	TAXIWAY	1	8,630	65	Fair

Section ID	Area (SF)	Surface	Est. Last Major Work Year	Est. Last Global Treatment Year	PCI	Condition Rating	PCI % Climate	PCI % Load	PCI % Other
10	8,630	AC	1965	2017	65	Fair	100	0	0

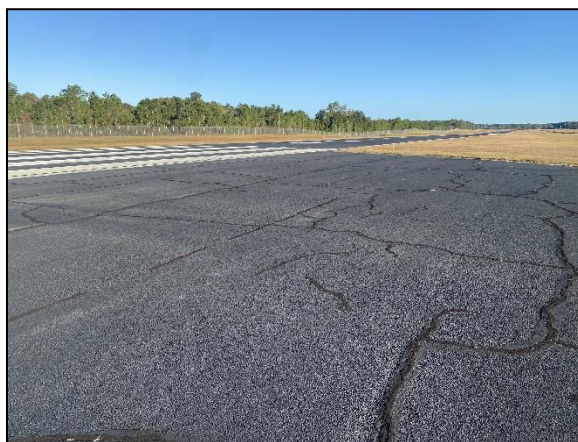
TW TA 2-10

Branch ID	Branch Use	Number of Sections	Branch Area (SF)	Branch Area-Weighted Avg PCI	Branch Condition Rating
TW TA 2	TAXIWAY	1	9,201	63	Fair

Section ID	Area (SF)	Surface	Est. Last Major Work Year	Est. Last Global Treatment Year	PCI	Condition Rating	PCI % Climate	PCI % Load	PCI % Other
10	9,201	AC	1965	2017	63	Fair	100	0	0

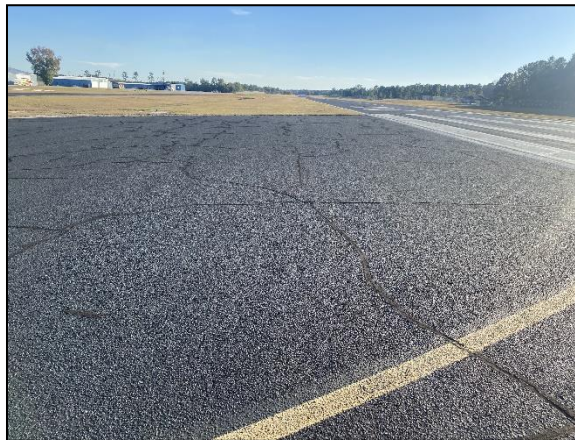
TW TA 20-10

Branch ID	Branch Use	Number of Sections	Branch Area (SF)	Branch Area-Weighted Avg PCI	Branch Condition Rating
TW TA 20	TAXIWAY	1	8,765	60	Fair

Section ID	Area (SF)	Surface	Est. Last Major Work Year	Est. Last Global Treatment Year	PCI	Condition Rating	PCI % Climate	PCI % Load	PCI % Other
10	8,765	AC	1965	2017	60	Fair	100	0	0

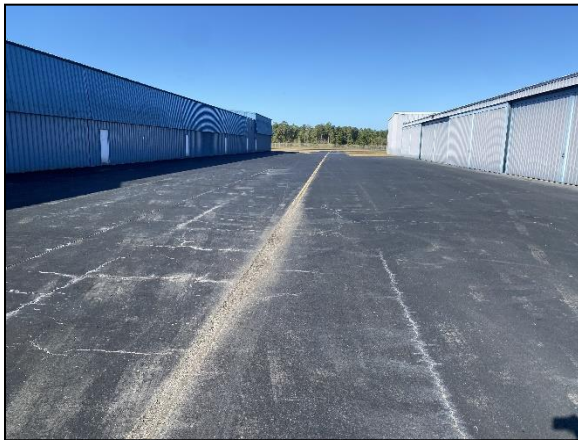
TL 01-10

Branch ID	Branch Use	Number of Sections	Branch Area (SF)	Branch Area-Weighted Avg PCI	Branch Condition Rating
TL 01	TAXILANE	2	67,122	70	Fair

Section ID	Area (SF)	Surface	Est. Last Major Work Year	Est. Last Global Treatment Year	PCI	Condition Rating	PCI % Climate	PCI % Load	PCI % Other
10	40,934	AC	2003	2017	63	Fair	100	0	0
20	26,188	AC	2007	2017	81	Satisfactory	100	0	0

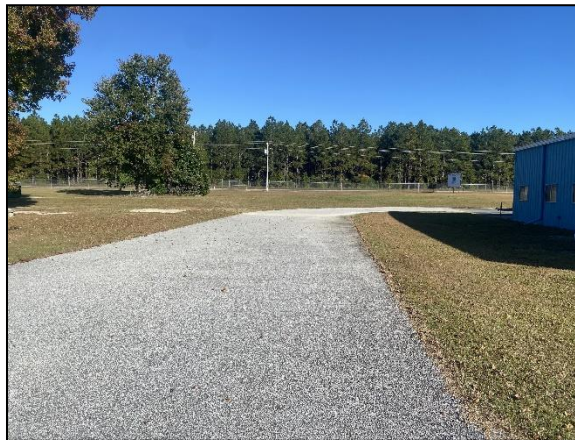
TL 02-10

Branch ID	Branch Use	Number of Sections	Branch Area (SF)	Branch Area-Weighted Avg PCI	Branch Condition Rating
TL 02	TAXILANE	1	5,220	43	Poor

Section ID	Area (SF)	Surface	Est. Last Major Work Year	Est. Last Global Treatment Year	PCI	Condition Rating	PCI % Climate	PCI % Load	PCI % Other
10	5,220	AC	2005	-	43	Poor	100	0	0

MNI	TL 02	10	RAVELING	Medium	5,220	SF	100.0%	Stopgap	Surface Seal	5,221	SF	\$ 1.65	\$ 8,620
MNI	TW A	10	WEATHERING	Medium	77,605	SF	100.0%	Stopgap	Surface Seal	77,605	SF	\$ 1.65	\$ 128,050
MNI	TW A	15	RAVELING	Medium	60	SF	1.9%	Stopgap	Surface Seal	60	SF	\$ 1.65	\$ 100
MNI	TW A	15	WEATHERING	Medium	2,201	SF	68.7%	Stopgap	Surface Seal	2,201	SF	\$ 1.65	\$ 3,640
MNI	TW A	20	L & T CR	Medium	1,520	LF	3.8%	Stopgap	AC Crack Sealing Narrow	1,520	LF	\$ 4.25	\$ 6,470
MNI	TW A	20	L & T CR	High	98	LF	0.2%	Stopgap	AC Crack Sealing Wide	98	LF	\$ 23.50	\$ 2,320
MNI	TW A	20	RAVELING	Medium	697	SF	1.7%	Stopgap	Surface Seal	698	SF	\$ 1.65	\$ 1,160
MNI	TW A	20	WEATHERING	Medium	9,670	SF	24.1%	Stopgap	Surface Seal	9,670	SF	\$ 1.65	\$ 15,960
MNI	TW B	10	WEATHERING	Medium	8,630	SF	100.0%	Stopgap	Surface Seal	8,631	SF	\$ 1.65	\$ 14,240
MNI	TW TA 2	10	WEATHERING	Medium	9,201	SF	100.0%	Stopgap	Surface Seal	9,201	SF	\$ 1.65	\$ 15,190

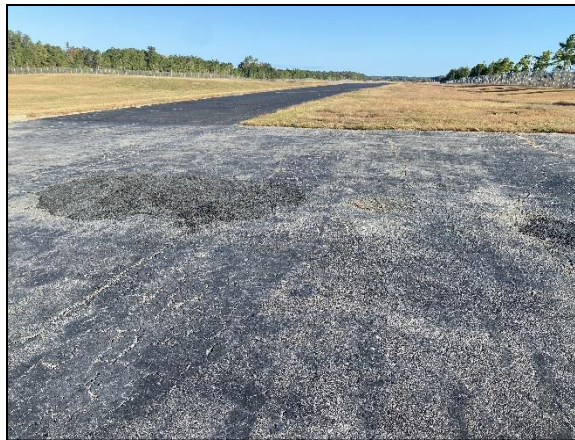
AP 02-10

Branch ID	Branch Use	Number of Sections	Branch Area (SF)	Branch Area-Weighted Avg PCI	Branch Condition Rating
AP 02	APRON	1	10,200	27	Very Poor

Section ID	Area (SF)	Surface	Est. Last Major Work Year	Est. Last Global Treatment Year	PCI	Condition Rating	PCI % Climate	PCI % Load	PCI % Other
10	10,200	AC	1981	2005	27	Very Poor	54	41	5

41	ALLIGATOR CR	M	72.00	SqFt
41	ALLIGATOR CR	H	38.00	SqFt
43	BLOCK CR	L	5091.00	SqFt
45	DEPRESSION	L	58.00	SqFt
50	PATCHING	L	18.00	SqFt
50	PATCHING	M	130.00	SqFt
52	RAVELING	L	1560.00	SqFt
57	WEATHERING	M	3641.00	SqFt
