SOUTH CAROLINA AERONAUTICS COMMISSION

STATEWIDE AIRFIELD PAVEMENT MANAGEMENT SYSTEM UPDATE

6J4 - Saluda County Airport

2023

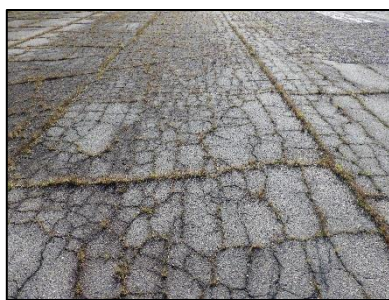
Poor/Failed Pavement

Pavements that are Poor to Failed require significant and costly interventions such as reconstruction to restore the pavement to operational service.

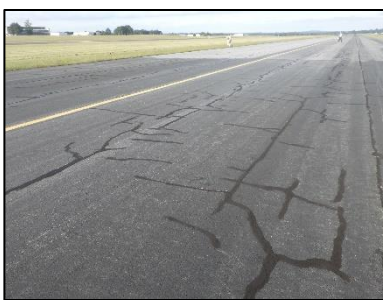
Fair Pavement

Pavements with a Fair condition rating typically require rehabilitation, or maintenance activities if rehabilitation cannot be immediately performed.

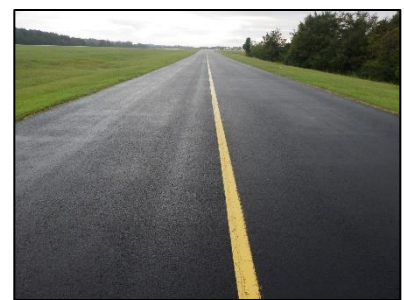
Good/New Pavement

Pavements classified as Good require either no treatment or would benefit from the application of preventive maintenance activities such as crack sealing.
