SOUTH CAROLINA AERONAUTICS COMMISSION

STATEWIDE AIRFIELD PAVEMENT MANAGEMENT SYSTEM UPDATE

PYG - Pageland Airport

2023

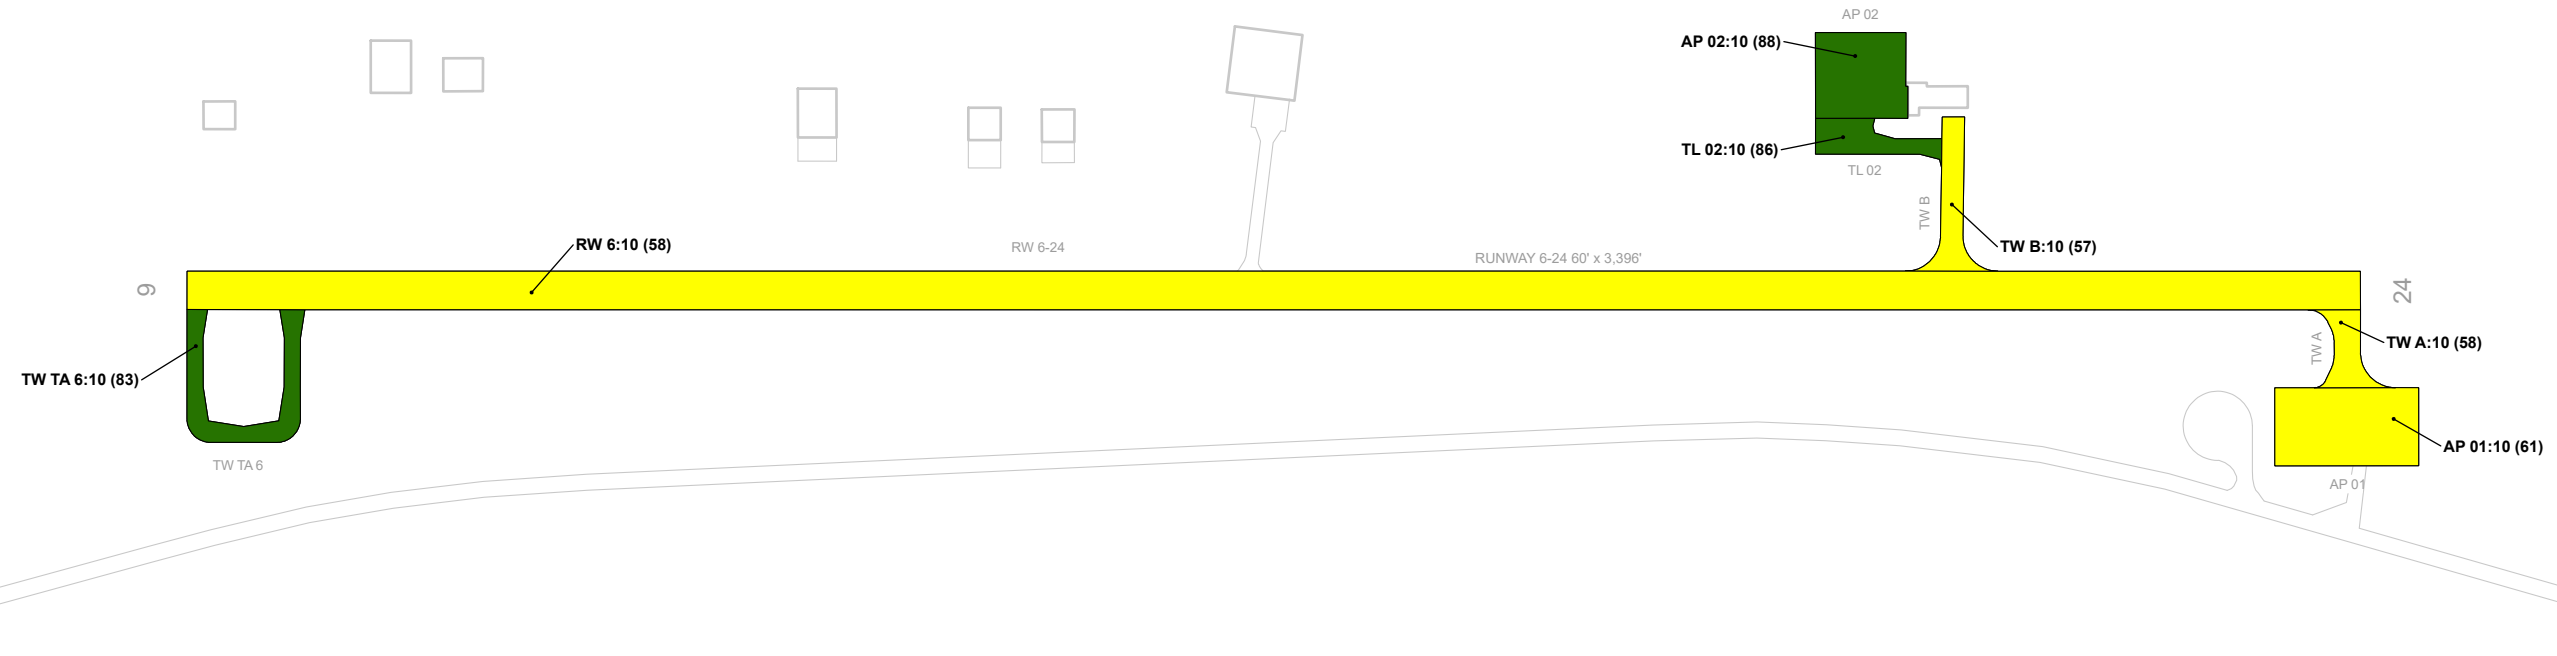
2023 Pavement Condition Index

The area-weighted average PCIs by branch use are summarized in the figure below. The current PCIs at a section-level are displayed graphically on the **2023 Airfield Pavement Condition Index Exhibit** and are summarized in **Table 2**.

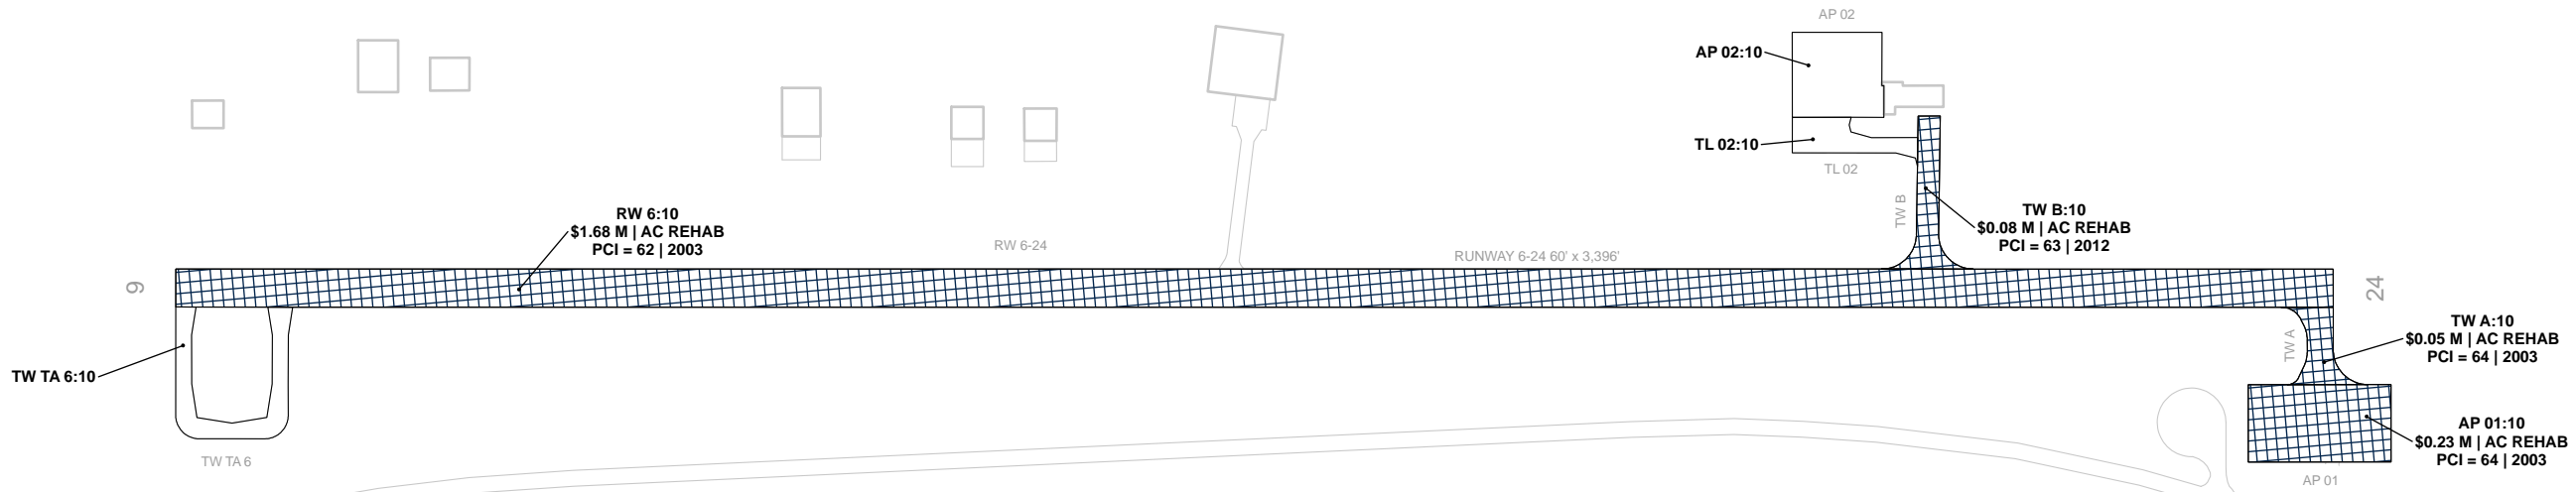
The 5-year major rehabilitation needs analysis at PYG results in a total 5-year cost of \$2.04M. The **5-Year Major Rehabilitation Needs Exhibit** graphically depicts the major rehabilitation needs at a section-level which are also summarized in **Table 5** with rounded costs. Annual needs are displayed graphically in **Figure 8**.

Program Year	Network ID	Branch ID	Section ID	Surface	Area (SF)	PCI Before	Rehabilitation Type	Planning Cost Estimate
2024	PYG	AP 01	10	AC	27,450	63	AC Rehabilitation	\$ 227,000
2024	PYG	RW 6	10	AC	203,760	61	AC Rehabilitation	\$ 1,681,000
2024	PYG	TW A	10	AC	6,539	63	AC Rehabilitation	\$ 54,000
2024	PYG	TW B	10	AC	9,735	62	AC Rehabilitation	\$ 81,000
Total 5-Year Major Rehabilitation Needs =								\$ 2,043,000
