20210525.CA

COLUMBIA METROPOLITAN AIRPORT

PAVEMENT MANAGEMENT PLAN
FINAL REPORT

December 2022

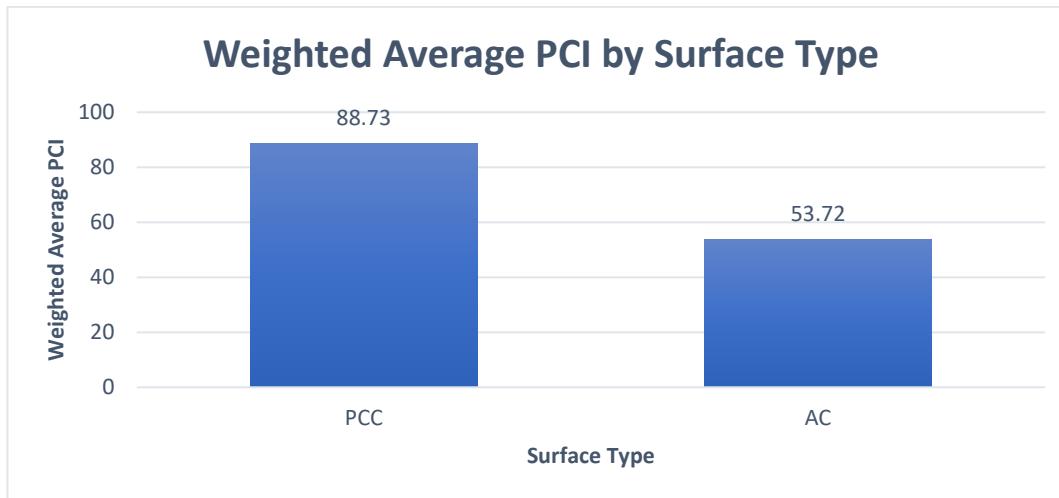
Figure I.1: Summary of PCI Results by Surface Types

This section of the report provides a detailed discussion regarding the overall pavement conditions and distresses present for each pavement facility. Appendix C lists all the pavement sections inspected at CAE that are subject to aircraft loadings and their respective PCI values. Overall, the airfield pavements at CAE have an area-weighted PCI value of 69, indicating that most of the airfield pavements are in "Fair" condition. However, it should be noted that the airfield is made up of approximately 63% PCC pavement, having an average PCI value of 88.73, and 33% AC/AAC pavement, having an average PCI value of 53.72. **Figures I.1** and **Figure I.2** provide an overview of the PCI results distributed by surface type and by branch use, respectively. This demonstrates that while the concrete pavements are in good condition, the asphalt pavements are in poor condition.

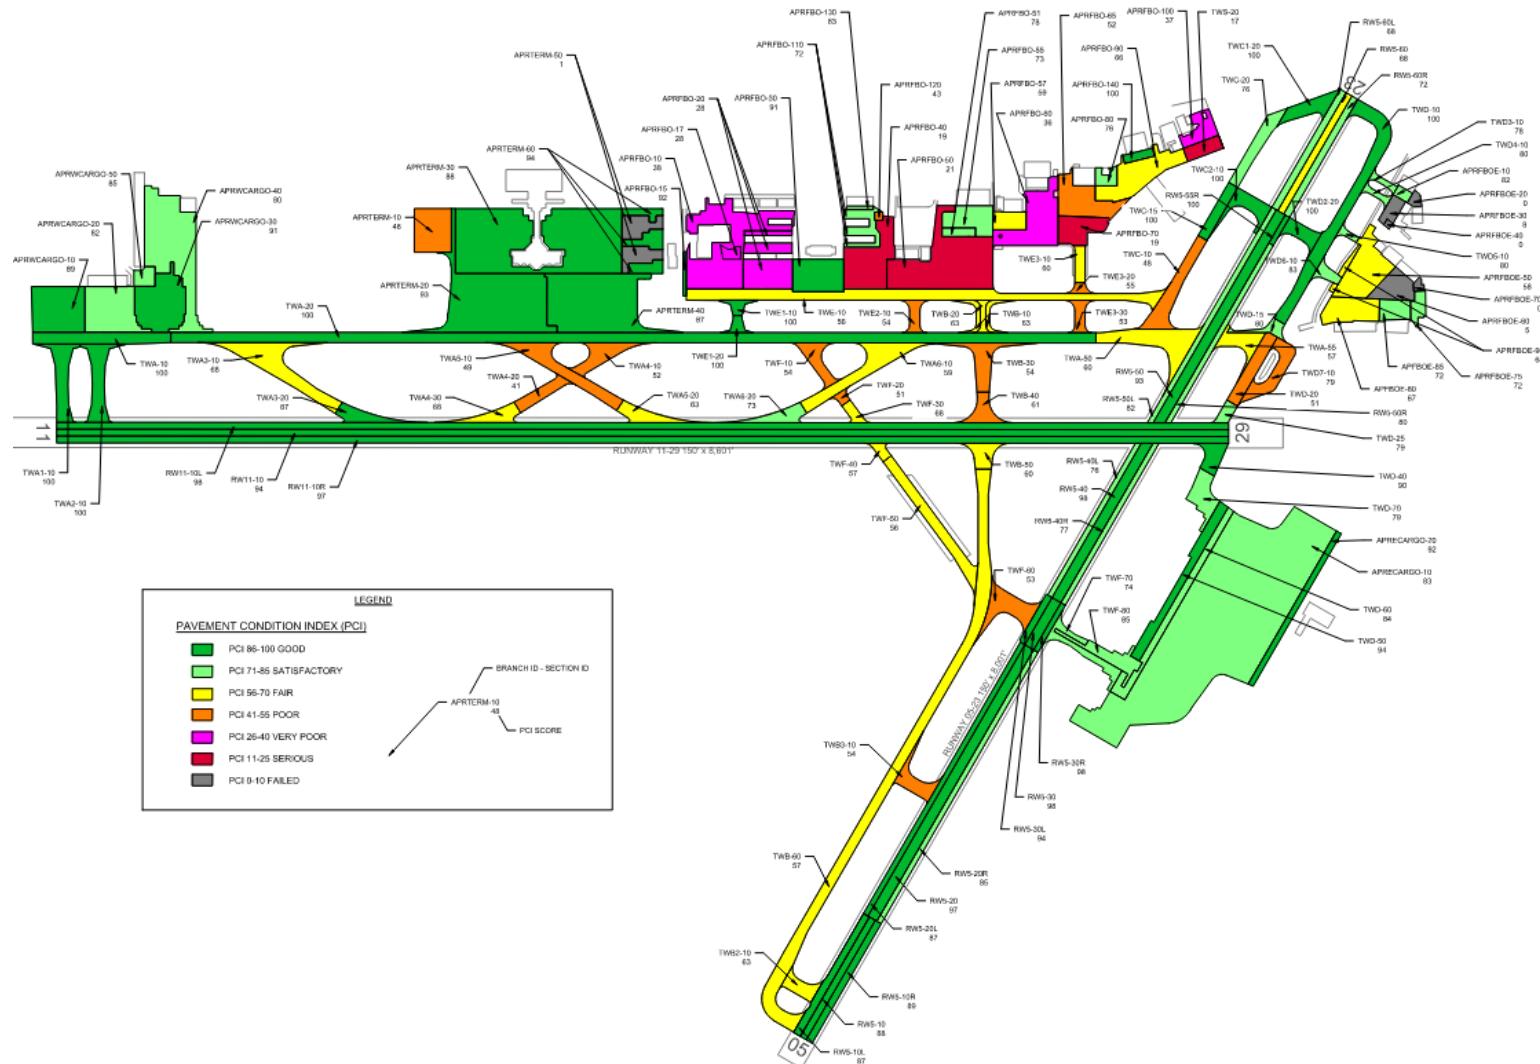
Figure I.3: Pavement Condition Index (PCI) Rating Map

A pavement condition map showing the PCI of each individual section is presented in **Figure I.3**: (See full size map in **Appendix D**).
