# SOUTH CAROLINA AERONAUTICS COMMISSION

# STATEWIDE AIRFIELD PAVEMENT MANAGEMENT SYSTEM UPDATE

5J9 - Twin City Airport

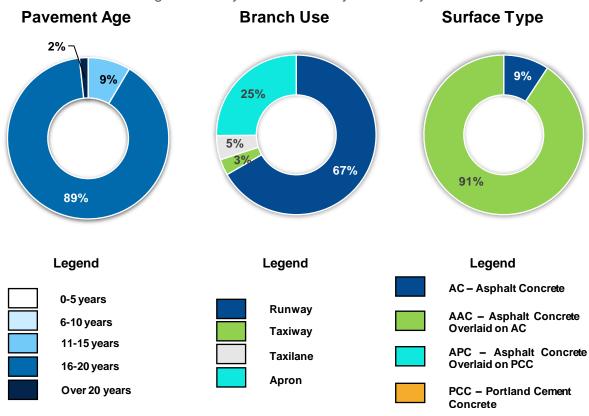
Figure 2 – System Inventory Summary

The following figure summarizes the inventory items at Twin City Airport (5J9). The **Estimated Age Exhibit** provides the last major work date for each pavement section based on the collected documentation.

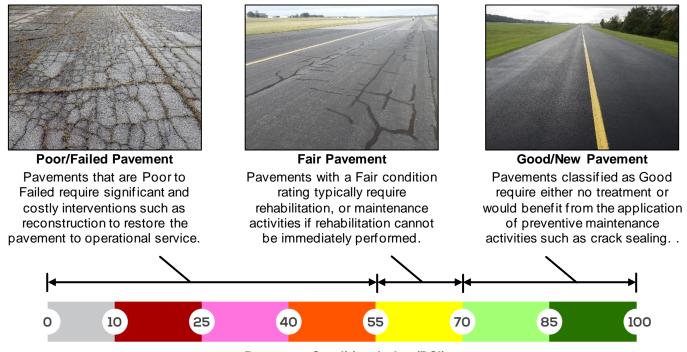
Figure 3 - Representation of Pavement Condition Index Values

Visual condition data collected during the PCI survey is analyzed and used to calculate the current PCI for each inspected sample unit and section. The PCI is a value ranging from 0 to 100, which indicates the apparent structural integrity and surface operational condition of the pavement, with "100" indicating a pavement in new condition and "0" indicating a failed pavement section. Pavement Condition Ratings are associated with PCI categories that range from "Failed" to "Good". Representative photos of varying Pavement Condition Ratings are displayed in **Figure 3**.

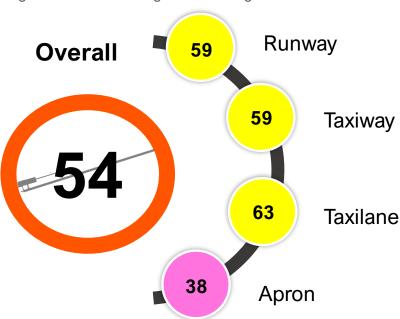
Figure 5 – Area Weighted Average Pavement Condition

The area-weighted average PCIs by branch use are summarized in the figure below. The current PCIs at a section-level are displayed graphically on the **2023 Airfield Pavement Condition Index Exhibit** and are summarized in **Table 2**.

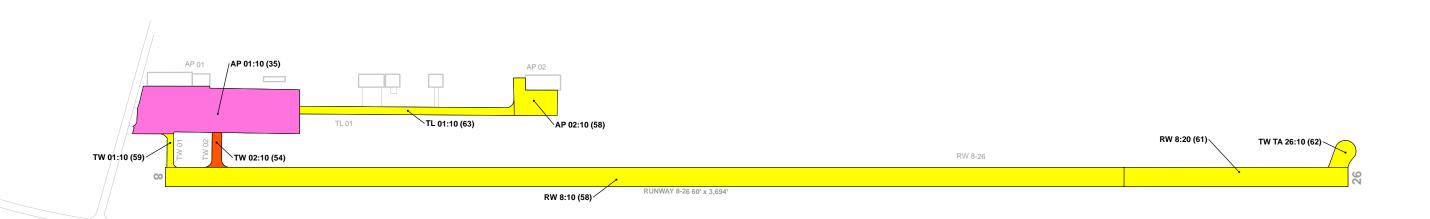
#### 2023 Pavement Condition Index

PCI 86-100 Good PCI 71-85 Satisfactory

PCI 0-10 Failed

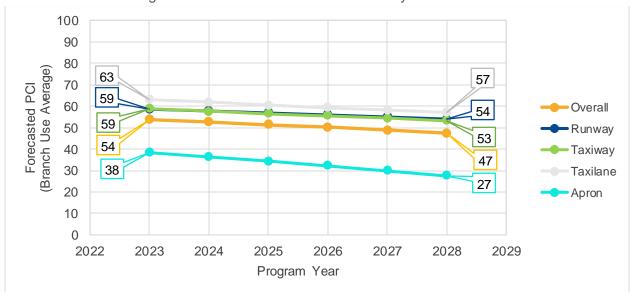
Figure 6 - Forecasted 5-Year PCI by Branch Use

A primary objective of this APMS is to estimate the future condition of each individual pavement section. PAVER<sup>TM</sup> was utilized to develop prediction curves and determine typical deterioration rates that are then used to forecast a future PCI value. This value will assist decision makers in determining at what point in time certain pavement sections will require rehabilitation. The figure below shows the current and 5-year area-weighted forecasted pavement condition distribution of each functional use (Runway, Taxiway, Taxilane, Apron) found at the Airport. The forecasted 5-year PCIs at a section-level are displayed graphically on the **2028 Forecasted Airfield Pavement Condition Index Exhibit** and are summarized in **Table 3**. All forecasts presented assume that no maintenance or rehabilitation is performed within the 5-year analysis period. **Figure 6** displays the forecasted pavement conditions at the branch-level for 5J9.

All condition forecasts are based on historical observations and analysis of South Carolina airfield pavements. The forecasts are not a guarantee of future PCI: - rather, they are a planning tool to aid in the timing of maintenance and rehabilitation activities.

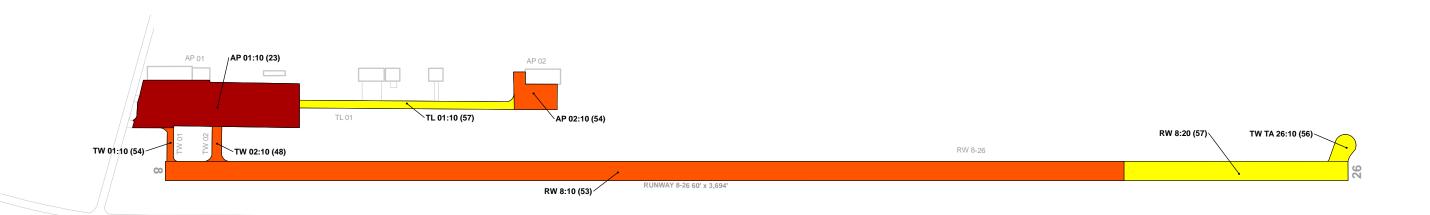
#### 2028 Forecasted Pavement Condition Index

PCI 86-100 Good PCI 71-85 Satisfactory

PCI 0-10 Failed

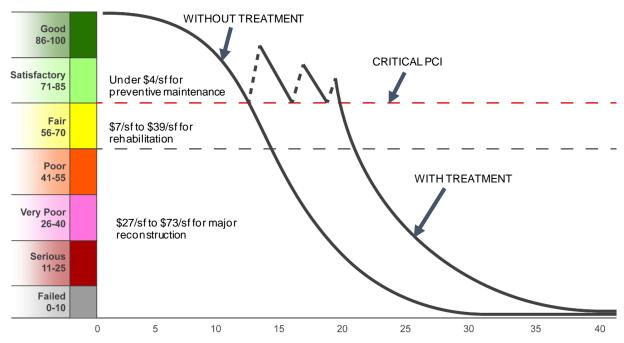
Figure 7 – Pavement Life and the Effect of Treatments

M&R planning considers various methods of repair to address the cause of the problem rather than just treating the symptom. As pavements deteriorate, repair costs can increase significantly. Once pavements have deteriorated below a certain condition threshold (the Critical PCI value), the pavement benefits more from substantial rehabilitation in lieu of maintenance activities. The figure below illustrates how the cost of pavement repairs can exponentially increase if M&R activities are delayed.

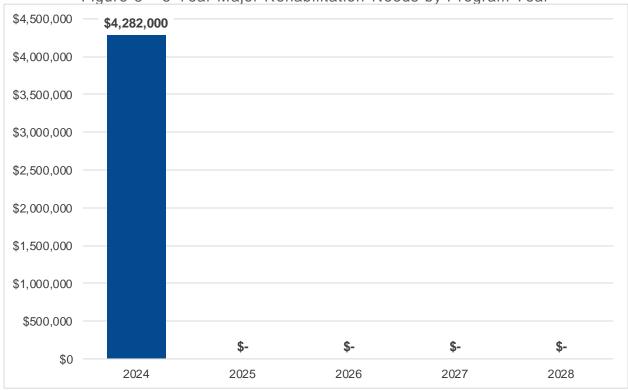
Figure 8 – 5-Year Major Rehabilitation Needs by Program Year

The 5-year major rehabilitation needs analysis at 5J9 results in a total 5-year cost of \$4.28M. The **5-Year Major Rehabilitation Needs Exhibit** graphically depicts the major rehabilitation needs at a section-level which are also summarized in **Table 5** with rounded costs. Annual needs are displayed graphically in **Figure 8**.
