SOUTH CAROLINA AERONAUTICS COMMISSION

STATEWIDE AIRFIELD PAVEMENT MANAGEMENT SYSTEM UPDATE

S19 - McCormick County Airport

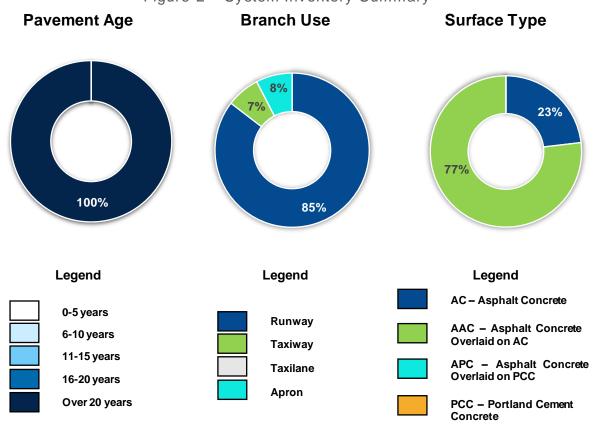
Figure 2 - System Inventory Summary

The following figure summarizes the inventory items at McCormick County Airport (S19). The **Estimated Age Exhibit** provides the last major work date for each pavement section based on the collected documentation.

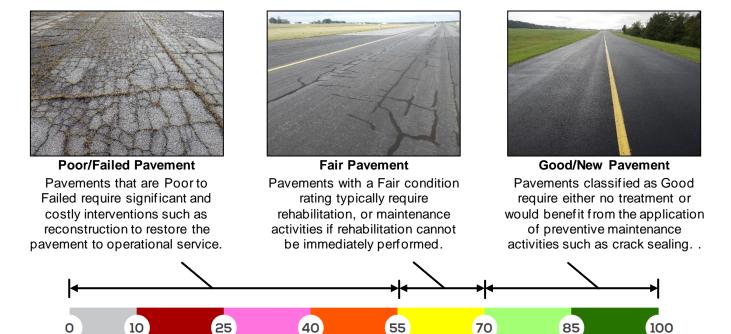
Figure 3 - Representation of Pavement Condition Index Values

Visual condition data collected during the PCI survey is analyzed and used to calculate the current PCI for each inspected sample unit and section. The PCI is a value ranging from 0 to 100, which indicates the apparent structural integrity and surface operational condition of the pavement, with "100" indicating a pavement in new condition and "0" indicating a failed pavement section. Pavement Condition Ratings are associated with PCI categories that range from "Failed" to "Good". Representative photos of varying Pavement Condition Ratings are displayed in **Figure 3**.

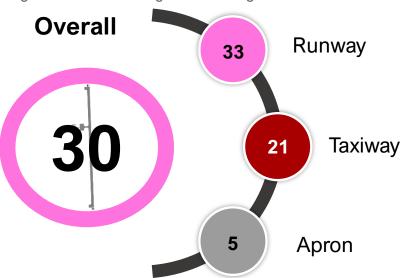
Figure 5 – Area Weighted Average Pavement Condition

The area-weighted average PCIs by branch use are summarized in the figure below. The current PCIs at a section-level are displayed graphically on the **2023 Airfield Pavement Condition Index Exhibit** and are summarized in **Table 2**.

The PCI survey for McCormick County Airport (S19) was performed in January 2023. **The overall area-weighted average PCI value of the network was 30**, representing a condition rating of **Very Poor**. None of inspected pavements are in Good, Satisfactory, or Fair condition. All the pavements are in Poor or worse condition as summarized in **Figure 4**.

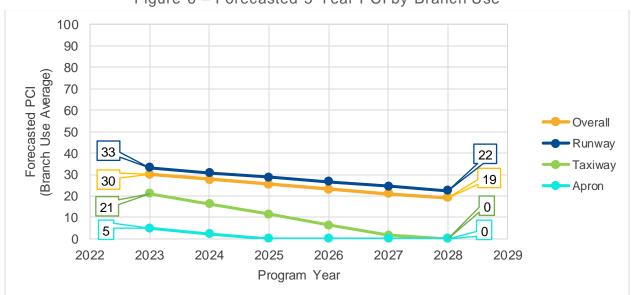
Figure 6 - Forecasted 5-Year PCI by Branch Use

A primary objective of this APMS is to estimate the future condition of each individual pavement section. PAVERTM was utilized to develop prediction curves and determine typical deterioration rates that are then used to forecast a future PCI value. This value will assist decision makers in determining at what point in time certain pavement sections will require rehabilitation. The figure below shows the current and 5-year area-weighted forecasted pavement condition distribution of each functional use (Runway, Taxiway, Apron) found at the Airport. The forecasted 5-year PCIs at a section-level are displayed graphically on the **2028 Forecasted Airfield Pavement Condition Index Exhibit** and are summarized in **Table 3**. All forecasts presented assume that no maintenance or rehabilitation is performed within the 5-year analysis period. **Figure 6** displays the forecasted pavement conditions at the branch-level for S19.

All condition forecasts are based on historical observations and analysis of South Carolina airfield pavements. The forecasts are not a guarantee of future PCI: - rather, they are a planning tool to aid in the timing of maintenance and rehabilitation activities.

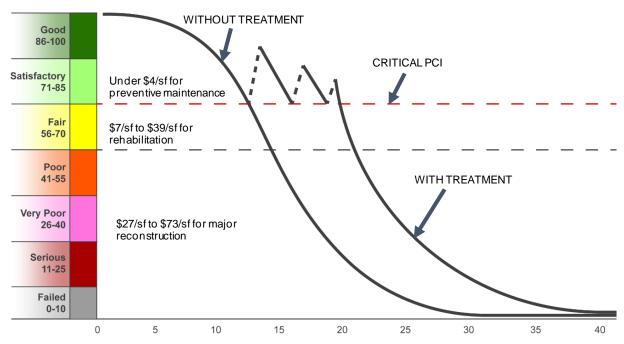
Figure 7 – Pavement Life and the Effect of Treatments

M&R planning considers various methods of repair to address the cause of the problem rather than just treating the symptom. As pavements deteriorate, repair costs can increase significantly. Once pavements have deteriorated below a certain condition threshold (the Critical PCI value), the pavement benefits more from substantial rehabilitation in lieu of maintenance activities. The figure below illustrates how the cost of pavement repairs can exponentially increase if M&R activities are delayed.
